NUMBER: 08-017-16

GROUP: Electrical

Incorrect Instrument Cluster Displays

This bulletin involves updating or replacing the Instrument Panel Cluster (IPC).

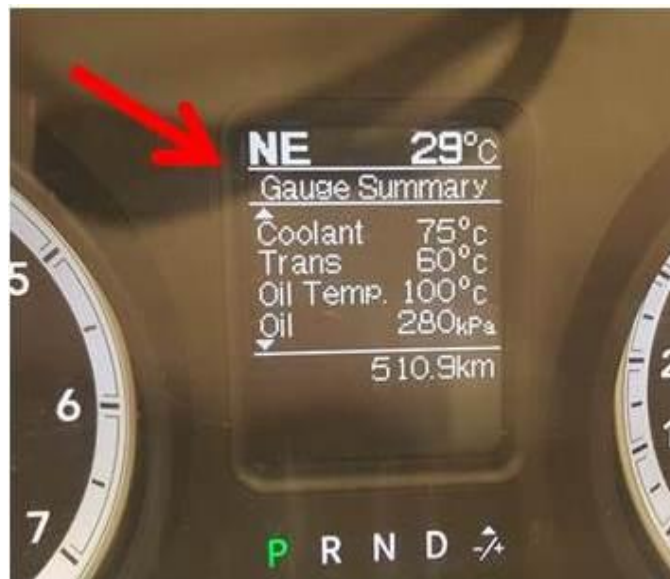
Fig. 1 Three Inch Monochromatic Display

- Cruise set speed shows the incorrect units after cycling the ignition (3.5" Monochromatic IPC).
- Loss of odometer line after Parking Assist screens or other events (3.5" Monochromatic IPC).
- Odometer "tenths" position does not increment correctly (7.0" Color IPC).
- Trailer Trip and Trailer Brake Gain menus appear when not equipped with this feature (7.0" Color IPC).
- PTO Menu appears on manual transmission equipped vehicle (3.5" and 7.0" IPC).
- Some of the text in the cluster for the Diesel Exhaust Fluid (DEF) reminder is overlapping.

- a. 3.5" Monochromatic Display (Figure 1) >>> Proceed to [Step #1](#) of Repair Procedure **#1 Reprogram IPC.**
- b. 7.0" Color Display (Figure 2) >>> Proceed to [Step #1](#) of Repair Procedure **#2 Replace IPC.**

#1. Reprogram IPC
