SI M51 02 16
Body Equipment

Rear Door Is Difficult to Open

F54 (Cooper Clubman, Cooper S Clubman)

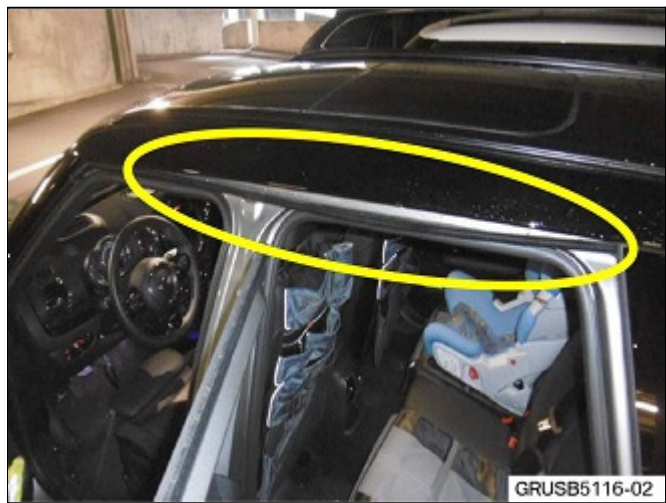
<p>GRUSB5116-02</p>	<p>1. Inspect the dislodged cover strip.</p> <p>Is the cover strip damaged or the securing clip broken?</p> <p>YES- replace the cover strip.</p> <p>NO- go to step 2.</p>
	<p>2. View of broken securing clip.</p>

Reinstall cover strip, unless damaged or the securing clip(s) are broken, then replace.

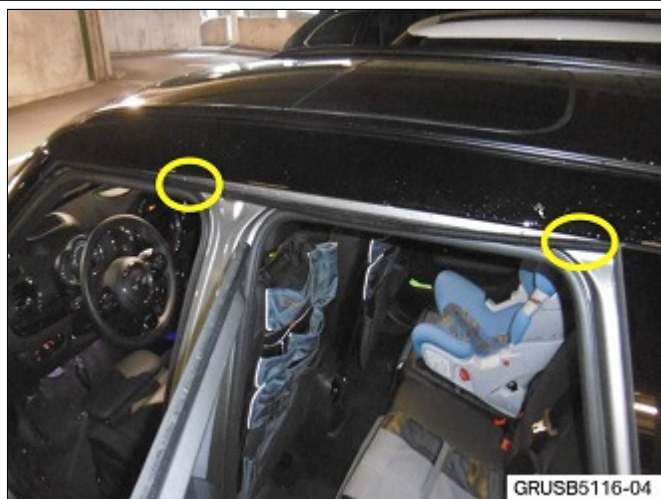
3. This close up picture shows the defect.

4. Clean the affected area between the B and C-pillar.
5. Prepare a piece of double sided adhesive tape (83 19 0 445 309) to a dimension of (50mm x 10mm x 1.2mm) and apply between the cover strip and body frame.
