**NUMBER:** 23-028-16

Rattle/Squeak From Rear Seat Armrest

2014 - 2016 (KL) Jeep Cherokee

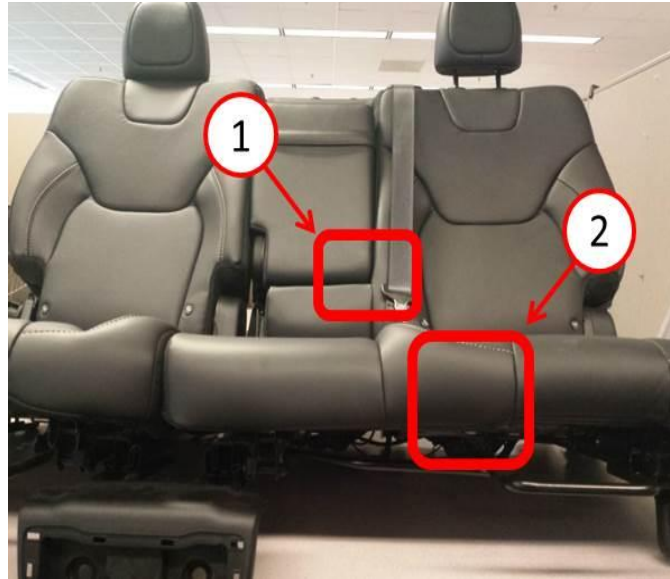
**Fig. 1 Seat Noise Areas**

1. If the customer describes symptom/condition, verify by driving the vehicle over roads of varying quality and surface types. A noise/rattle may be heard from the upper area of arm rest/seat back and/or the lower portion of the seat bottom cushion.
2. Where is the noise/rattle coming from (Fig. 1)?
  - a. If the noise is coming from both areas of the seat, proceed to [Step #1](#) of Repair Procedure A and continue through [Step #1](#) of Repair Procedure B.
  - b. If the noise is coming from the lower portion of the seat, proceed to [Step #1](#) of Repair Procedure A.
  - c. If noise is heard from the top area of rear seat, start at [Step #1](#) of Repair Procedure B.

- 1 - Top Area Of Rear Seat
- 2 - Lower Portion Of The Seat

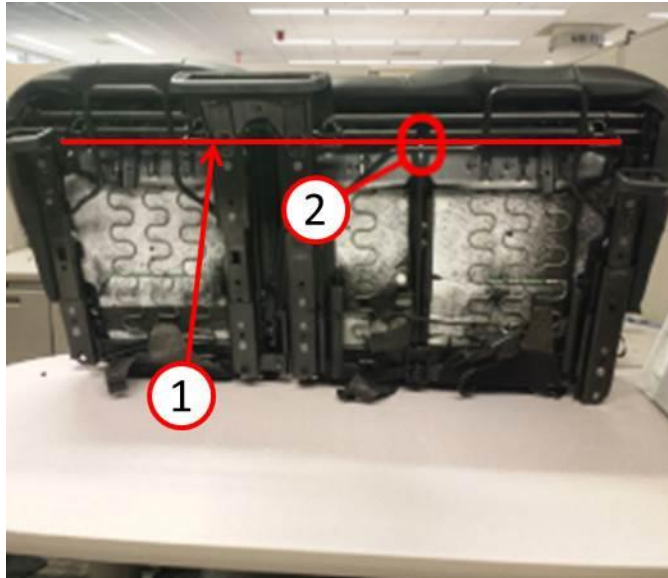
**Fig. 2 Kneel Tube And Contact Area**

- 1 - Line Indicates Position Of Kneel Tube
  - 2 - Intersection Of Kneel Tube And Center Rail Notch
-

1. Pull down on the kneel tube near the area shown in (Fig. 2) and wedge a piece of folded paper between kneel tube and center rail notch (Fig. 3). Drive vehicle over bumpy or uneven road surfaces and listen for the noise.

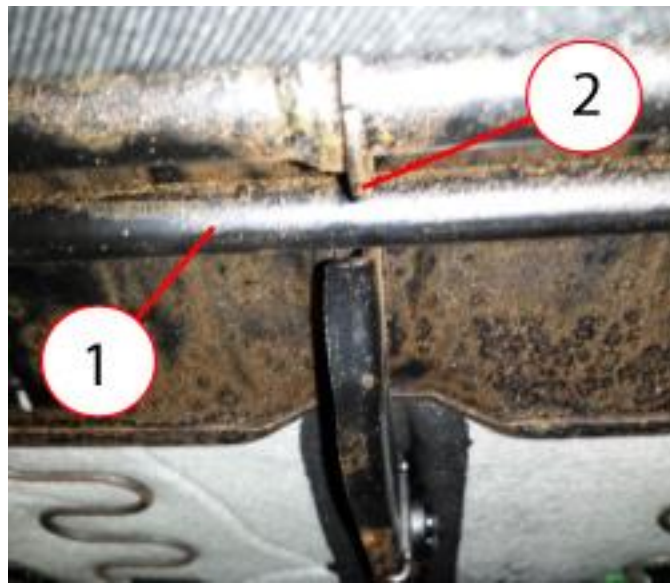
**Fig. 3 Kneel Tube Contact Area**

- 1 - Kneel Tube
- 2 - Center Rail Notch

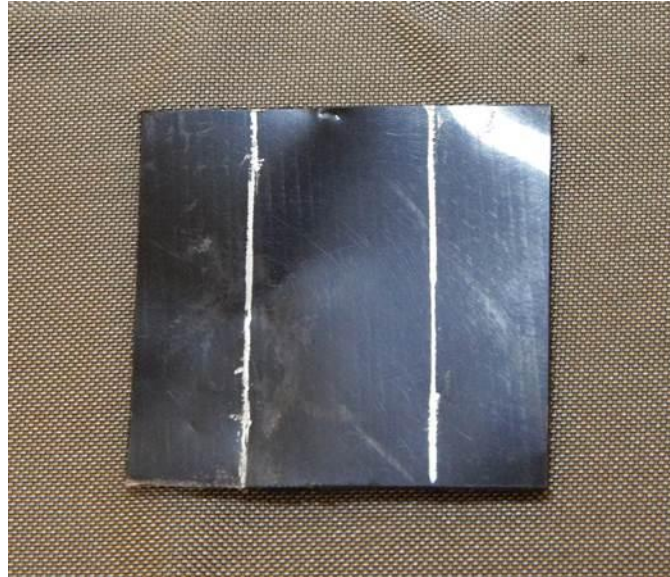
**Fig. 4 Tape Dimensions**

1 - Cut Tape To Dimensions

3. Cut flock tape to the proper width of 4 cm (1.5 in.). Divide into thirds and remove the adhesive backing from both sides, leaving the center intact. The backing over the center of the tape will assist in positioning of the tape around the kneel tube.(Fig. 4).

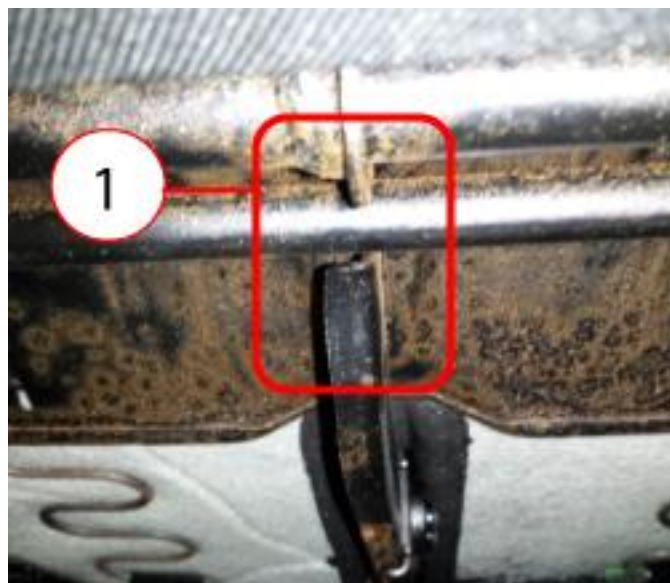
**Fig. 5 Kneel Tube Contact Area**

1 - Contact Point Of Center Rail And Kneel Tube

- 
4. Locate the kneel tube to center rail notch connection shown in (Fig. 5). Move the seat forward if necessary.

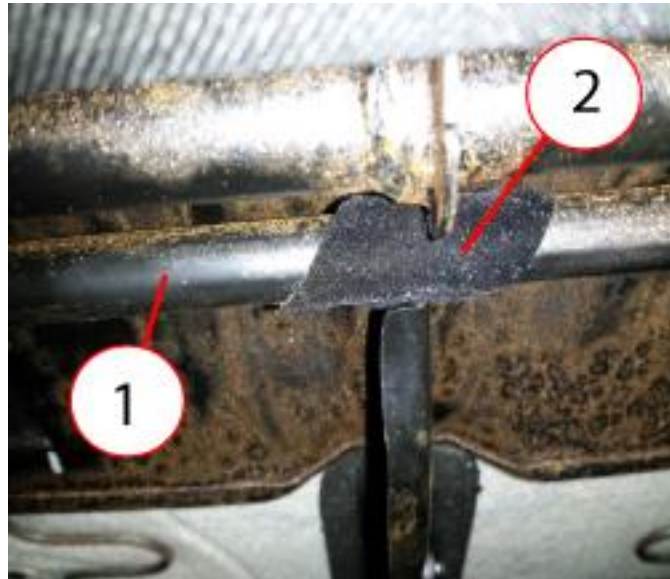
**Fig. 6 Flock Tape Installed**

1 - Kneel Tube

2 - Flock Tape

5. Clean the area with isopropyl alcohol or equivalent to remove any grease, oil, etc. from the kneel tube surface.
6. Wedge the tape around the kneel tube ([Fig. 6](#)).

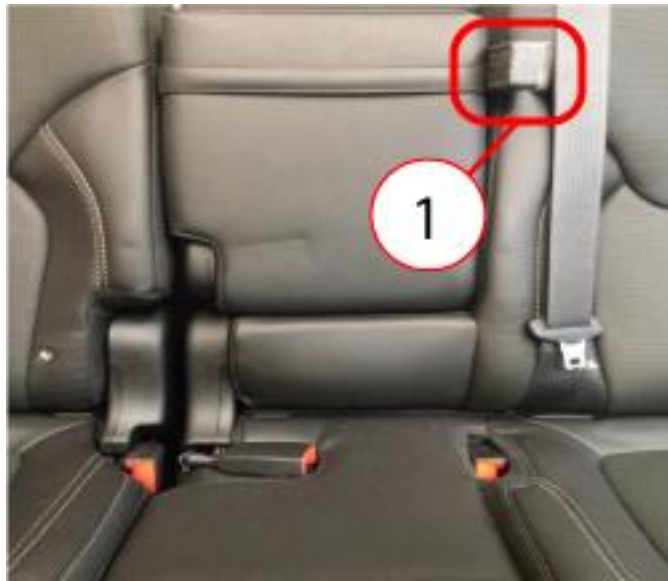
**Fig. 7 Shim Placement**

1 - Area Where Wedging Object Should Be Placed

1. If a rattle is heard and can be silenced by wedging an object approximately 2.5 cm (1 in) in width between the upper right side of the armrest and the seat back ([Fig. 7](#)), proceed to [Step #3](#) of Repair Procedure B.

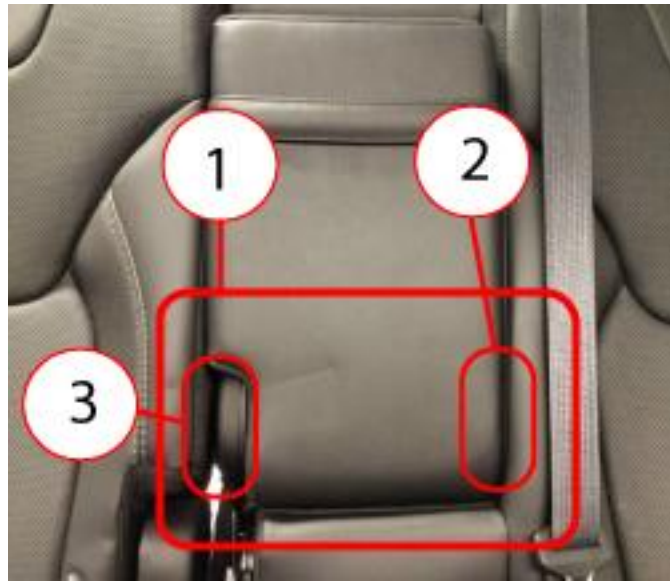
***Fig. 8 Rear Armrest Front***

- 1 - Area Where Noise Can Be Heard
- 2 - Area Where Tape Will Be Placed
- 3 - Side Shield Location

2. With wedge installed, pound on seat back to simulate effect of rough or inconsistent roads.
3. Does the rattle noise stop?
  - a. YES>>> Remove wedge and continue with [Step #4](#) of Repair Procedure B.
  - b. NO>>> This Bulletin does not apply. Remove wedge, normal diagnosis should be performed.
4. Fold down the 40% portion of the rear seat to access the armrest side shield.

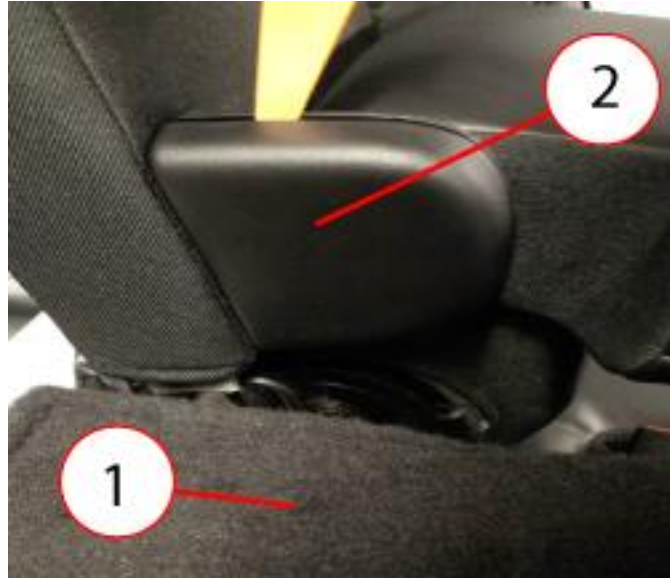
**Fig. 9 Side Shield**

- 1 - 40% Portion Of The Rear Seat (Folded Down)
  - 2 - Side Shield Cover
-

- Using a trim/panel tool, remove the armrest side shield (Fig. 9).

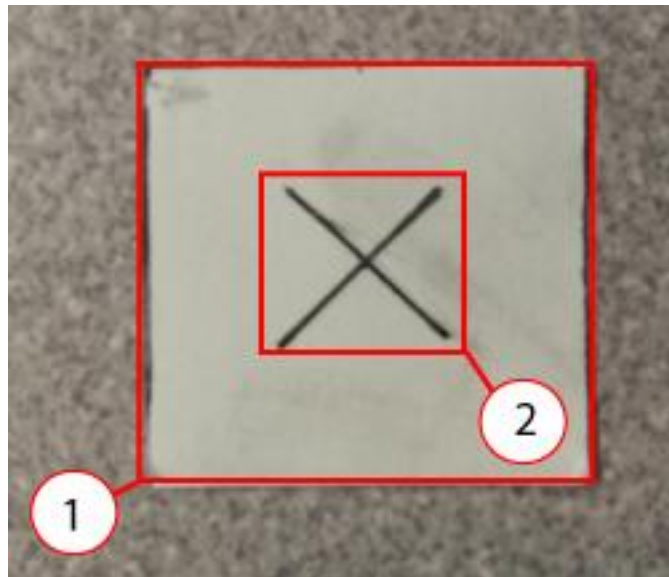
**Fig. 12 Final Cut dimensions**

- 1 - Outside Dimensions Of 2.5 cm X 2.5 cm (1 inch X 1 inch)
  - 2 - Inside Dimensions Of 1.25 cm X 1.25 cm (1/2 inch X 1/2 inch)
-

10. Cut the anti-squeak tape in a 2.5 cm (1 in.) square. Notice the 'X' in the center of the ([Fig. 12](#)), tape. Slice/cut along the lines of the "X" creating four flaps. This is intended to create a pass-through point for the armrest rod when the tape is applied to the armrest pivot bracket.
