NUMBER: 23-024-16

Distorted Door Run Applique At Top Of Window

2016 (PF) Dodge Dart

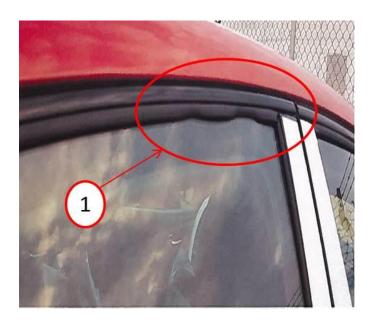
Fig. 1 Door Glass Run Inspection Area

The customer may describe that the left front door glass run applique has a wrinkled appearance or that the window does not fully close due to applique seal entrapment.

- 1. Inspect the left front door glass run applique molding for fit and finish.
- 2. Is the left front door glass run applique wrinkled or distorted as shown in (Fig. 1)?
 - a. YES>>> Proceed to Step #1.
 - b. NO>>> This bulletin has been completed, use LOP (23-33-20-9N) to close the active RRT.

1 - Distorted Applique

- Remove and discard the front door glass. Refer to the detailed service procedures available in DealerCONNECT> TechCONNECT under: Service Info>23 - Body/Door -Front/Glass, Door/Removal.
- 2. Remove and discard the front door glass run applique molding. Refer to the detailed service procedures available in DealerCONNECT> TechCONNECT under: Service Info>23 Body/Door Front/Applique/Removal.
- Install the new door glass run applique molding. Refer to the detailed service procedures available in DealerCONNECT> TechCONNECT under: Service Info>23 -Body/Door - Front/Applique/Installation.
- 4. Install the new front door glass. Refer to the detailed service procedures available in DealerCONNECT> TechCONNECT under: Service Info>23 Body/Door Front/Glass, Door/Installation.
