NUMBER: 23-004-16 REV. A

GROUP: Body

Tailgate Contacting Pickup Box Panel When Closing

2015 - 2016 (DS) Ram 1500 Pickup

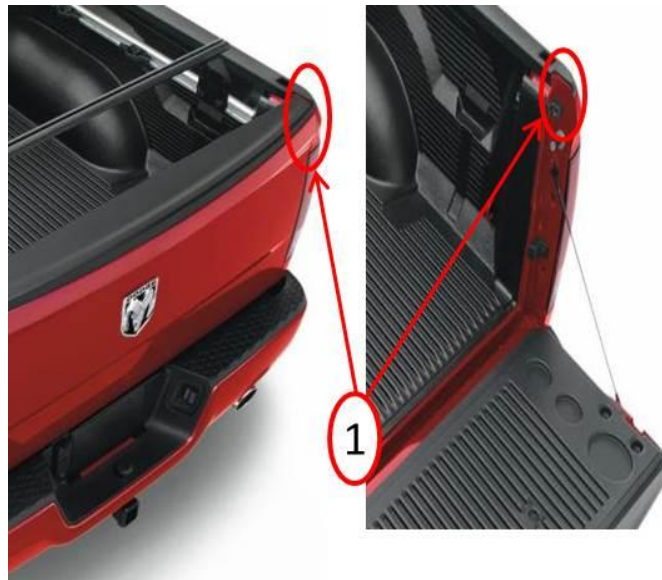
Fig. 1 Contact Area

The customer may describe the tailgate making contact with the passenger side outer box panel.

1. Visually inspect the passenger side of the tailgate for contact with the outer box panel as shown in (Fig. 1).

1 - Contact Area

2. Does the tailgate make contact with the passenger side outer box panel?
 - a. YES>>> Proceed to [Step #3](#).
 - b. NO>>> This bulletin does not apply, use LOP (23-00-25-90) to close the active RRT.
3. Flatten the passenger side outer pickup box sheet metal flange to prevent contact with the tailgate.
4. Feather sand the surface area with P500 sandpaper.
5. Which type of basecoat will be used?
 - a. Solvent basecoat >>> proceed to [Step #6](#).
 - b. Waterborne basecoat >>> proceed to [Step #14](#).
