NUMBER: 23-006-16 REV. A

Right Front Door Outer Belt Molding Too High

2016 (DS) Ram 1500 Pickup

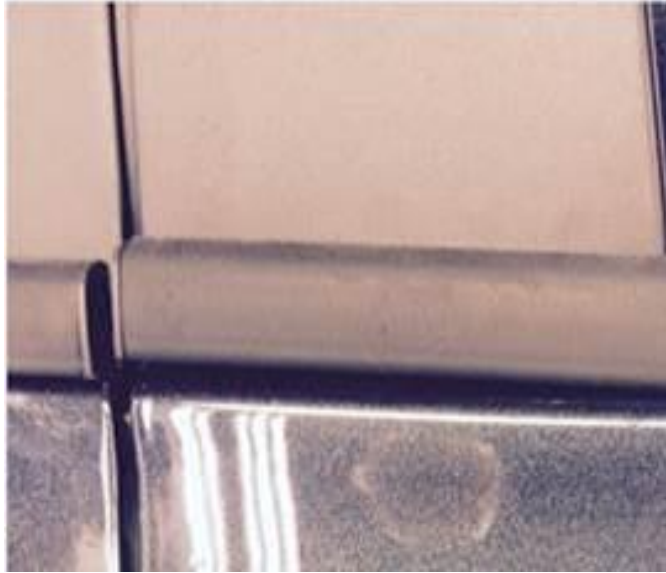
The customer may describe that the outer belt molding is sitting too high on the door.

1. Inspect the right front outer belt molding for fit and finish.
2. Is the right front outer belt molding sitting too high on the door as shown in (Fig. 1)?
 - a. YES>>> Proceed to [Step #1](#).
 - b. NO>>> This bulletin has been completed, use LOP (23-51-16-9C) to close the active RRT.

Fig. 1 Outer Belt Molding Difference

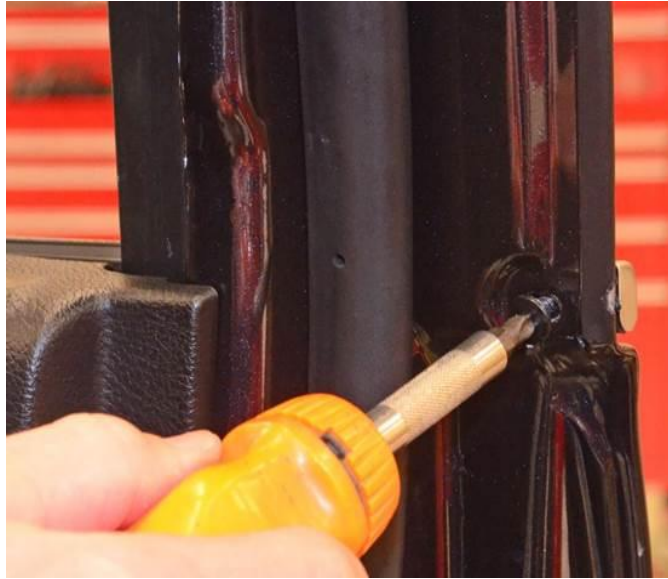
Fig. 2 Screw Securing Belt Molding

1. Remove the outer belt molding retaining screw(Fig. 2).

- 8. Remove the tape used to protect B pillar surface and trim stick (Fig. 3) install and align the outer belt molding back into place to match the rear door outer belt molding and install the screw (Fig. 2).

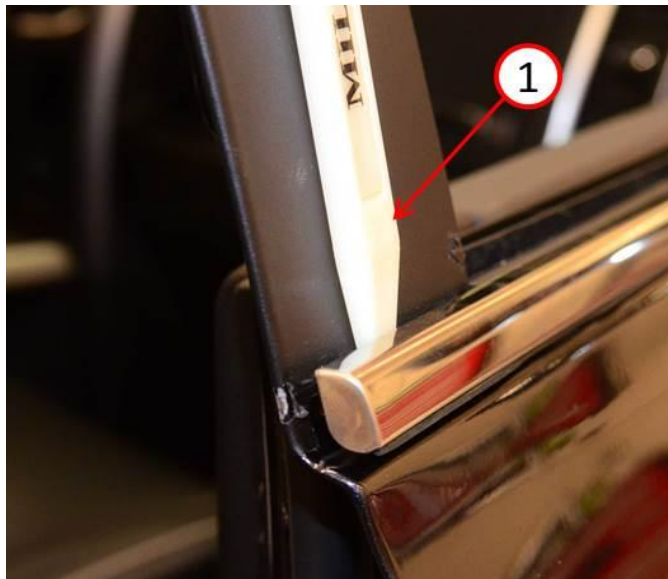
Fig. 3 Trim Stick

1 - Trim stick

NOTE: Use care not to damage the molding, Do not apply excessive outward force.

3. Insert a trim stick between the B pillar and belt molding (Fig. 3).

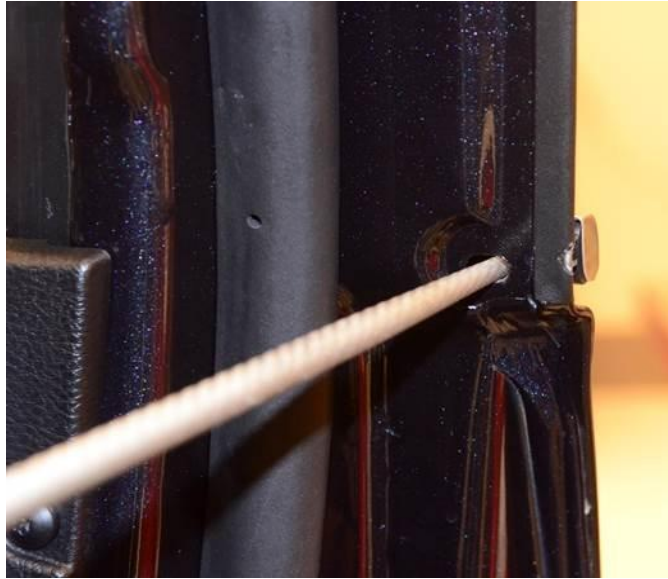
Fig. 4 File Area

- Use a file to open up the bottom of slot for the screw hole on the door (Fig. 4). The final height of the slot should be around 8mm (0.315 in). Do not exceed 10mm (0.4 in) slot height (Fig. 5). Be careful not to damage the surface or molding with the file.

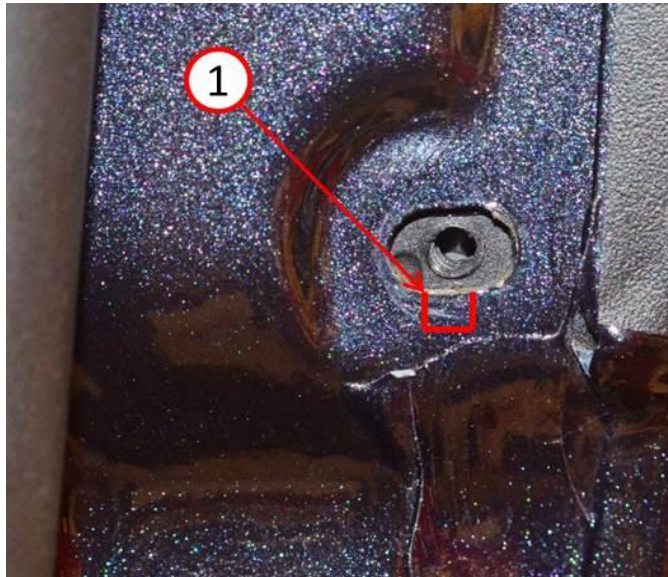
Fig. 5 Area To Be Filed

1 - Material To Be Removed Around 8mm (0.315 in)

-
- Remove the burrs and remove all residue.
 - Clean the areas to be painted using a cloth with a low solvent content or equivalent.
 - Apply a corrosion-preventor primer (3M® single step primer) or equivalent. Allow the primer to dry for approximately 10 minutes at a temperature of 60°-70°C (140°-158°F).
