**NUMBER:** 23-007-16

Water Entering Passenger Side Floor Area

2016 (DS) RAM 1500 Pickup

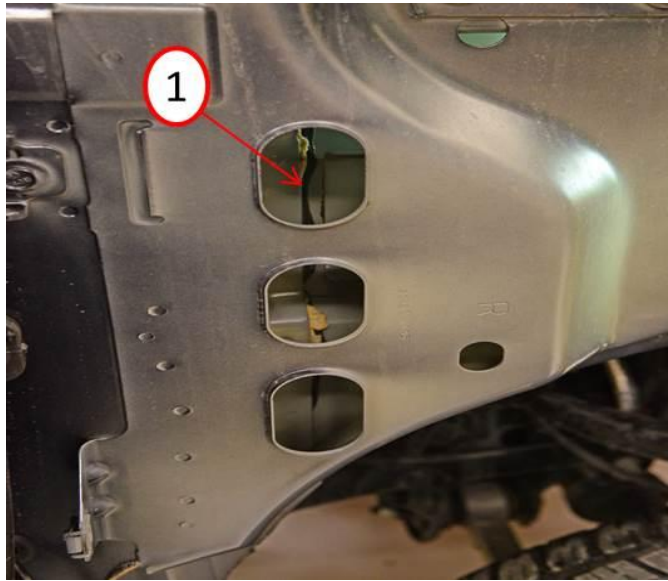
***Fig. 2 Seam To Be Repaired***

The customer may experience wet carpet in the right front footwell. This condition may be due to an insufficient adhesive bead between the aperture and cowl side.

1 - Seam

2. Locate the seam between the aperture and cowl through the three access holes (Fig. 2).
