NUMBER: 23-019-16

DATE: May 05, 2016

Trunkpan Bolts Loose Causing Clunk When Driving Over Bumps

2016 (ZD) Dodge Viper

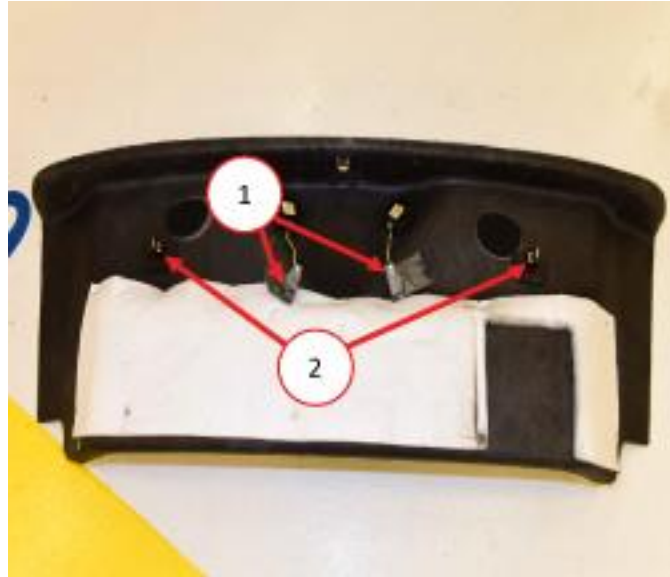
Fig. 3 Trunk Trim Panel

- 1 - Cargo lamp connectors
 - 2 - Spring clip tab locations
-

4. Remove the rear valance close out cover ([Fig. 3](#)). Use trim stick to assist with removing spring clip retainers. Take care in removal of panel, spring clips are bonded to panel and may be damaged if care is not taken during removal.

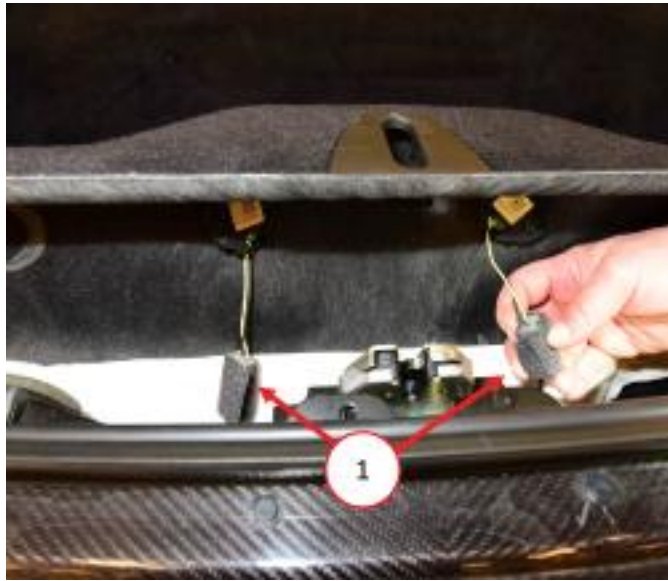
Fig. 4 Foam Tape On Electrical Connector

1 - Foam tape around cargo lamp connectors

5. Take care in removing foam tape from rear cargo lamp connectors (Fig. 4), during connector separation.

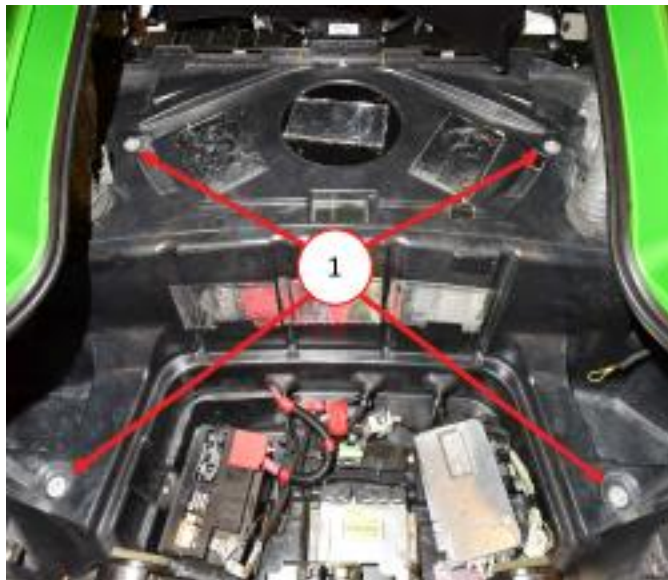
Fig. 7 Trunkpan Bolt Locations

The customer may describe a noise heard from the rear interior of the vehicle when driving at lower speeds over bumps or on a rough road.

1 - Trunkpan bolt locations

12. Torque the four main M-8 bolts to 22 N·m (16 Ft·Lbs) (Fig. 7).
