**NUMBER:** 17-001-16

Rear Shock Noise

This bulletin involves replacing both rear shock jounce bumpers.

2015 - 2016 (LD) Dodge Charger

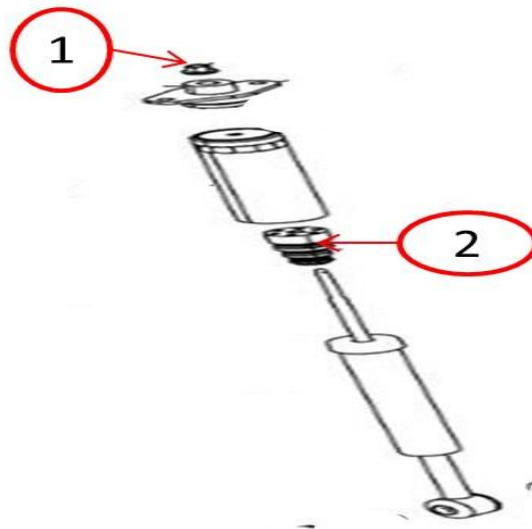
**Fig. 1 Rear Shock Assembly**

Some customers may experience a noise in the rear of the vehicle when going over bumps.

1. Raise and support the vehicle. Refer to the detailed service procedures available in DealerCONNECT> TechCONNECT under: Service Info> 04 - Vehicle Quick Reference> Hoisting - Standard Procedure.
2. Remove the rear shock absorber assembly. Refer to the detailed service procedures available in DealerCONNECT> TechCONNECT under: Service Info>17 - Rear Suspension/Shock Absorber, Suspension/Removal>Non SRT.
3. Disassemble the rear shock assembly then remove and discard the old jounce bumper and install the new jounce bumper ([Fig. 1](#)). Reassemble the shock absorber in reverse order. Tighten Shock Rod to Shock Mount Nut to 24 N·m (18 ft.lbs).

- 
4. Install the rear shock absorber assembly. Refer to the detailed service procedures available in DealerCONNECT> TechCONNECT under: Service Info>17 - Rear Suspension/Shock Absorber, Suspension/Installation>Non SRT.
  5. Repeat procedure for the other side.
  6. Lower the vehicle. Repair is complete.
