NUMBER: 08-074-16

Flash: Video Routing Module Enhancements For Rear Seat Entertainment System

2017 (RU) Chrysler Pacifica

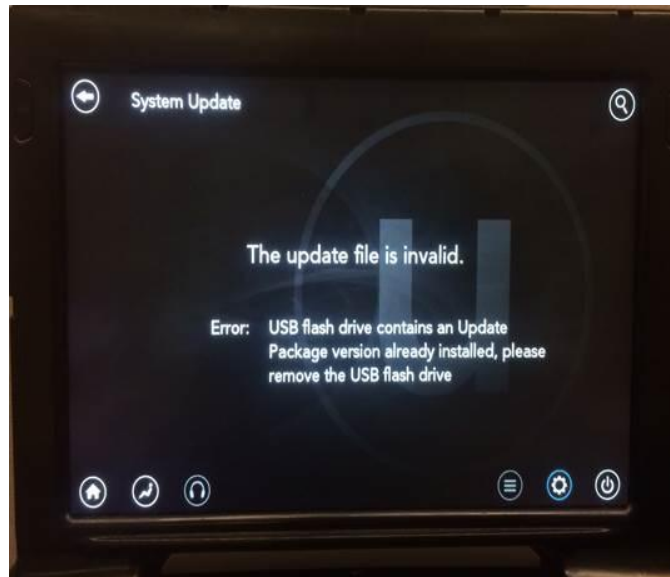
Fig. 2 Error Screen

NOTE: If USB stick is left in the port after system reboot, there will be a pop-up that states the file is invalid ([Fig. 2](#)). This is not a concern as the system is already up-to-date. Remotes will also need to be re-paired if not already done so through new vehicle prep.
