**NUMBER:** 08-075-16

Body Control Module (BCM) Re-configure

2017 (DS) RAM 1500 Pickup

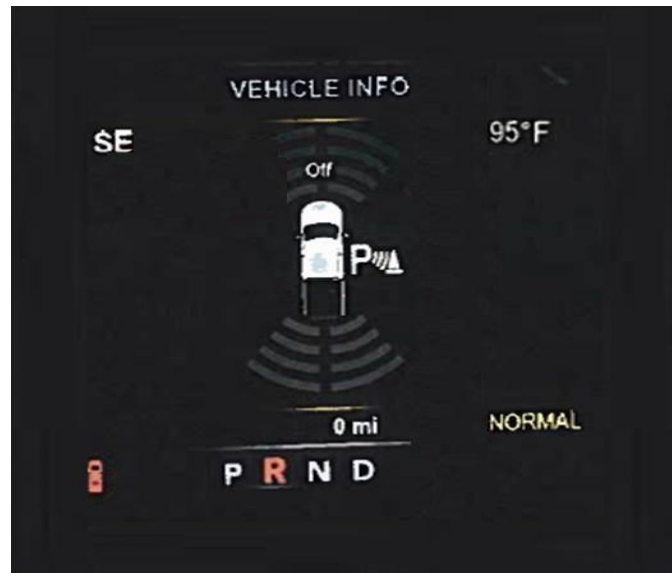
**Fig. 1 Cluster Screen**

The customer may describe the cluster screen on specific Rebel units, shows Front Park Assist "OFF"(Fig. 1) when vehicles are not equipped with Front Park Assist.

1. Using wiTech, configure vehicle to Rear Park Assist only. This routine is available under the 'Diagnostic Procedures' tab found on the home, 'Vehicle View', page of wiTECH.
2. Using wiTECH clear any DTCs which may have been set during the reconfiguration.
