NUMBER: 08-057-16 REV. A

RA3 And RA4 Radio Enhancements

This bulletin involves inspecting and if required, updating the radio software.

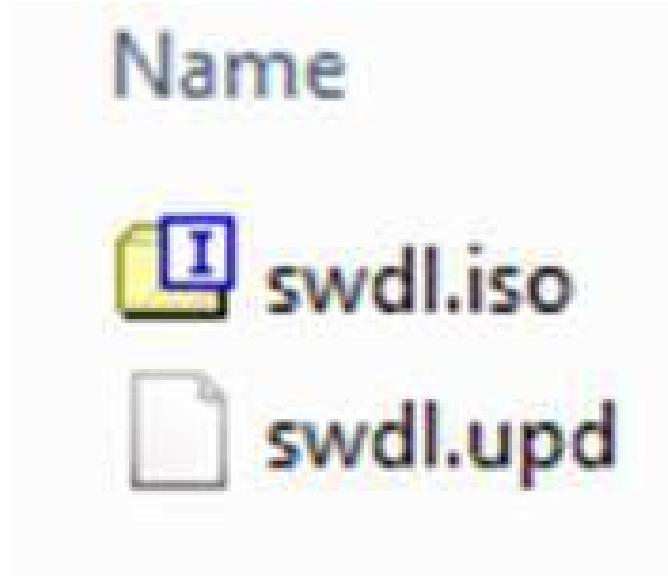
Fig. 1 Two USB Files

NOTE: **Two files will be loaded onto the USB flash drive (Fig. 1).**

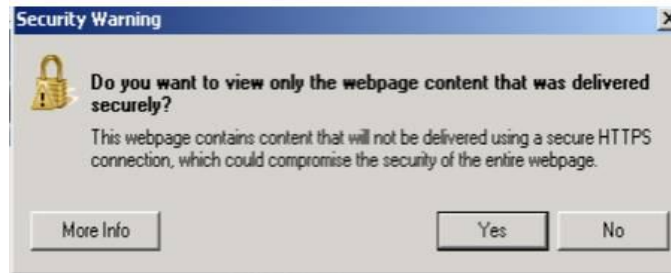
Fig. 2 Pop-up Security Message

3. If a security message appears “Do you want to view only the web page content that was delivered securely?” (Fig. 2). Press No to continue.

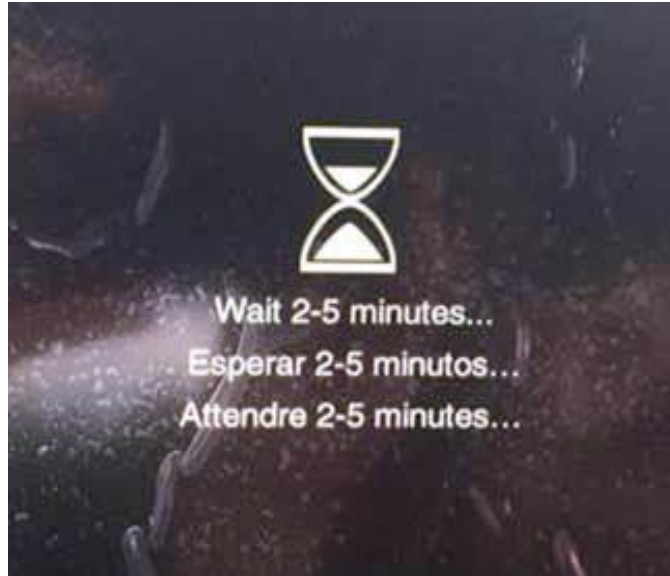
Fig. 3 Hourglass Screen

NOTE: During the update process you will see multiple hourglass screens for extended periods of time (several minutes) (Fig. 3). DO NOT remove the USB flash drive at this time. Only remove the USB flash drive when the update has completed, when the screen displays the software levels again.**

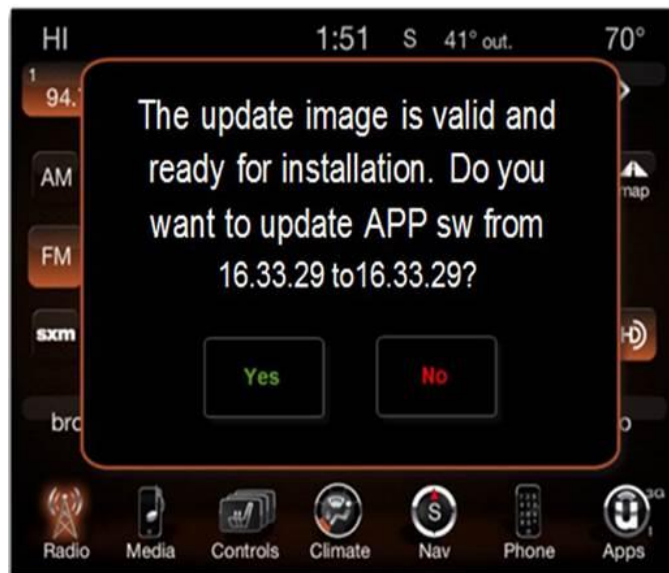
Fig. 4 Updated Software Screen

10. After the update is done the screen will display the software levels again ([Fig. 4](#)).
