**NUMBER:** 23-043-16

Dual Pane Sunroof Assembly Making Contact With The Roof

This bulletin involves adjusting the fixed rear dual pane sunroof assembly.

2017 (RU) Chrysler Pacifica

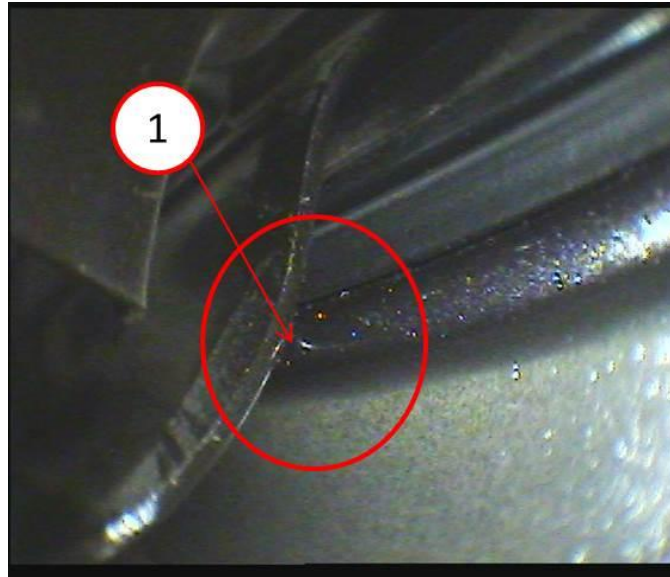
***Fig. 1 Contact With Roof***

The customer may describe an audible creak/rattle heard from the rear dual pane sunroof assembly while driving.

The sunroof may be in contact with the roof causing a noise ([Fig. 1](#)).

1 - Rubbing Against Roof

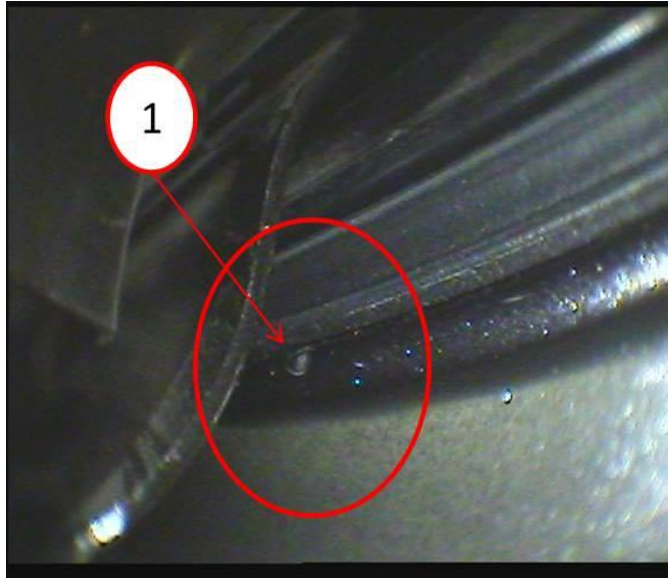
***Fig. 2 Clearance After Repair***

1 - Area That Was Making Contact

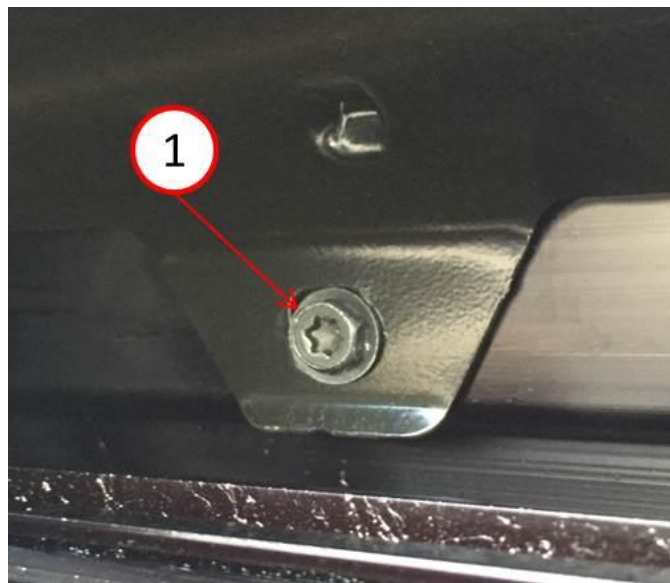
**Fig. 3 Sunroof Adjustment**

1 - One Of The Adjustments Points

1. Is the vehicle unsold and on the RRT VIN List?
  - a. YES>>>Proceed to [Step #4](#).
  - b. NO>>> Proceed to [Step #2](#).
2. Open the sunshade completely and have a passenger sit in the 2nd row seat to listen for the noise. Drive the vehicle on a medium to rough road between 40-56 Kph (25-35 Mph) making sure the radio & HVAC controls are off and all windows are closed.
3. Was a noise heard from the left or right hand side or both?
  - a. YES >>> Proceed to [Step #4](#).
  - b. NO>>> This Bulletin does not apply. Normal diagnosis should be performed.
4. With the sunshade completely open, use a T-25 torx® bit on a screwdriver or extended socket wrench to loosen the rear two fasteners on both sides of the dual pane sunroof rear glass panel shown in ([Fig. 3](#)) and ([Fig. 4](#)).

- 
5. With the sliding door open, have a second tech stand on the sill and adjust the rear glass panel to be flush with the roof surface.
  6. Tighten the rear two fasteners on both sides while the second tech holds the glass flush to the roof surface (Fig. 3). Tighten to 4.5 N·m (40 In lbs).
  7. Verify there is no audible creak/rattle noise after adjustment is performed.

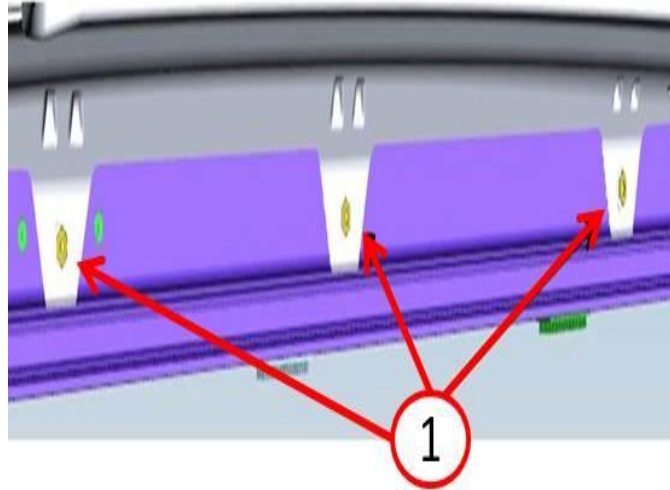
**Fig. 4 Sunroof Adjustment Locations**

1 - Location Of Torx® Bolts
