NUMBER: 23-045-16

Water In Either Left Or Right Front Floor Footwells

This bulletin involves correcting a sealant void between the cowl plenum lower panel and dash crossmember.

2015 - 2016 (UF) Chrysler 200

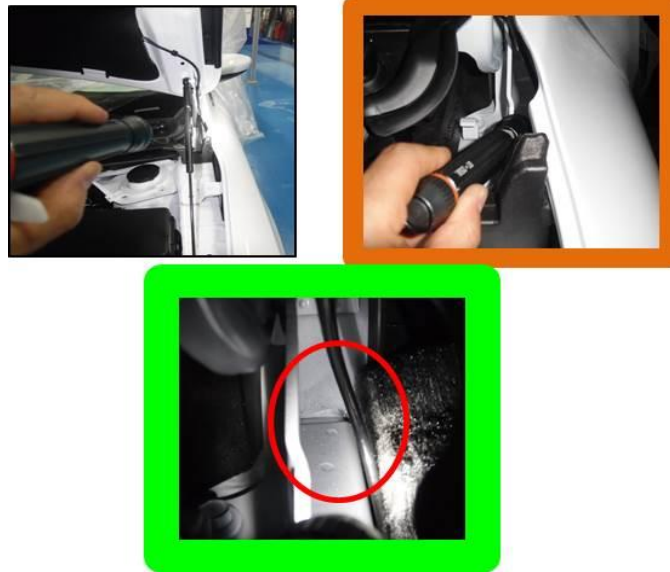
Fig. 1 Inspection of Beam

1. Open the hood.
2. Using a flash-light locate the horizontal weld behind hood's hinge (between the hinge and the fender as shown in (Fig. 1)).

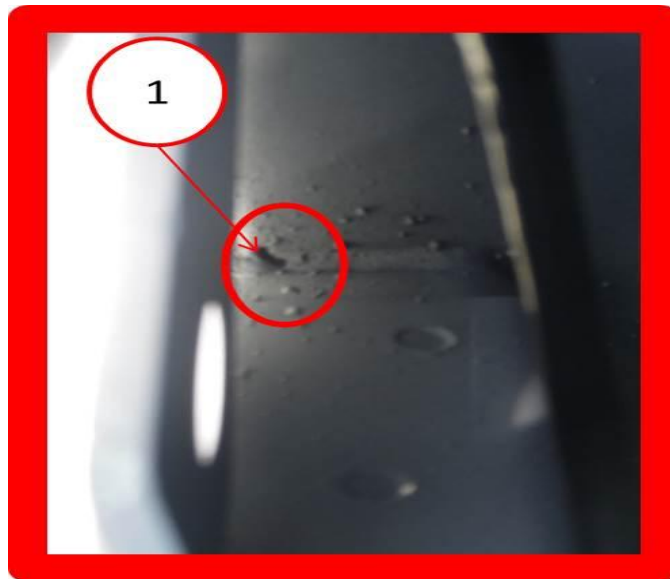
Fig. 2 Insufficient Weld

1. Does the horizontal seam have a hole at the weld (Fig. 2)?
 - a. YES>>> Proceed to [Step #2](#).
 - b. NO>>> Proper Sealant is applied and no further action needed at this location (Fig. 3). Proceed to [Step #4](#).

1 - Hole At The Weld (BAD)

2. Apply the sealant to the affected area (Fig. 4).
3. Allow the sealant/sealer to dry per the manufacturer's directions.

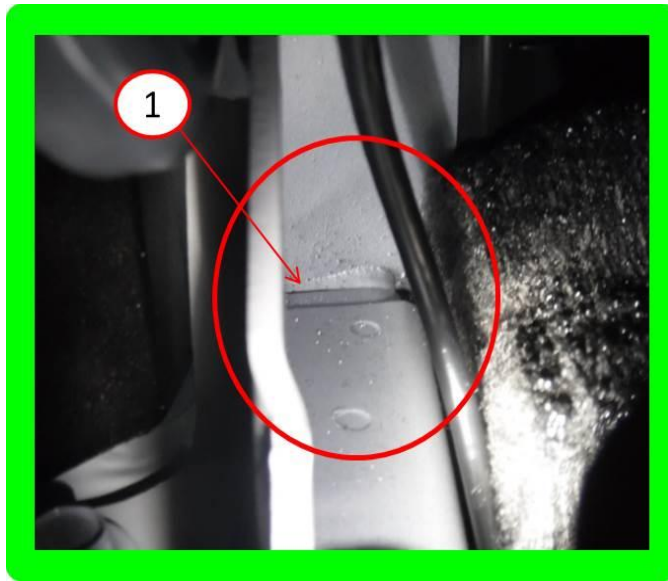
Fig. 3 Proper Amount Of Weld

1 - Proper Amount Of Weld (GOOD)

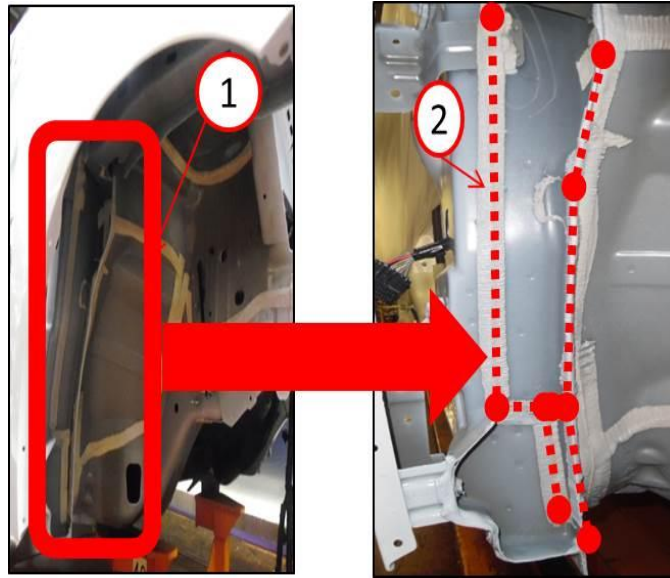
Fig. 5 Wheel House Sealant Location

4. Inspect the wheel house opening ([Fig. 5](#)).

- 1 - Current Sealant On Vehicle
- 2 - New Sealant To Be Applied To Exposed Locations Within The Dotted Lines

-
6. Apply the sealant at the locations with the dotted lines to the affected area (Fig. 5).
 7. Allow the sealant/sealer to dry per the manufacturer's directions.

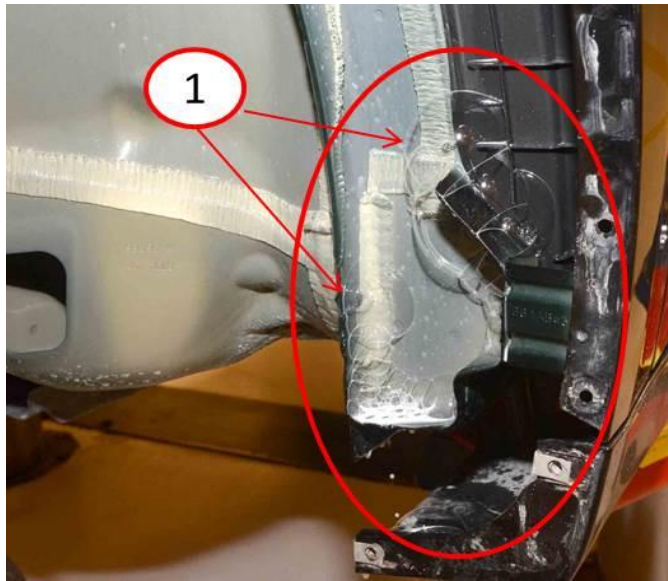
Fig. 6 Air Bubbles Behind Inner Fender Well Location

-
5. Is there air/bubbles leaking from the seam area behind the inner fender well ([Fig. 6](#))?
 - a. YES>>> Proceed to [Step #6](#).
 - b. NO>>> Proper Sealant is applied and no further action needed at this location ([Fig. 5](#)). Proceed to [Step #8](#).

1 - Air Bubbles AT Wheel House

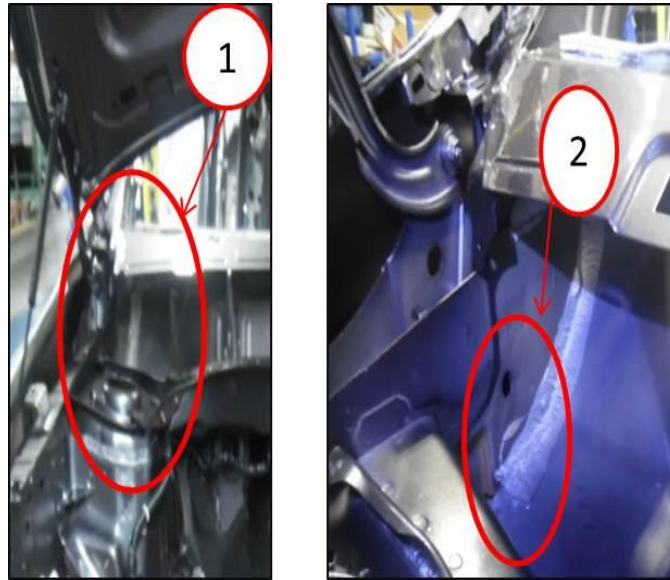
Fig. 7 Plenum Sealant

8. Locate seam of plenum to cowl side (Fig. 7).

- 1 - Location Behind Strut Tower
- 2 - Location Of Sealant To Be Applied

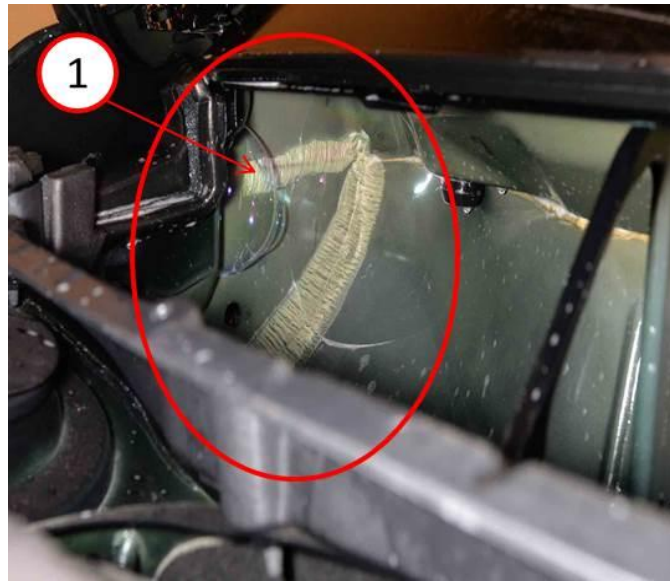
Fig. 8 Air Bubbles At Cowl

-
9. Is there air/bubbles leaking from the plenum to cowl side (Fig. 8) or is there a seam showing that does not have sealant over it (Fig. 9)?
 - a. YES>>> Proceed to [Step #11](#).
 - b. NO>>> Proper Sealant is applied and no further action needed at this location (Fig. 10). Proceed to [Step #13](#).

1 - Air Bubbles At Cowl

-
10. (If needed for sealant repair). On the drivers side remove the wiper motor and arm assembly. Refer to the detailed service procedures available in DealerCONNECT> TechCONNECT under: Service Info> 08 - Electrical / 8R - Wipers/Washers / Linkage, Wiper Arm/Removal.
 11. Apply the sealant to the affected area as shown in (Fig. 7).
 12. After the sealant has been allowed to fully dry per manufacture's specs.
 13. Spray soapy water in the areas of repair, inspect for any trace of air/bubbles coming from the repaired areas. If no air or bubbles are found, then the sealant process is complete.

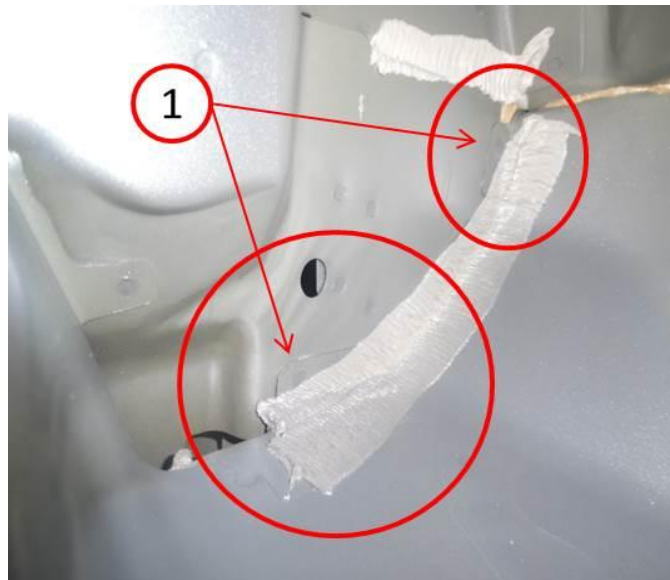
Fig. 9 Seam Not Sealed Correctly

1 - Exposed Seam

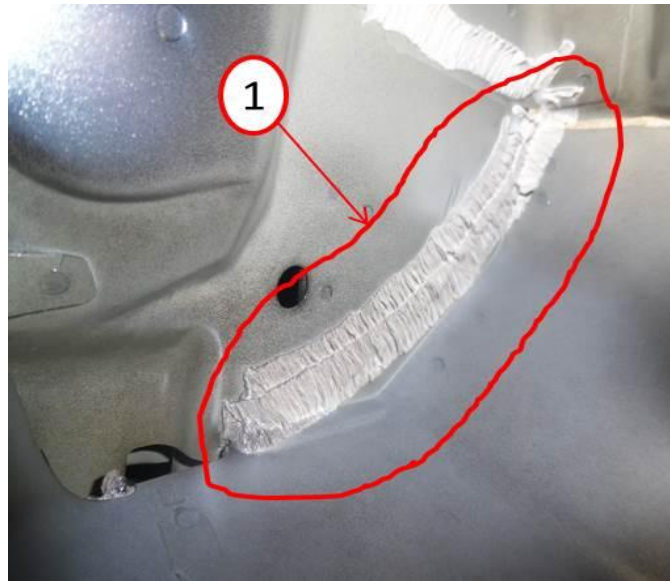
Fig. 10 Seam Sealed Correctly

1 - Seam Sealed Properly
