NUMBER: 23-041-16 REV. A

Click, Creak, Or Groaning Sound Near C-Pillar, Dual Pane Sunroof

2016 WK Grand Cherokee

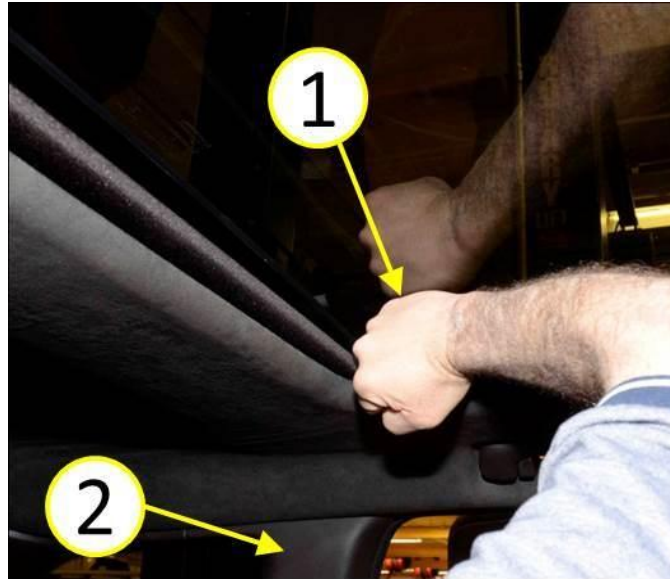
Fig. 1 Push And Tap On Sunroof Glass Panel

1. Test drive the vehicle over uneven road surfaces or where the customer advises the noise can be duplicated. Attempt to duplicate the noise by pushing upward on the dual pane sunroof rear panel at the rear corner with increasing pressure, then release while listening for a creak/groan noise. Also try tapping with fist on the dual pane sunroof rear panel at the rear corner while listening for a click/tick noise ([Fig. 1](#)).

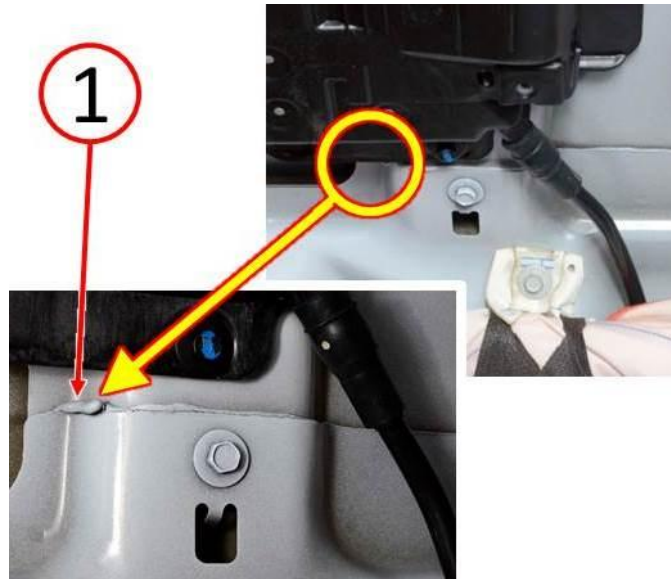
Fig. 2 Visually Inspect For Adhesive

3. Visually inspect for adhesive filling the space between the sheet metal structural components at C-pillar nearest rear corner of sunroof module where the noise was heard. Can adhesive be seen filling the space identified in (Fig. 2)?

- a. Yes>>> Repeat the diagnostic test of pushing upward on the dual pane sunroof rear panel at the rear corner with increasing pressure and then releasing while listening for creak/groan noise as performed in Step #1. Ensure that the noise is coming from the area identified in (Fig. 2) before proceeding to Step #4. If noise is not coming from this structural joint, this bulletin does not apply and further diagnosis is required.

- b. No>>> Adhesive was not observed filling the identified area. Continue to Step #4.
