NUMBER: 18-087-16 REV. A

GROUP: Vehicle Performance

Engine Oil Viscosity Upgrade And Flash Enhancements

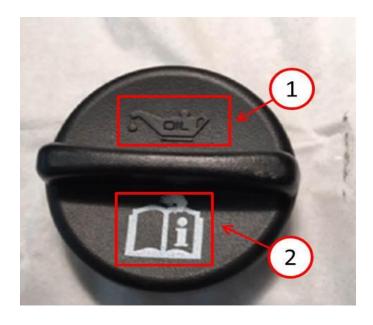
Fig. 1 Cap Before Sticker Applied

- 1 Do Not Cover This Embossed International Oil Symbol
- 2 Cover This Old Oil Info Symbol With The New "5W40" Label

- 6. Remove oil fill cap.
- 7. Clean top of oil fill cap with Isopropyl alcohol or equivalent and apply engine oil viscosity rating sticker as shown in (Fig. 1).

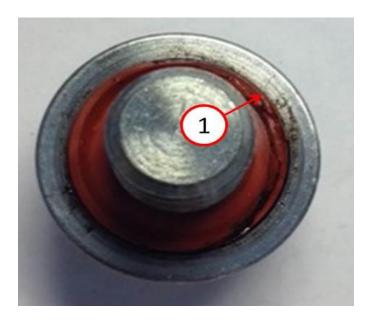
Fig. 2 Damaged Rubber Seal

1 - Oil Drain Plug Gasket Seal Crushed

- 8. Remove the oil drain plug and allow oil to drain for at least 5 minutes or until it stops dripping.
- 9. Inspect the oil drain plug and gasket for damages (Fig. 2). Replace if necessary.

- 10. Reinstall the oil drain plug. Tighten to 45 N·m (33 ft. Lbs.).
- 11. Add 5W-40 synthetic engine oil to the engine. Use 10 quarts for (DS) Ram trucks and 8 quarts for (WK) Jeep Grand Cherokee. Take care not to spill oil on engine.

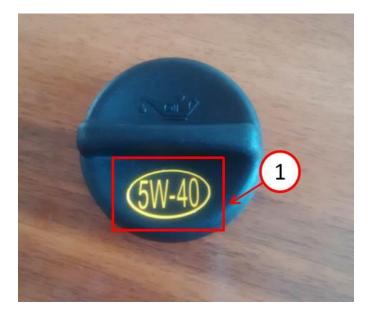
Fig. 3 Cap After Sticker Applied

1 - "5W-40" Sticker Affixed To Oil Filler Cap

12. Reinstall the oil fill cap with the new 5W-40 sticker firmly attached (Fig. 3).
