NUMBER: 23-029-16

DATE: June 10, 2016

Power Sliding Door Handle Button Inoperative

2017 (RU) Chrysler Pacifica

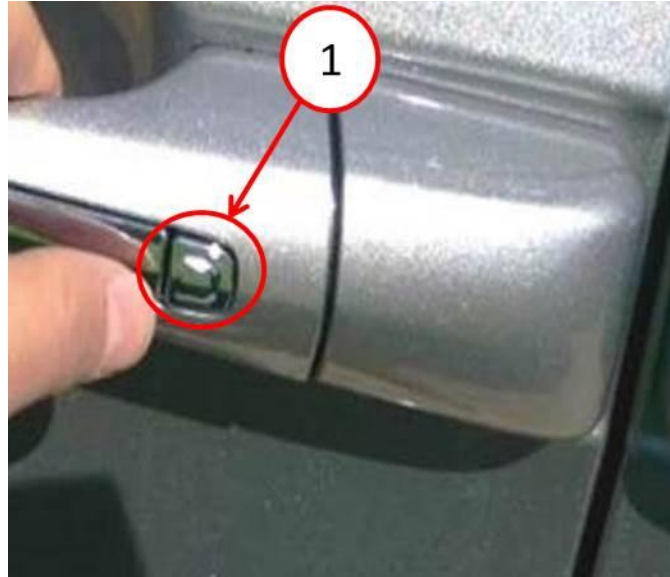
Fig. 1 Door Handle Button

1. Test the left and right power sliding door handle button functions. With key fob in hand, push the power sliding door handle button on the door handle ([Fig. 1](#)).

1 - Power Sliding Door Handle Button

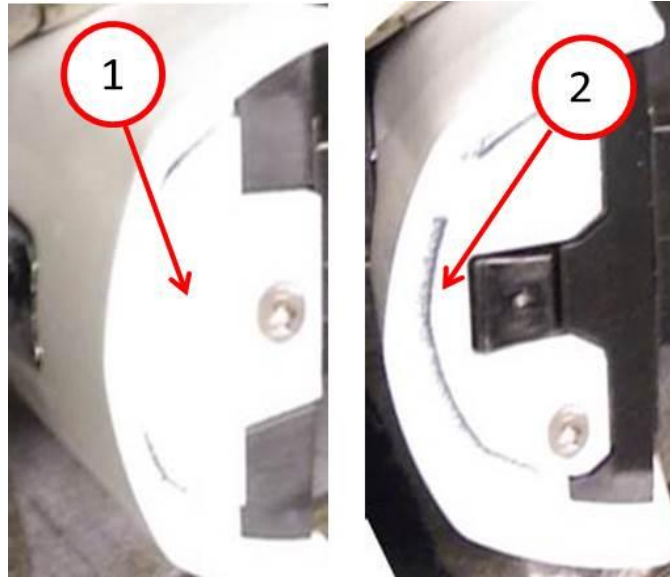
Fig. 2 Visual Inspection Of Door Handle End

3. Open the left and right power sliding doors and inspect the door handle ends (Fig. 2).
4. Are the left and right door handle ends correct (Fig. 2)?
 - a. YES >>> The door handles are correct. Further diagnosis should be performed. This bulletin has been completed, use LOP (23-42-15-94) to close the active RRT.
 - b. NO >>> One or both of the door handle end caps are incorrect. Proceed to the Repair Procedure [Step #1](#).

- 1 - **CORRECT** Sliding Door Handle Ends
- 2 - Incorrect Sliding Door Handle Ends

1. Replace the left, right or both power sliding door handles. Refer to Parts Required table. Disconnect and isolate the negative battery cable. If equipped with an Intelligent Battery Sensor (IBS), disconnect the IBS connector first before disconnecting the negative battery cable.

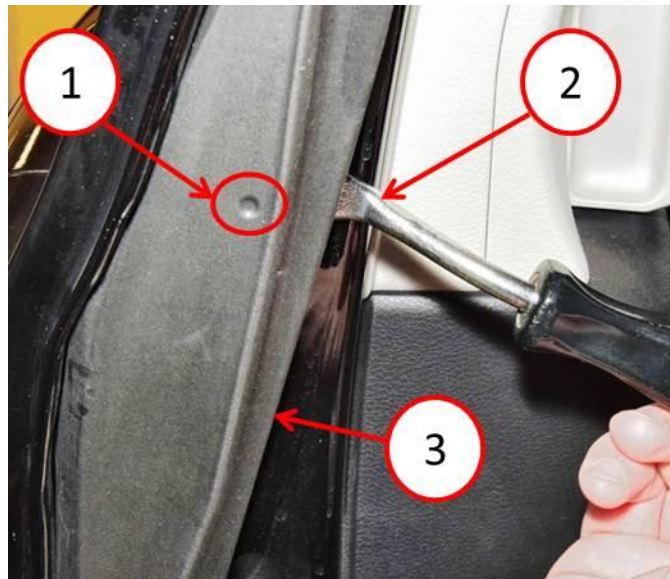
Fig. 3 Door Seal With Fasteners

- 1 - Fastener Dimple Locator
 - 2 - Fastener Removal Tool
 - 3 - Door Seal
-

2. Using a suitable fastener removal tool, remove door seal from power sliding door (Fig. 3).

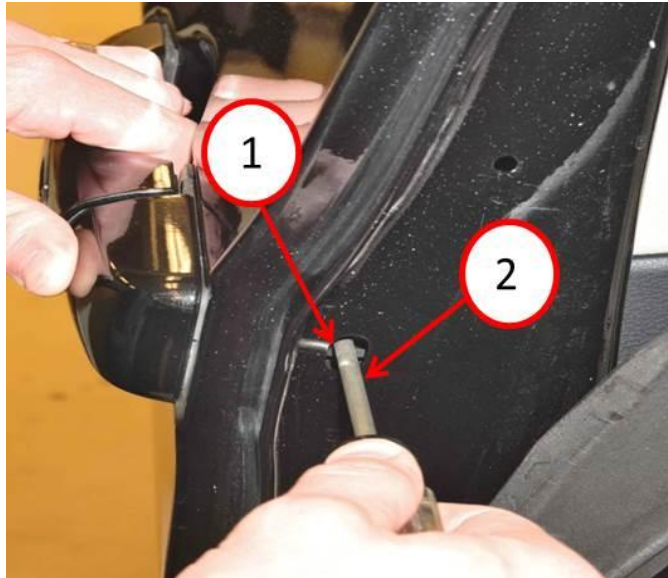
Fig. 4 Set Screw Access Hole

1 - Set Screw Access Hole

2 - #20 Torx Driver

3. Using a #20 Torx driver, loosen set screw inside power sliding door until screw assembly stops turning ([Fig. 4](#)).

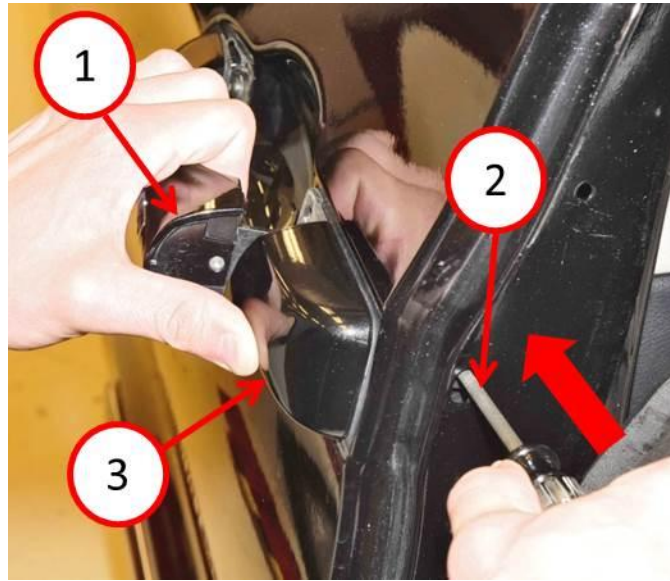
Fig. 5 Holding Door Handle And Trim Cap

- 1 - Door Handle Held Fully Open
2 - Door Handle End Cap Held In Place
3 - #20 Torx Driver Pushing Inward

- NOTE:**
- Both the door handle and end cap must be held in place at the same time while resetting the bell crank.
 - Door handle will stay in the open position when the bell crank is reset properly. Do not proceed with the repair procedure until the handle stays in the open position.
4. While holding door handle in the full open position, place thumb on door handle end cap to hold in place. Using #20 Torx driver apply light inward pressure and push set screw assembly rearward until it stops ([Fig. 5](#)).

-
5. Did the door handle stay in the full open position ([Fig. 5](#))?
a. YES >>> Continue with the Repair Procedure. Proceed to the next step.
b. NO >>> Repeat [Step #3](#) and [Step #4](#).
6. Remove end cap from door panel.
7. Slide door handle forward to remove door handle from bell crank and disconnect electrical connector from door handle.

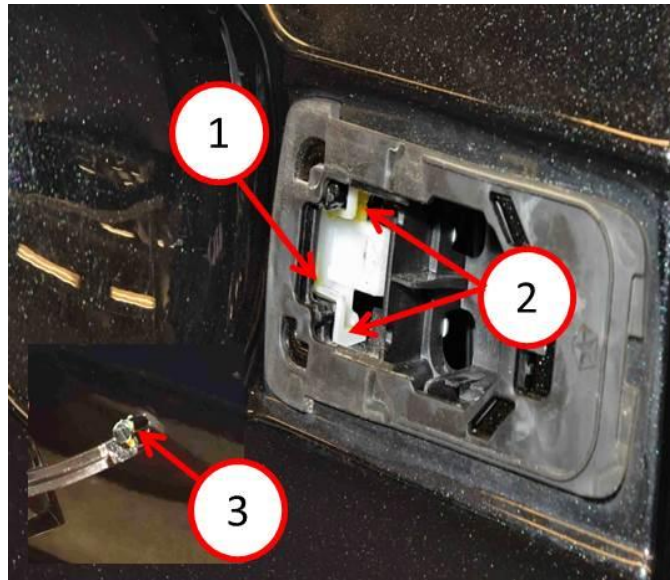
Fig. 6 Bell Crank Reset Correctly And Handle Pin

- 1 - Bell Crank In **CORRECT** Reset Position
- 2 - Bell Crank Door Handle Fastener
- 3 - Door Handle Pin

NOTE: Visual confirmation bell crank has been reset correctly (Fig. 6).

8. Connect electrical connector to door handle and install door handle into bell crank by placing door handle pin into bell crank handle fastener and slide rearward (Fig. 6).
