**NUMBER:** 23-001-16 REV. E

**GROUP:** Body

Center Console Lid Binding

This bulletin involves adding a rubber bumper to the console lid to **prevent** the lid from binding.

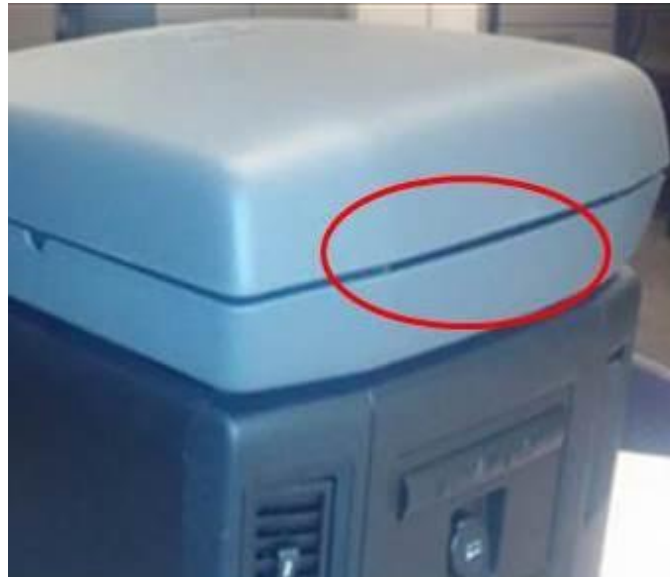
**Fig. 1 Check Lid For Rubbing**

1. Locate the center console inside the vehicle.
2. Slowly open the upper lid of the center console while checking the gap between the bottom of the upper lid and the top of the lower lid for rubbing together as shown in (Fig. 1).

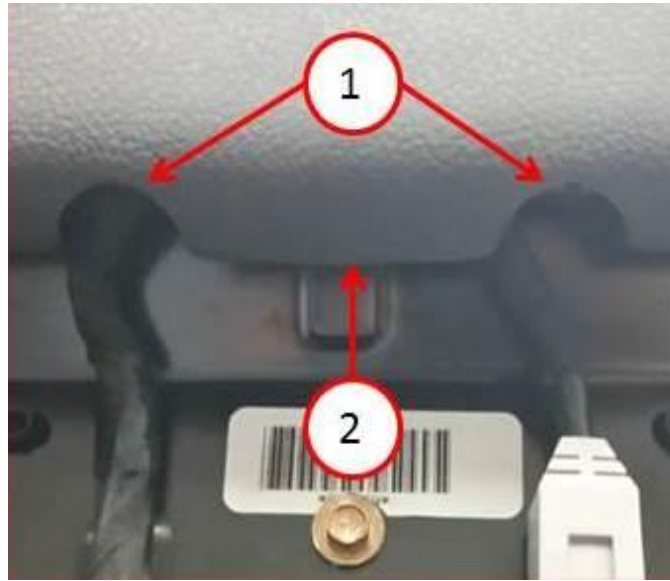
***Fig. 5 Bumper Location***

1 - Notches

2 - Location Of Bumper Installation

10. At the rear of the center console wall on the lower lid, identify the two notches as shown in (Fig. 5).

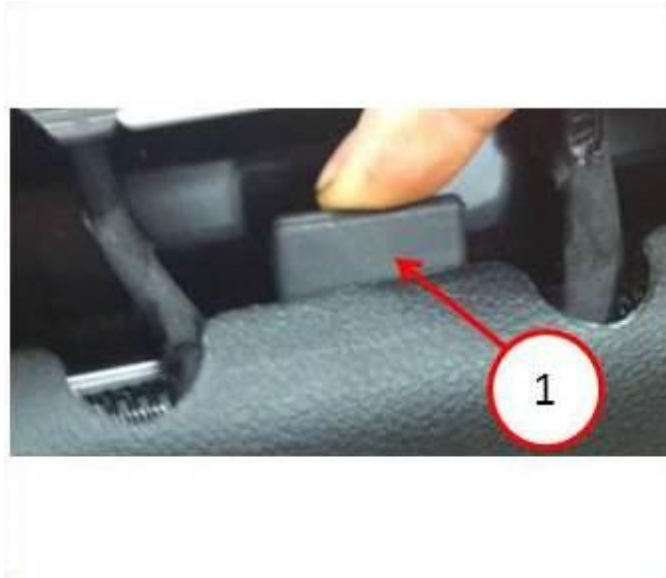
***Fig. 7 Bumper Being Installed***

1 - Bumper

11. At the center of the console wall on the lower lid (as noted in the previous step), insert the bumper where the red triangle is shown. It will take some effort to push the bumper in flush with the edge of the lower lid as shown in (Fig. 6) and (Fig. 7).

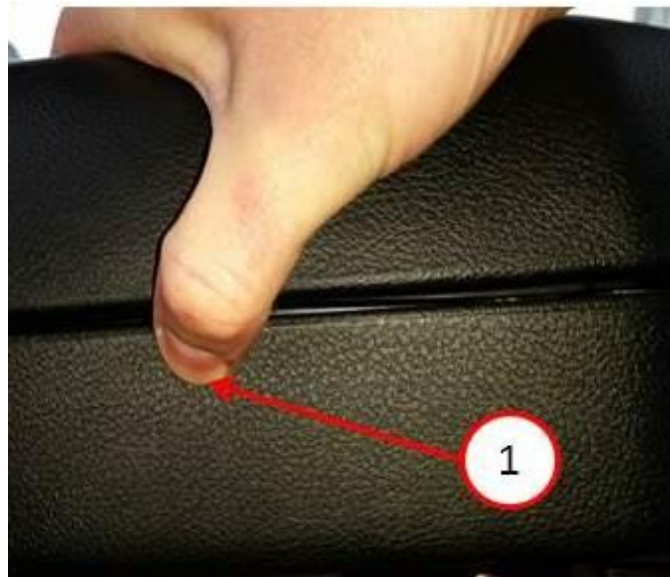
**Fig. 8 Bumper Installation Continued**

1 - Press The Back Wall

12. To assist the installation of the bumper, press the back wall of the lower lid to relieve some tension while inserting the bumper as shown in (Fig. 8).
