NUMBER: 23-019-16 REV. A

Trunkpan Bolts Loose Causing Clunk When Driving Over Bumps

This bulletin involves inspecting and re-tightening the trunkpan bolts in the rear of vehicle.

2016 (ZD) Dodge Viper

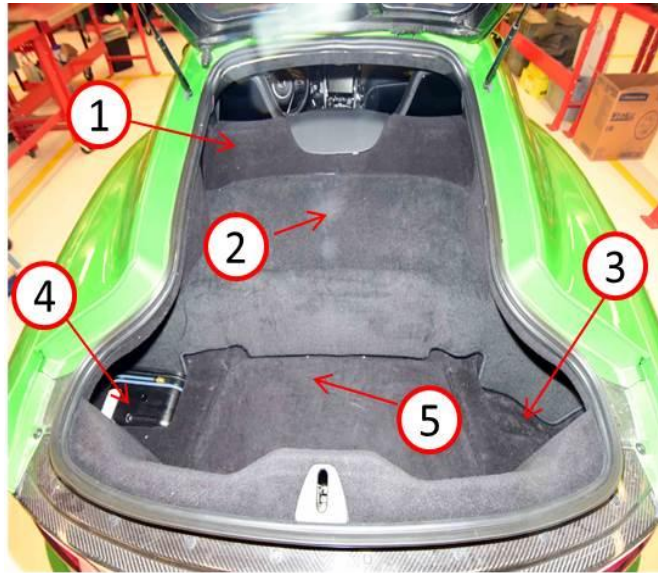
Fig. 1 Component Call-outs

- 1 - Bulkhead Trim Panel
- 2 - Top Stack Carpet
- 3 - Carpet Inserts
- 4 - Tire Air Compressor/inflator
- 5 - Trunk Load Floor Panel

1. Open the liftgate (Fig. 1).

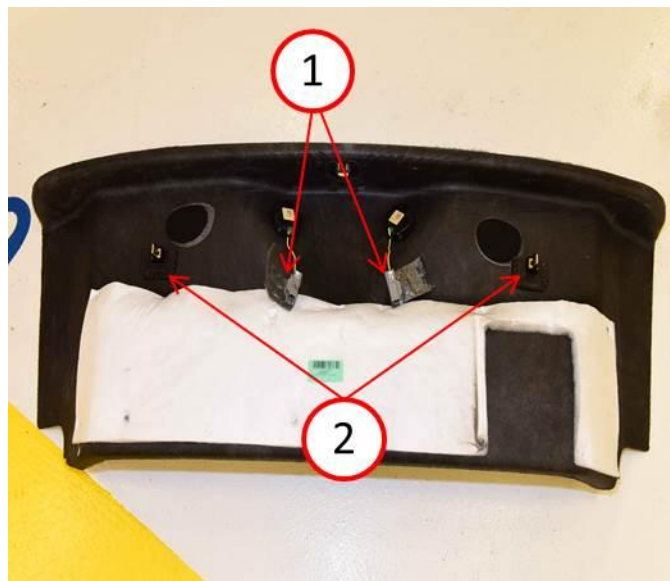
Fig. 3 Trunk Trim Panel

- 1 - Cargo lamp connectors
- 2 - Spring clip tab locations

4. Remove the rear valance close out cover (Fig. 3). Use trim stick to assist with removing spring clip retainers. Take care in removal of panel, spring clips are bonded to panel and may be damaged if care is not taken during removal.

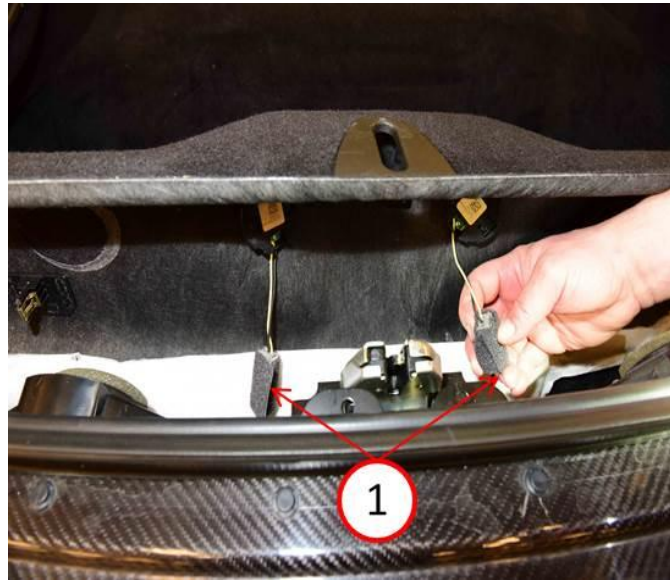
Fig. 4 Foam Tape On Electrical Connector

1 - Foam tape around cargo lamp connectors

5. Take care in removing foam tape from rear cargo lamp connectors (Fig. 4), during connector separation.

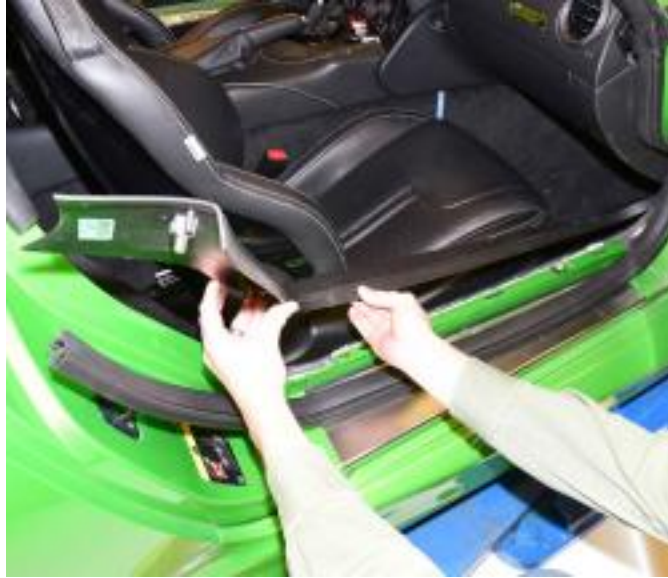
Fig. 5 Cowl Trim Piece

CAUTION: The upper and lower trim pieces are connected together and care should be taken during removal as one piece. The two pieces are bonded together and removing separately may damage trim pieces.

8. Remove upper and lower “B” pillar trim pieces from both sides of vehicle ([Fig. 5](#)), (right side shown, left side similar).

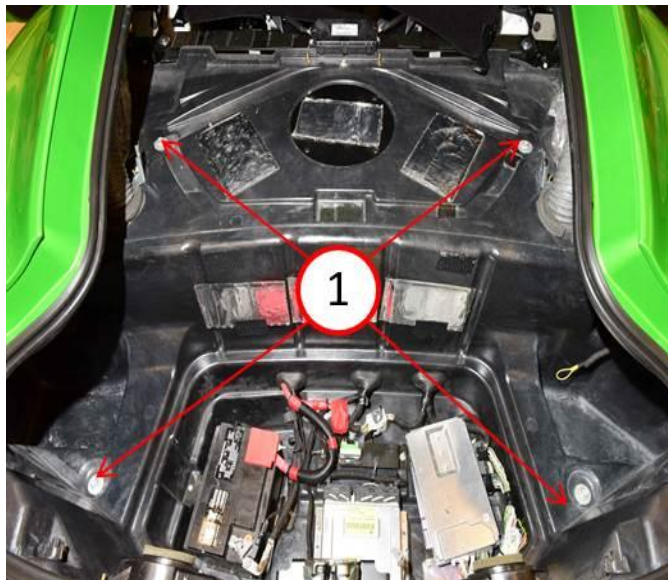
Fig. 7 Trunkpan Bolt Locations

1 - Trunkpan bolt locations

12. Torque the four main M-8 bolts to 22 N·m (16 Ft·Lbs) (Fig. 7).
