NUMBER: 24-005-16

DATE: May 26, 2016

Blend Door Stuck In Full Heat Mode (X64 Warranty Extension)

2014 - 2015 (RT) Chrysler Town & Country Dodge Grand Caravan

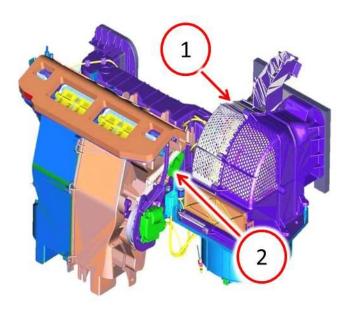
Fig. 1 Blend Door Actuator - Reference

This bulletin involves re-calibrating or replacing the right side Heating, Ventilation, Air Conditioning (HVAC) Blend Door actuator.

- 1 Right Side HVAC Module
- 2 Temperature Blend Door Actuator

- 6. Remove the right blend door actuator. Refer to the detailed service procedures available in DealerCONNECT> TechCONNECT under: Service Info> 24 Heating and Air Conditioning/Controls, Front/Actuator, Blend Door/Removal.

- 7. Install the right blend door actuator. Refer to the detailed service procedures available in DealerCONNECT> TechCONNECT under: Service Info> 24 Heating and Air Conditioning/Controls, Front/Actuator, Blend Door/Installation.
