PRODUCT CAMPAIGN BULLETIN

APPLICABILITY: 2003-2004 Baja
 2003-2008 Legacy and Outback
 2004-2005 Impreza, WRX, STI

SUBJECT: Takata Front Passenger Air Bag
 Inflator Replacement

NUMBER: WQR-53R

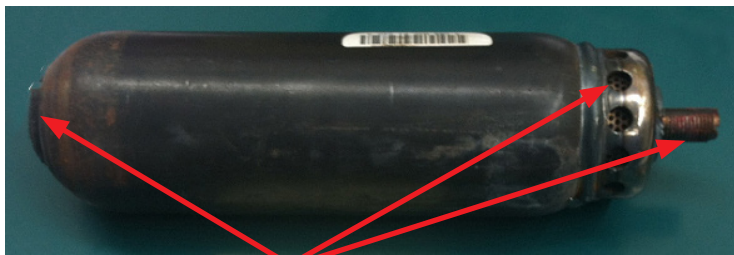
The shape, holes, and copper-colored stud indicate this not a Genuine Subaru inflator.

- Document the presence of the aftermarket or counterfeit device on the repair order and with photos. Report this information immediately on a Quality Monitoring Report (QMR).
