TO: Mercedes-Benz Dealer Principals, General Managers, Sales Managers, Service Managers, Parts Managers	FROM: Thomas Brunner, Department Manager, Vehicle Compliance and Analysis, Engineering Services
RE: <b>Service Campaign 2016010010, Model 117 (CLA), Model Year 2015. Check Air Ducts Under Instrument Panel, Retrofit if Necessary</b>	DATE: February 19, 2016

Campaign No. 2016010010, February 2016

SUBJECT: **Model 117 (CLA), Model Year 2015**  
**Check Air Ducts Under Instrument Panel, Retrofit if Necessary**

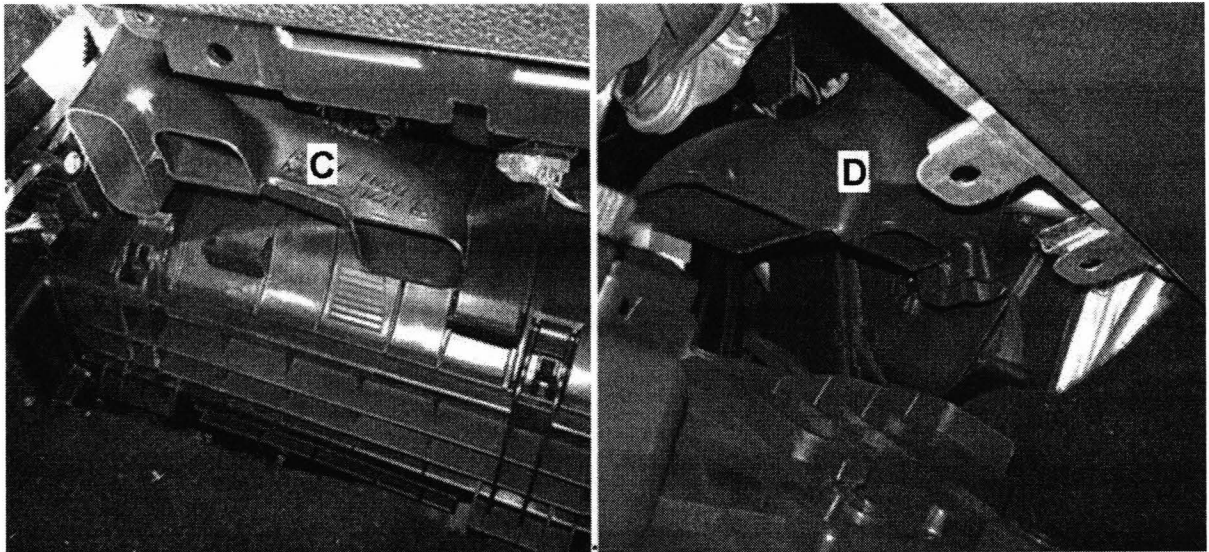
**Figure 2**

Check if air ducts (C and D, Figure 2) are present below left and right side of instrument panel:
  - If air ducts (C and D) are present: Reassemble in reverse order; **Procedure is complete.**
  - If air ducts (C and D) are **not** present: Proceed to step 3.

Retrofit missing air ducts (C and D, Figure 2) then reassemble in reverse order.

Air ducts (C and D) can be installed from below instrument panel without additional disassembly.
