40 16 01 February 2, 2016 2043146

### Strut or Shock Absorber Leak Assessment

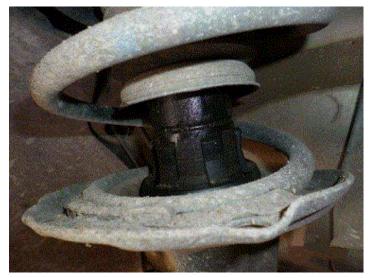
• A slightly dried oil residue at the top of the shock/strut does not indicate a leak (see figure 3 and 4).

This type of residue can be caused by shock/strut assembly and sweating around the seal.

Figure 3) Not a leaking shock/strut

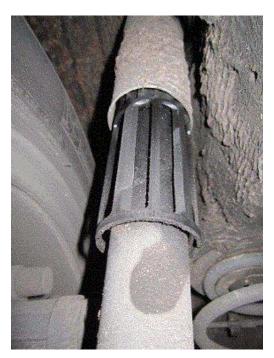
Figure 4) Not a leaking shock/strut
