VW Elsa Newsletter

Edition 173: February 15, 2016

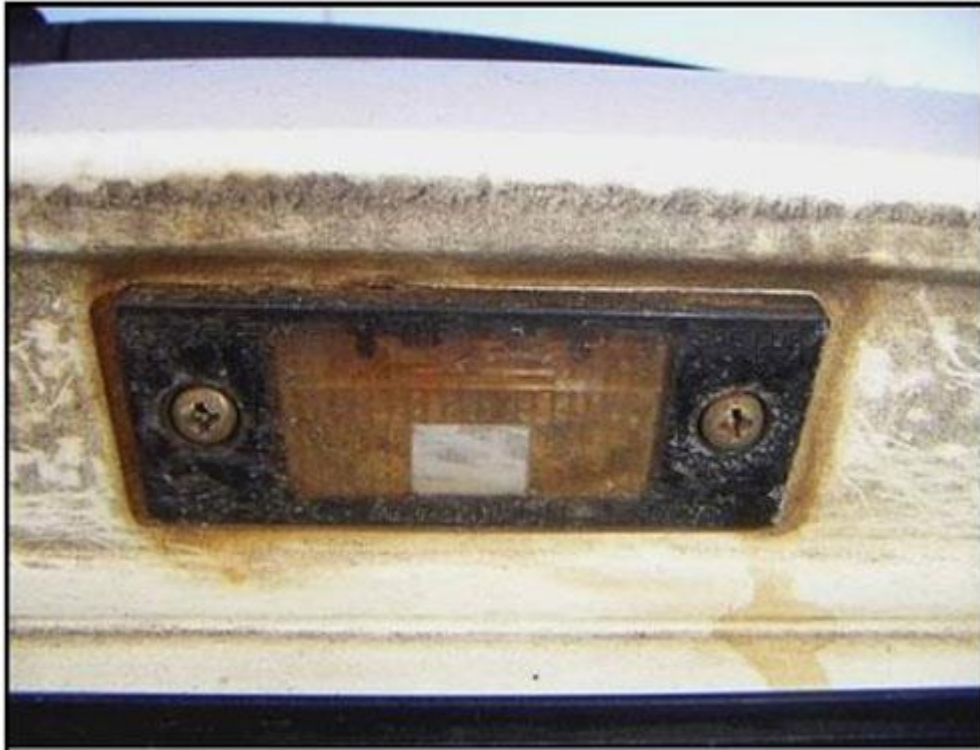
Corrosion on the Rear Lid around License Plate Lights.

Figure 1: Corrosion on and around the license plate light

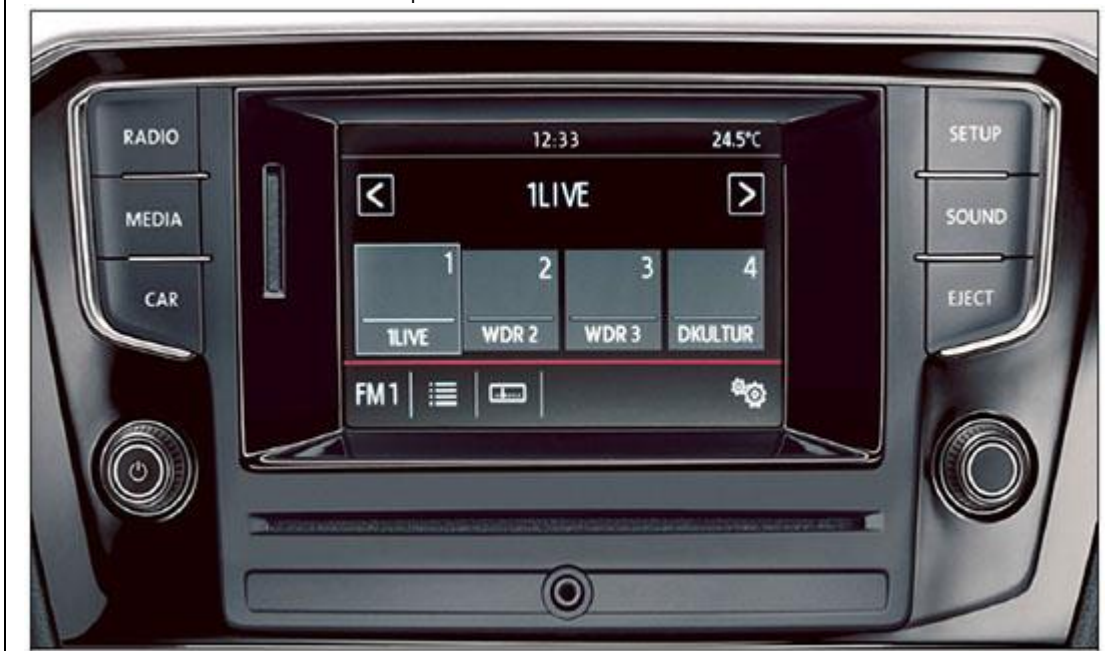
Composition Color Identification.

This will occur when driving and only when listening to AM/FM radio stations. This results from the antennae signals "bouncing" off of buildings or other structures, amplifying the radio signal. This is a normal characteristic. As such, no repairs should be made.
