VW Elsa Newsletter

Edition 171: February 1, 2016

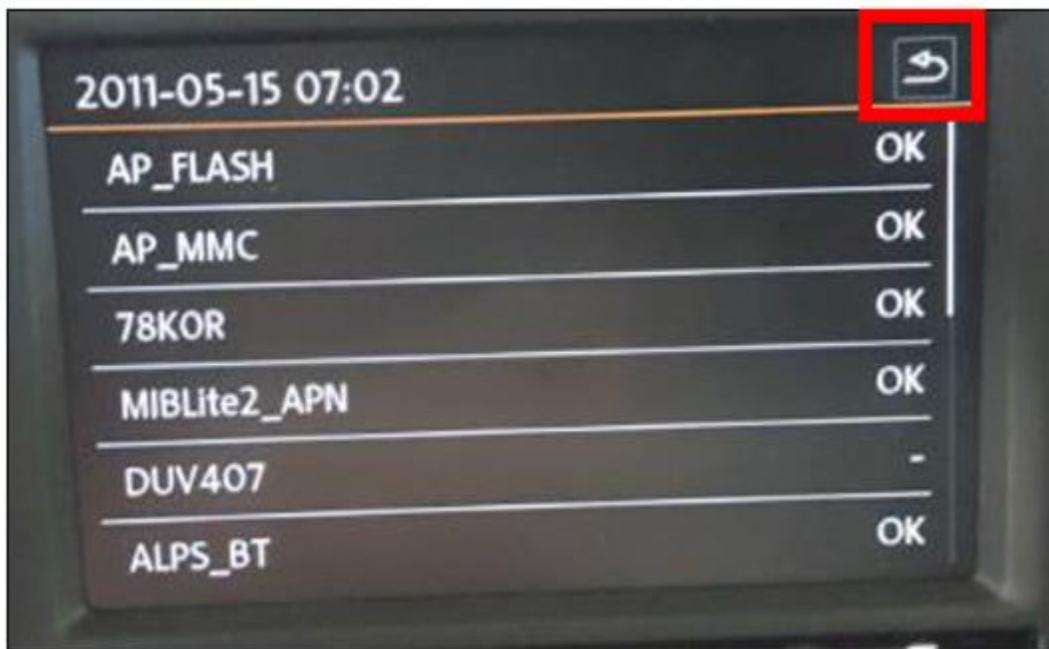
96-16-03 91N9 Update Freezes

The 91N9 Update may freeze during the update process. If the screen freezes on the following screen, press the back arrow in the upper right corner and the software update will continue.

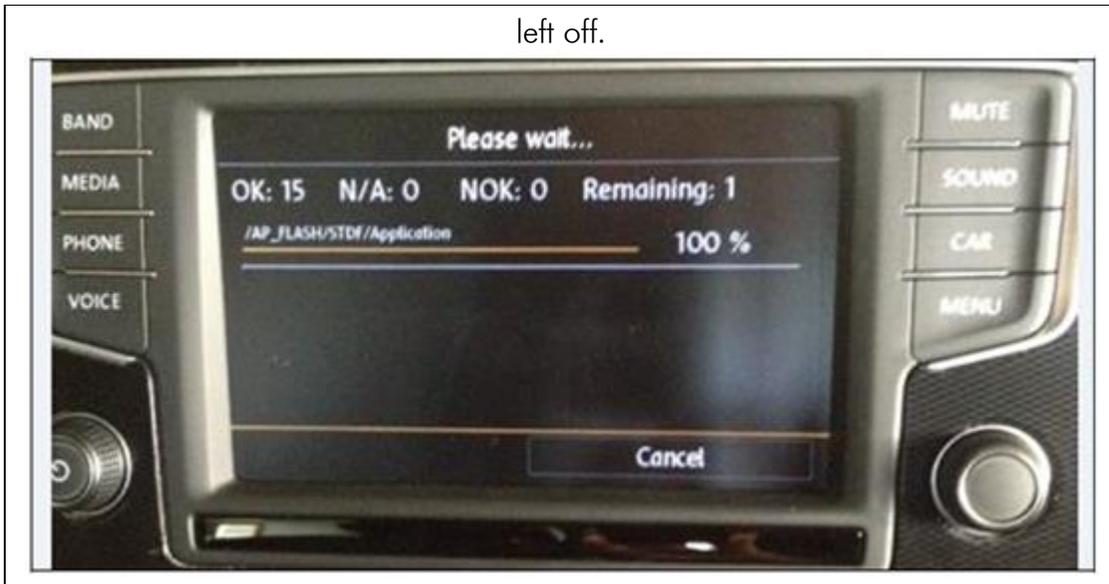
If the screen freezes on the following screen, hold down the power button on the radio for 10 seconds to reboot the J794. The software update should start where it

left off.
