VW Elsa Newsletter

Edition 172: February 8, 2016

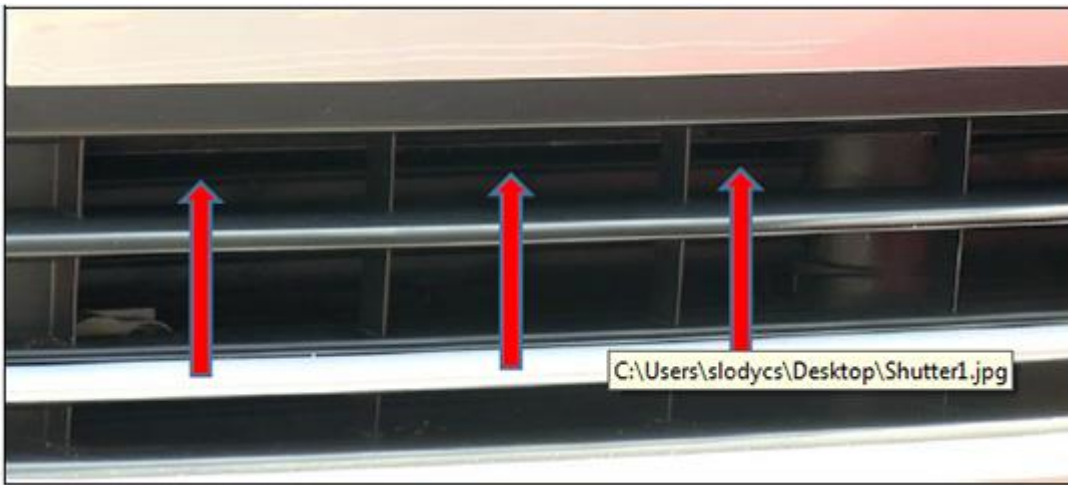
**01-16-01 P05A3 Active Grille Air Shutter "A" Control Circuit
Range/Performance**

Please inspect the lower grill active shutter for any obstructions i.e. accident damage, snow, ice or debris.

If an obstruction is found, please remove/clean active grill shutters and perform a road test until the vehicle reaches full operating temperature (80°C) to verify operation and recheck for any active DTC.

If obstruction is not found, please check circuit integrity at the V544 T4 as connector:

- Battery voltage on pin 4
- Ground on pin 1
- Check resistance of wire from T91/76 to terminal 3

If the correct readings are achieved, please replace the V544 motor and road test to verify operation.
