# Service Bulletin

**Subject:** Rattle Noise From Second Row Seat

**Models:** 2015-2016 Cadillac Escalade Models  
2015-2016 Chevrolet Suburban, Tahoe  
2015-2016 GMC Yukon Models

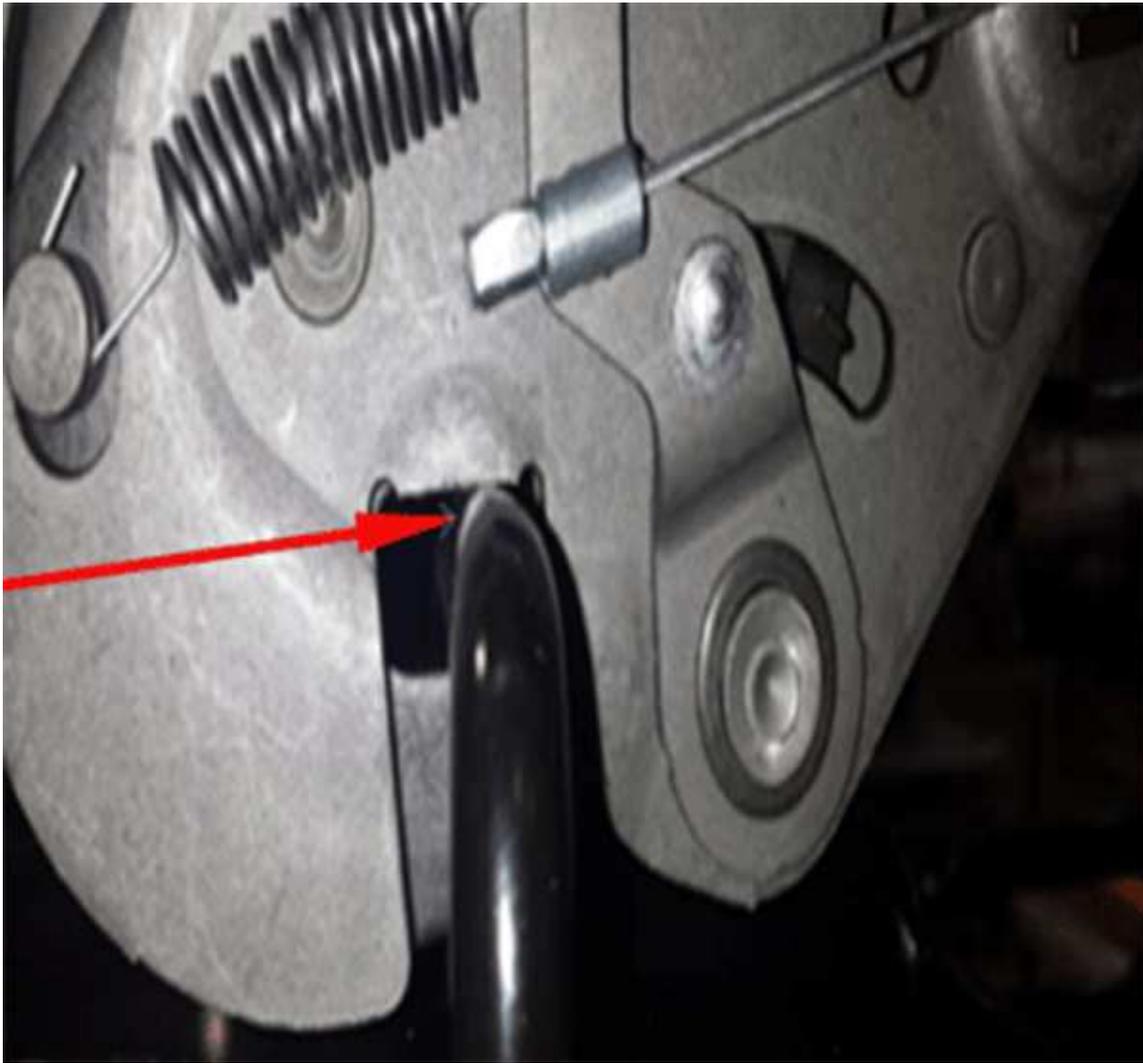
Cause 1: The striker is not properly aligned in the latch opening, see picture below. This could cause a rattle or the striker to drag on the side of the latch opening not allowing the seat to flip forward or latch down

1.1 To repair this condition, rework/adjust the striker in the direction to center it in the latch opening. An adjustable wrench may be used to rework/adjust the striker, as shown below.

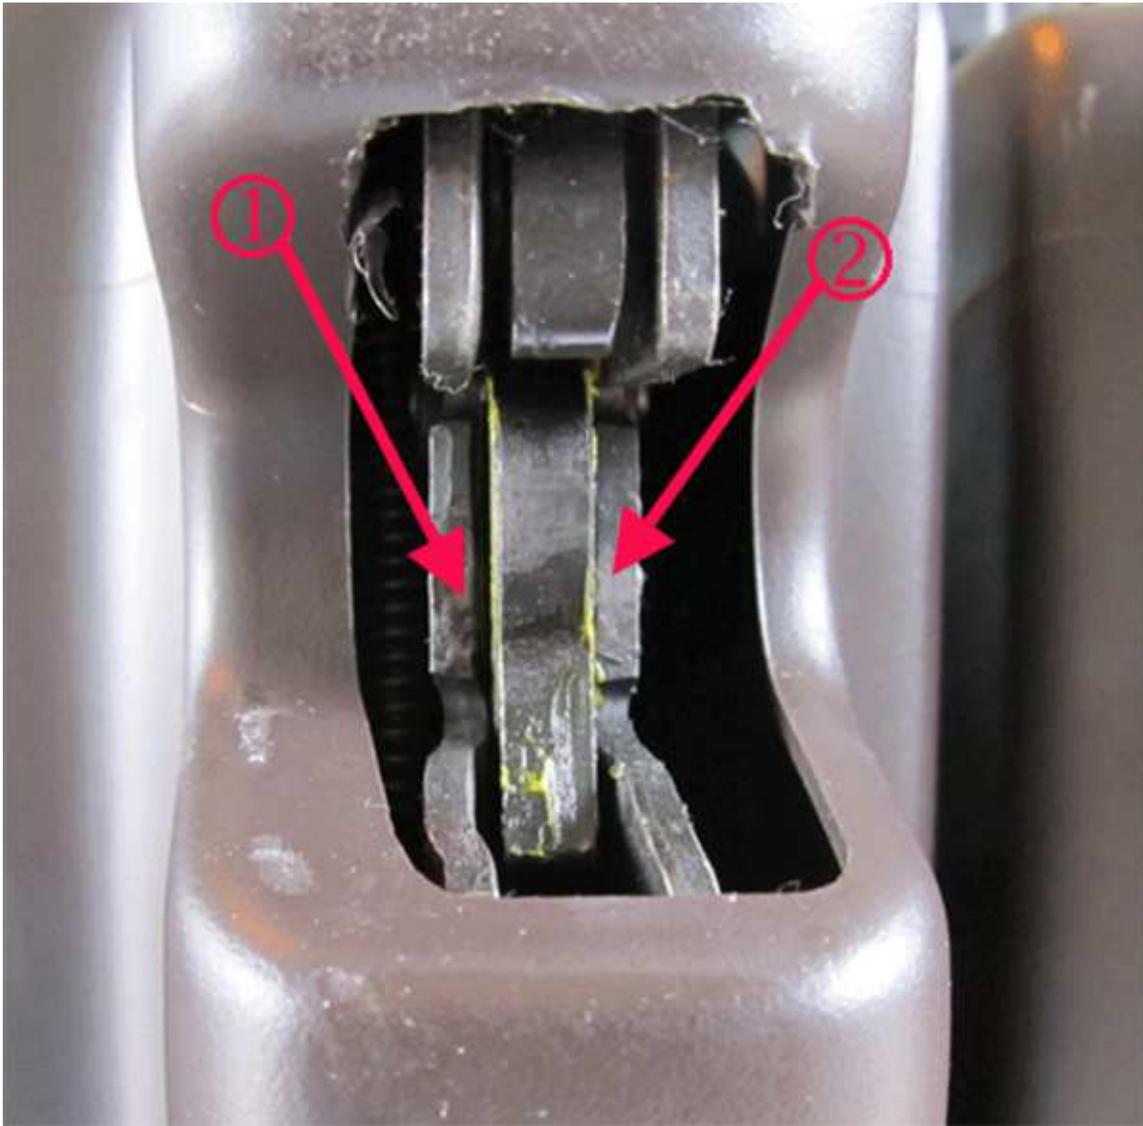
Cause 2: A seat bottom latch (inboard and/or outboard latch) may have an unequal latch opening for the striker to seat into. See picture below, opening (1) may protrude down farther than opening (2), which can cause a rattle. With the seat latched down, if the striker to latch interface is inspected on both sides of a latch, there will be a gap on one side of the latch and no gap on the other side of the same latch.

This procedure will form the protruding latch opening to the striker, which will allow the two opening to be equal/parallel to each other so the striker contacts both openings.

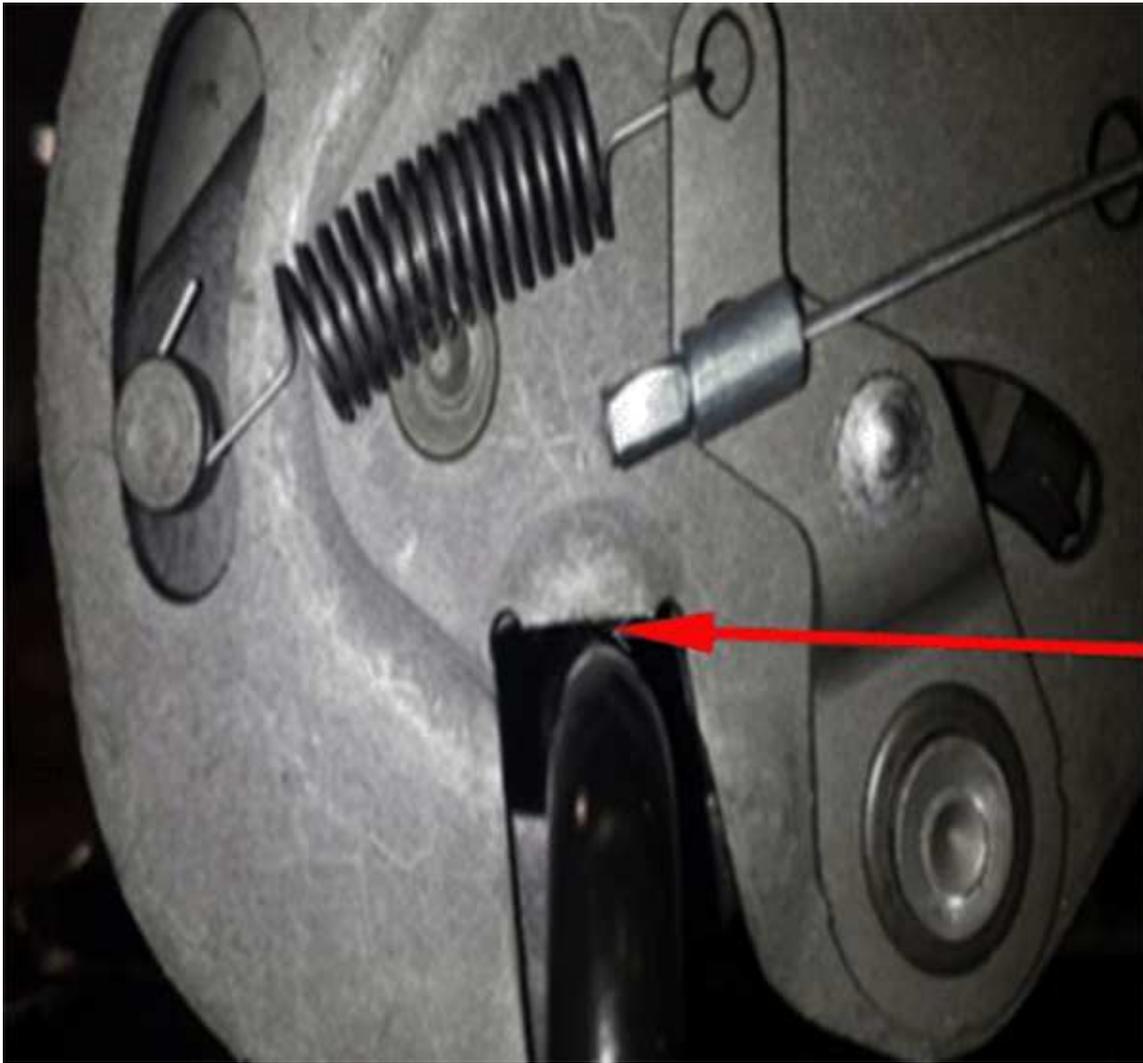
Cause 3: Inboard to outboard striker height variations, causing uneven gapping between the left and right seat bottom latches, see picture below. This can cause the latch with the gap to rattle.

This procedure will level the seat base plate by installing spacer washers between the floor and seat base plate.

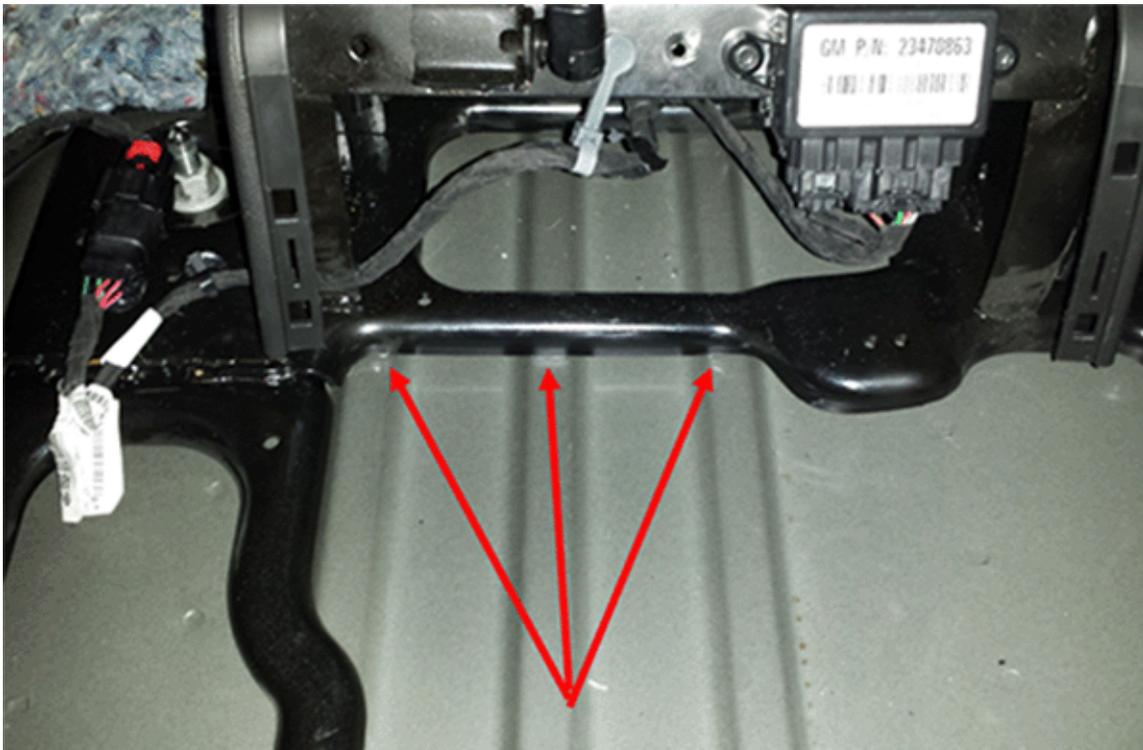
Cause 4: The seat base plate contacting/rattling against the ribs of the floor pan.

4.3. Remove the seat assembly and using the appropriate tools (example wood 2x4 and hammer) contoured the floor pan slightly to create clearance between

the seat base plate to floor pan.

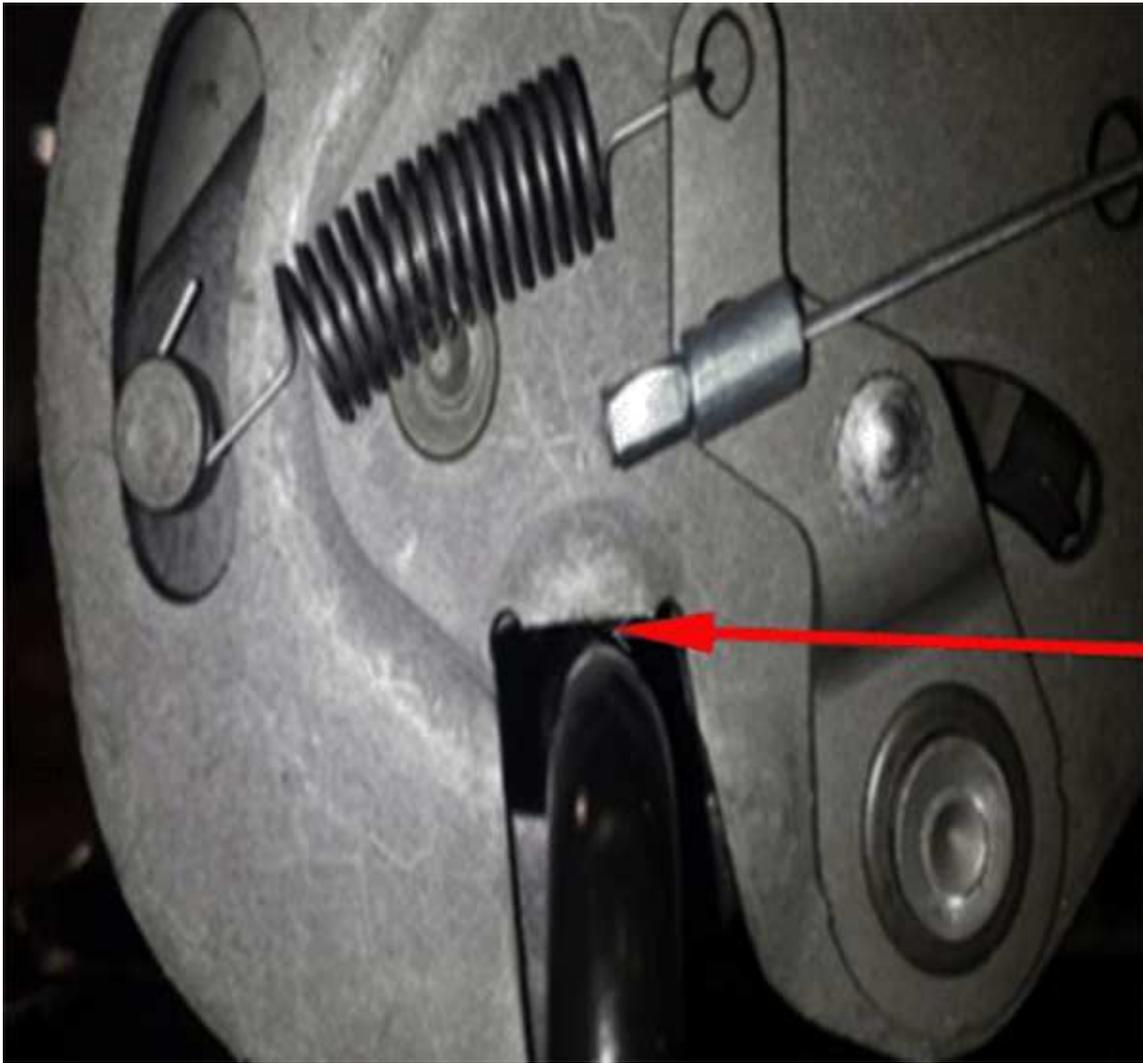
- Cause 3: Inboard to outboard striker height variations, due to an unlevel seat base plate, can cause uneven gapping between the inboard to outboard striker to latch, shown below.

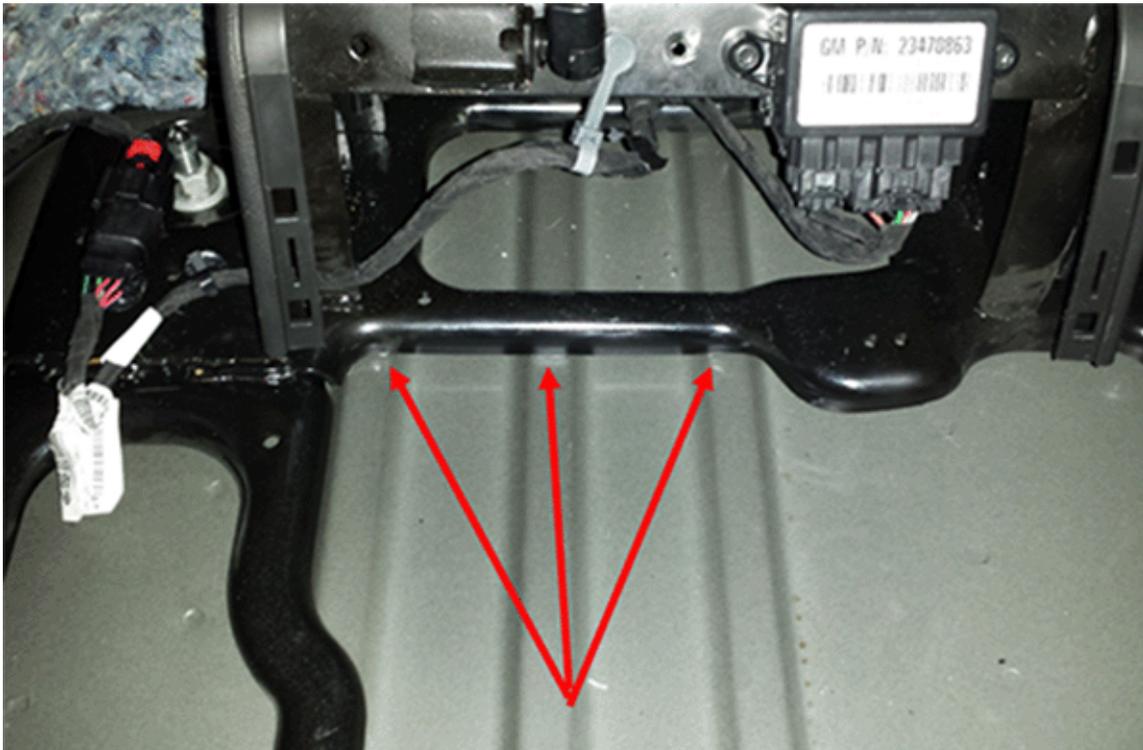
4.2 Inspect the seat base plate for contacting the ribs of the floor pan, as shown below. If contact is present paint damage can normally be seen at the area of contact.
