Service Bulletin

Bulletin No.: 16-NA-008

Subject: Auto-On Rear Window Defogger and Outside Rear View Mirror (OSRVM) Defogger Not Operating

Brand:	Model:	Model Year:		VIN:		Engine:	Transmission:
		from	to	from	to		
Cadillac	ATS	2013	2016			All	All

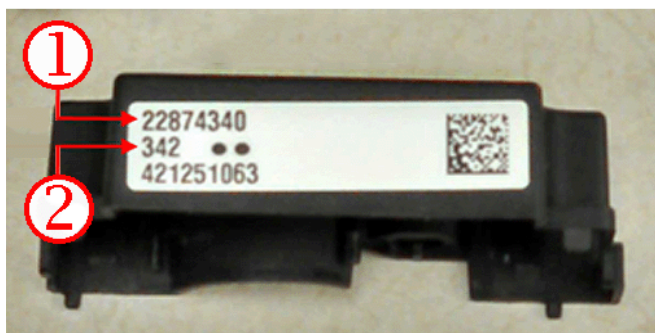
Radio Antenna Coil Label

- (1) Original Part Number = 22874340
 - (2) Date Code; 2-digit "week", 1-digit "year" example: week "34", year "2012"
 - Supplier DUNS number
2. Replace the current radio antenna coil in the vehicle with radio antenna coil P/N 84043838. Record on the RO the P/N and the date code of the radio antenna coil removed from the vehicle (see picture above for locations) before installation of the new radio antenna coil.
 3. Remove the Supplement To The 2013-2016 Cadillac ATS Sedan Owner Manual from field action 15299.
 4. Contact the Techline Customer Support Center (TCSC) at 1-800-828-6860 (English) or 1-800-503-3222 (French) for instructions for how to reprogram the HVAC control module. Before contacting TCSC, the part number and date code of the original and the replacement radio antenna coil will be required. The TCSC will also need the RO number that the radio antenna coil was replaced on.
