Service Bulletin

File in Section: -
 Bulletin No.: 16-NA-015
 Date: January, 2016

Subject: Engine Stall or Stumble - Replace Coil Connector

Attention: Vehicles equipped with 1.4L RPO LUJ/LUV turbocharged engine.

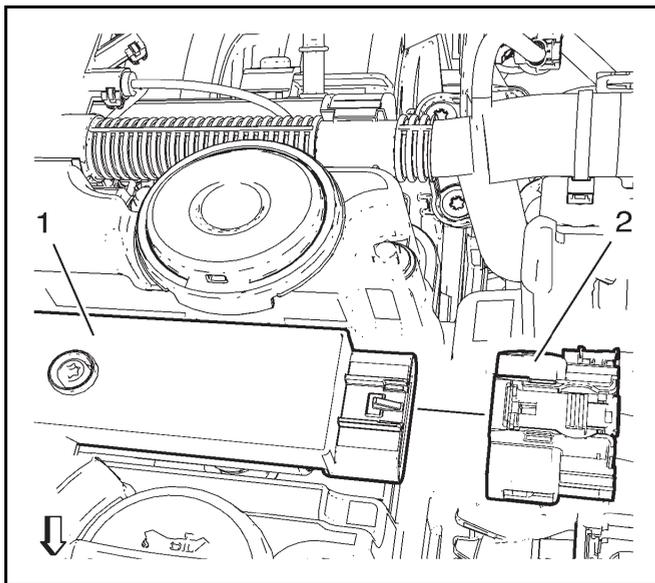
2191363

Condition	Some customers may comment that the engine stalls, stumbles, and/or has a hesitation when accelerating from a stop.
Cause	The ignition coil connector may have fretting on the terminals, causing a poor connection.

Ignition coil (1) and 7-pin ignition coil wiring harness connector (2)

Inspect the 7-pin coil pack connector for poor terminal contact or fretting. Replace connector with part number 19300958 if needed.

1. Inspect the 7-pin coil pack connector (2) for damage. If no damage is found, follow normal SI diagnostics.
2. If damage is found, replace the coil pack connector. Refer to *Ignition Coil Replacement* and *Splicing Copper Wire Using Splice Sleeves* in SI.
3. Verify the repair.
