Service Bulletin

Bulletin No.: 16-NA-021

Subject: Radio Inoperative - Blank Screen, No Audio, No Navigation and/or Lack of Audible Signal Chimes

Brand:	Model:	Model Year:		VIN:		Engine:	Transmission:
		from	to	from	to		
Chevrolet	Impala (VIN 1)	2014	2014	Start of 2014 Production	November 1, 2013	All	All

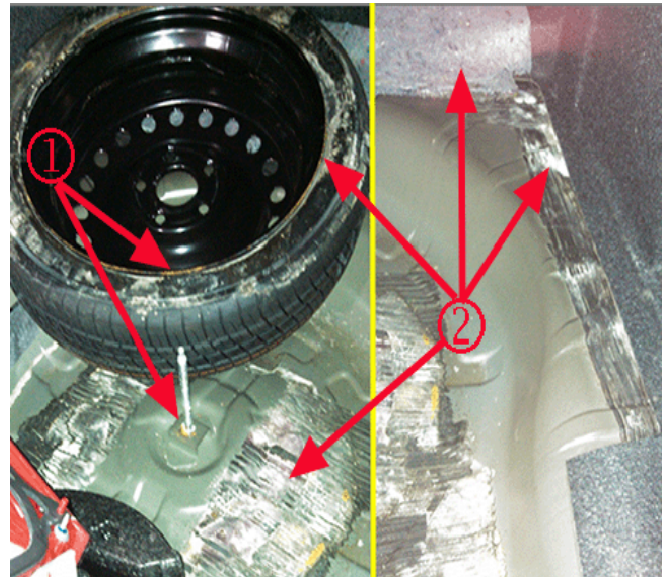
4353866

Condition	Some customers may comment that the radio is inoperative; has blank screen, no audio, no navigation and/or lack of audible signal chimes.
Cause	The cause of the condition may be water damage that may have occurred due to tail lamp seals losing the ability to properly seal the trunk area. Two Recalls, #13426 and #14047, addressed replacement of the failed tail lamp seals, however an affected vehicle may not have had the recall repair completed yet, or the water damage may have taken place prior to the replacement the seals.
Additional Options	Equipped with RADIO-INFOTAINMENT SYSTEM - UPLEVEL WITH CONNECTIVITY AND EMBEDDED NAVIGATION (RPO IO6) and SPEAKER SYSTEM-PREMIUM AUDIO BRANDED WITH SURROUND AMPLIFIER (RPO UQS)

Verify the condition, then remove trunk trim as necessary to inspect the trunk floor and spare tire for evidence of rust (1) or mold/residue (2).
