Service Bulletin

Bulletin No.: 16-NA-022

Subject: Instrument Panel Upper Trim Pad Discoloration and/or Shiny Spot

Brand:	Model:	Model Year:		VIN:		Engine:	Transmission:
		from	to	from	to		
Chevrolet	Express	2016	2016	SOP	August 25, 2015	All	All
GMC	Savana	2016	2016	SOP	August 25, 2015	All	All

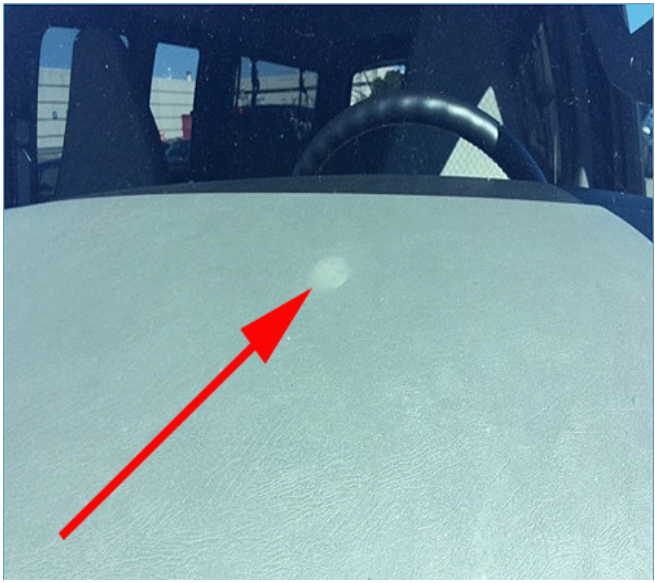
4336165
	Some customers may comment on a shiny spot and/or a white discoloration on the instrument panel upper trim pad directly in front of the instrument panel cluster.
Cause	This may be caused by a tooling change within the production of the part.

If you encounter a vehicle with the above concern, replace the trim pad. Refer to Instrument Panel Upper Trim Pad Replacement in SI.
