Program Bulletin

CUSTOMER SATISFACTION PROGRAM

SUBJECT: Tail Lamp Gasket Seal

MODELS: 2014 Chevrolet Impala

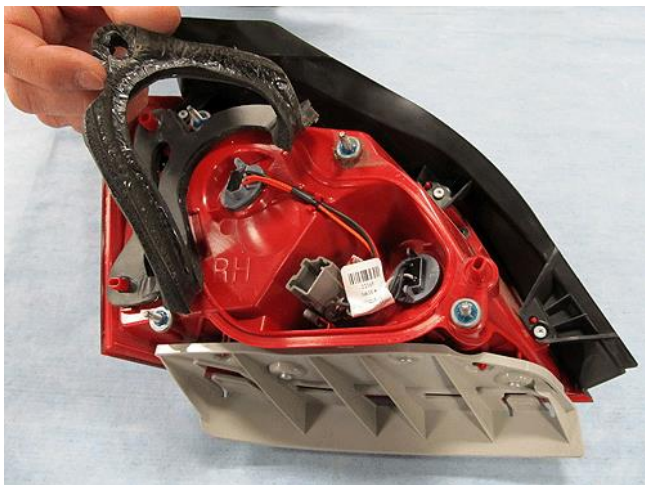
3649621

3. Place the tail lamp assembly on a soft work area to prevent damage to the outer lens area.

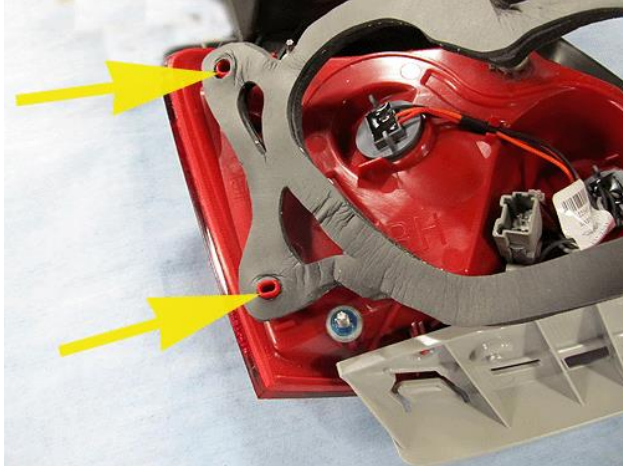
3649624

- 4. Slowly peel the seal away from the housing, using care to remove the adhesive from the housing. **Tip:** Removing the seal at a 45 degree angle while slightly stretching the rubber will remove most of the adhesive with the seal.

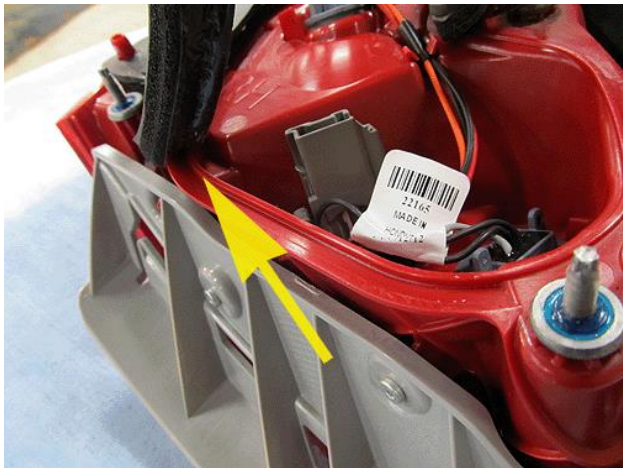
3649627

- 5. Clean any old adhesive from the tail lamp housing using a general purpose adhesive remover.
- 6. Start the new seal application by placing the two outer alignment pins through the holes on the seal. Ensure that the adhesive side of the seal is facing the tail lamp.

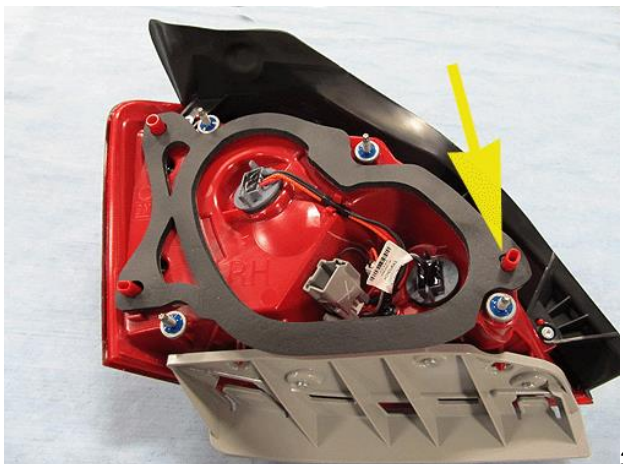
3649630

- 6.1 Install the seal, ensuring that it is centered on the compression ribs on the tail lamp housing as shown.
