Program Bulletin

CUSTOMER SATISFACTION PROGRAM

SUBJECT: Hood Striker Corrosion / Fracture

MODELS: 2015-2016 Chevrolet Colorado
2015-2016 GMC Canyon

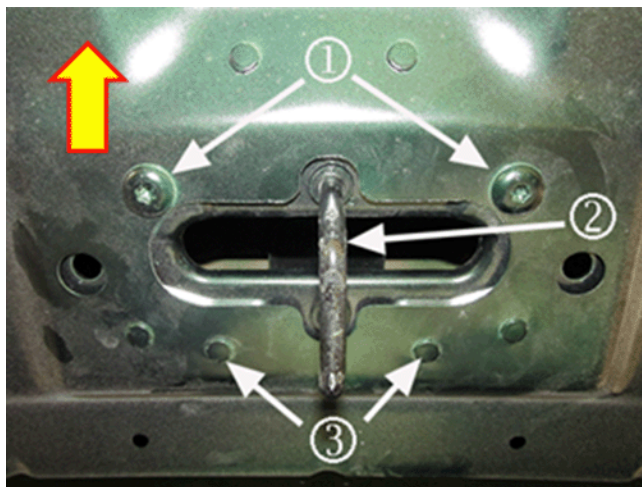
4170778

- (1) Forward screws
- (2) Stationary hood striker
- (3) Rear, inboard hood clinches

1. Open the hood and verify components noted above.
