Service Bulletin

SUBJECT: Service Update for Inventory and Customer Vehicles
Excessive Wiring Harness Length
Expires with Base Warranty

MODELS: 2015 Chevrolet Colorado
2015 GMC Canyon
Equipped with 3.6L V6 Engine (RPO LFX)

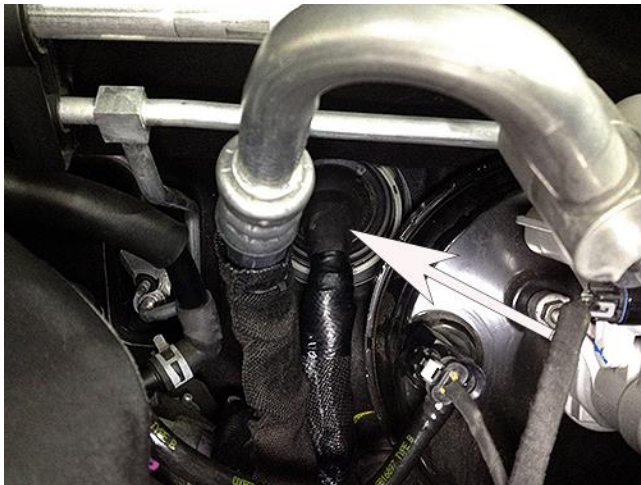
4355970

1. Locate the main body wiring harness branch in the engine compartment where it exits the front of dash.

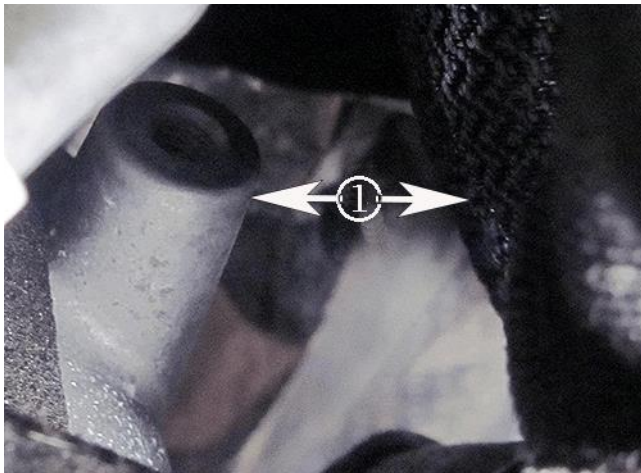
4355973

2. Measure the clearance between the threaded boss on the engine cylinder head and the wiring harness as shown (1).

- If the clearance (1) is 25mm (1.0 in.) or **more**, no further action is required.
- If the clearance (1) is **less** than 25mm (1.0 in.), proceed to the repair steps below.
