Service Bulletin

SPECIAL COVERAGE

SUBJECT: Special Coverage Adjustment – Fuel Tank Inlet Check Valve Fracture

MODELS: 2004 Buick Rainier
2003-2004 Chevrolet SSR
2002-2004 Chevrolet TrailBlazer, TrailBlazer EXT
2002-2004 GMC Envoy, Envoy XL
2004 GMC Envoy XUV
2002-2004 Oldsmobile Bravada

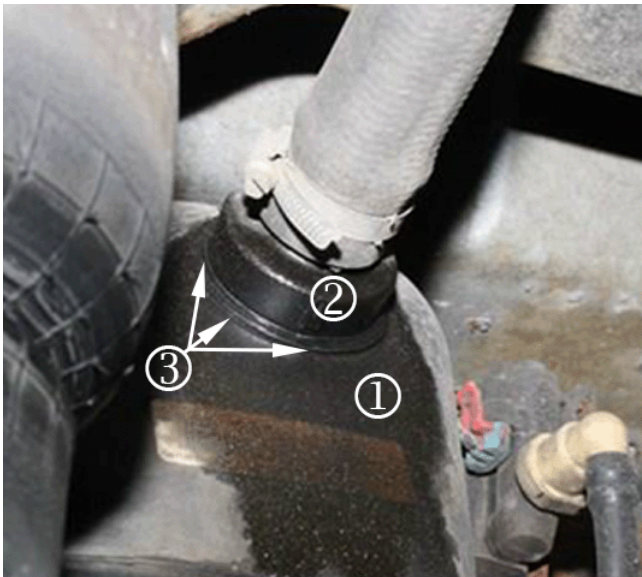
(1) Fuel Tank (2) Inlet Check Valve (3) Weld Zone

Note: Refer to the photograph to view the location of the weld zone, which is between the ICV and fuel tank. Vapor and/or fuel leaks may occur if the weld zone between the ICV and fuel tank is fractured. A fractured ICV could allow fuel vapors to pass through and droplets of fuel to accumulate on the side of the fuel tank as it passes over the fracture during refueling. If the ICV fractures, the vehicle's Service Engine Soon (SES) light may illuminate, and the owner may notice a fuel odor and/or a few drops of fuel on the ground when refueling the vehicle.

1. Inspect the fuel tank for a leak at the fuel tank inlet check valve (ICV). Refer to *Fuel Tank Leak Test* in the Diagnostic Information and Procedures section of SI.
 - If the fuel tank does NOT require replacement, no further action is required. Inform the customer that any additional diagnosis and repairs are not covered under this special coverage.

- If a fuel leak is present at the fuel tank ICV, replace the fuel tank. Refer to *Fuel Tank Replacement* in SI.
