Service Bulletin

Bulletin No.: 16-NA-004

Subject: Intermittent Multiple IPC Warning Lamps Illuminated, Loss of Power Steering Assist,

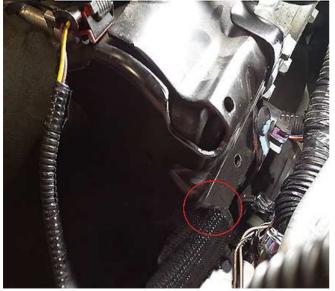
4363219

| Condition | Some customers may comment on the following conditions: Intermittent multiple IPC warning lamps illuminated. Loss of power steering assist. Service Power Steering message. Malfunction Indicator Lamp illuminated. Multiple HSLAN U-Codes set. | |
|---|--|--|
| Cause | This may be caused by the engine wiring harness chaffing on the edge of the fuel purcover. | |

- 1. Inspect the engine wiring harness conduit and wires for chaffing.
- Repair the wires per the Wiring Repairs procedure in SI.

- 3. Wrap the engine wiring harness with Polyester Electrical/Anti-Abrasive Tape (PET) or equivalent anti-abrasion tape.
- Using a small metal file, remove any burrs and sharp edges along the fuel pump cover edge in the area illustrated above.
- 5. Position the engine wiring harness away from the edge of the fuel pump cover.
