Service Bulletin

Bulletin No.: 16-NA-013

Subject: No Reverse, No Third, DTC P0716, P0717

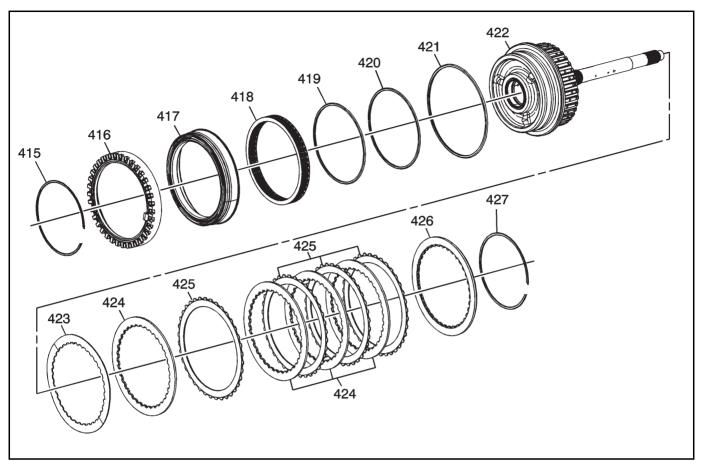
1725896

Condition	Some customers may comment on a condition of no Reverse. Some may also comment on no 3rd gear. Technicians may find an erratic input speed signal. DTCs P0716 and/or P0717 may be found as active or history DTCs.
Cause This condition may be caused by the Input Shaft Speed Sensor Reluctor Ring Ring being out of the groove.

Replacement of the Retainer Ring (415), Input Shaft Speed Sensor Reluctor Wheel (416), 3-5-Reverse Clutch Piston (417) and 3-5-Reverse and 4-5-6 Clutch Housing Assembly (422). Inspect and replace other distressed parts as needed.
