Service Bulletin

Bulletin No.: 16-NA-014

Subject: Delayed Engagement After Sitting With Engine Off

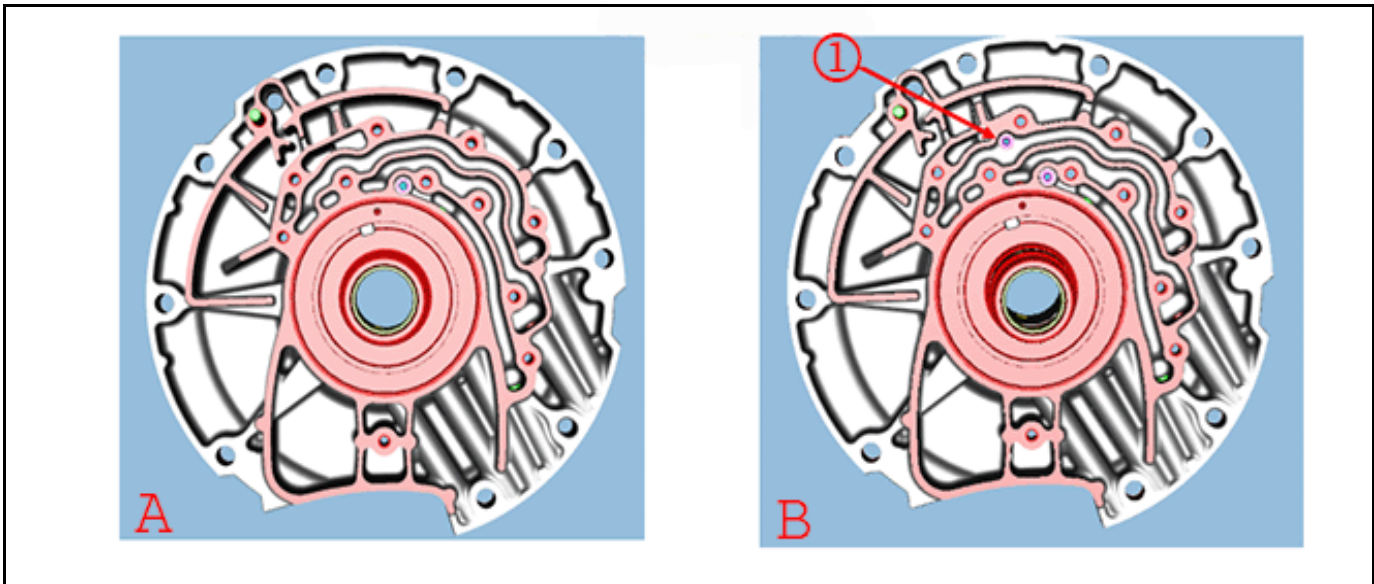
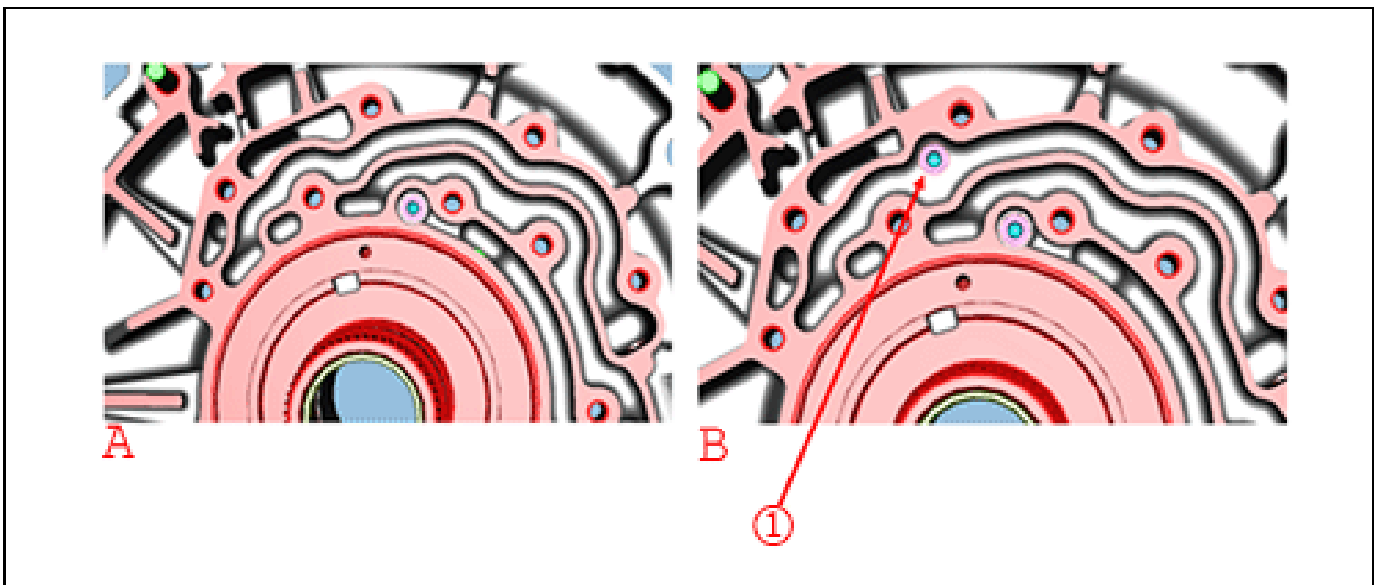
(A) Old stator support asm 24274636/
24275106/24272656

(B) New stator support asm 24277234

Note: The new stator shaft support assembly has a second check ball (1) added (see illustrations).

- Remove the turbine shaft O-ring seal (1). Discard the seal.
- Remove the nine stator shaft support bolts (2).
- Remove the stator shaft support assembly (3).

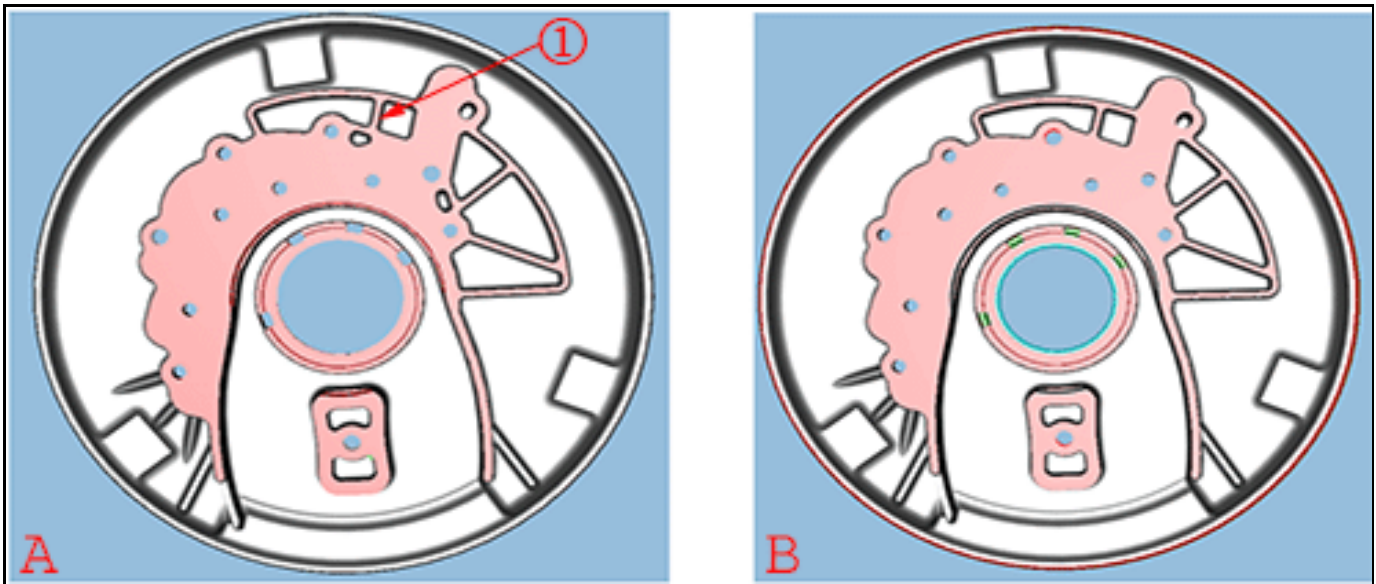
4358782

(A) Old cover 24272660

(B) New cover 24277964

Note: The casting void has been eliminated from the underside of the cover (see illustration).
