Technical product information

Transaction No.: 2027022/4

New Continental GT - GTC and Flying Spur - Steering wheel noise

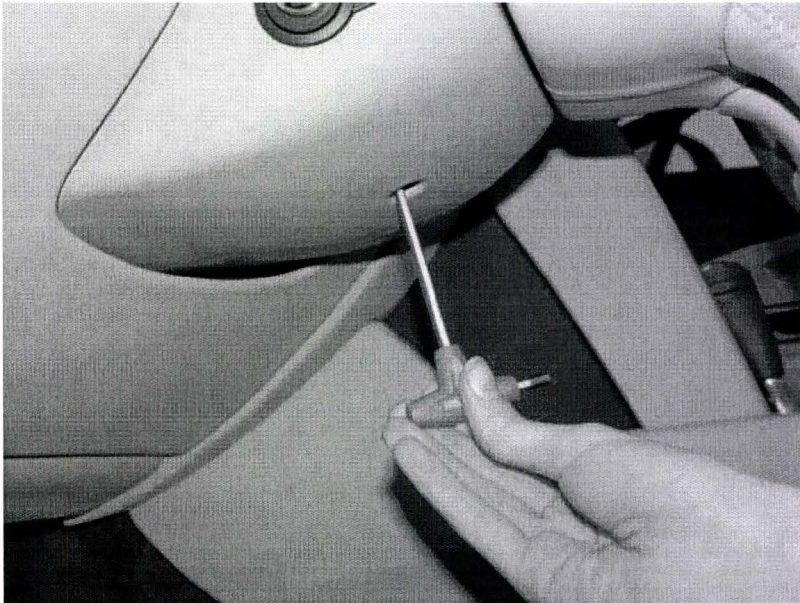
Figure 1

The chafing/grinding noise occurs when turning the steering wheel from lock to lock. The noise is not always evident throughout the full cycle. The noise is due to the multi-function switch coupling contacting the inner face of the steering cowl.

1. Slacken off the multi-function switch 4mm Allen bolt fixing which can be accessed through the steering column lower cowl (Figure 1).
