| <b>Topic</b> | 2012MY New GT family - Winter tyre option – enabling corresponding data to be displayed in the infotainment unit (RNS) |
| <b>Brand</b> | Bentley |
| <b>Transaction No.</b> | 2028457/3 |

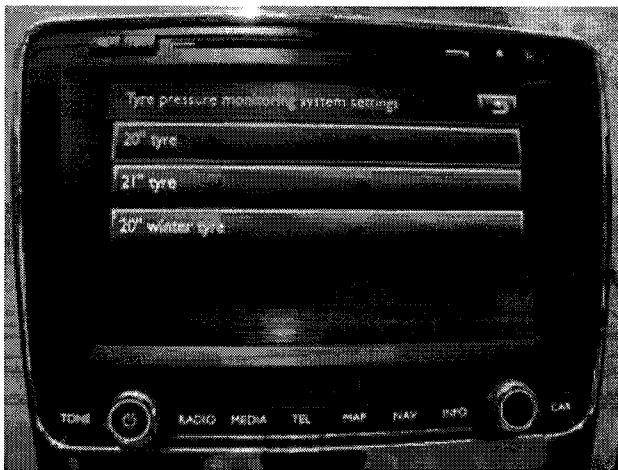
Figure 1

The vehicle is to be fitted with 21" winter tyres or 20" snow chains and the infotainment unit is displaying only 20" winter tyre

Currently the Infotainment unit (RNS) is programmed during manufacture to display only the 20" winter tyre option.

If the vehicle is to have 21" winter tyre or 20" snow chains fitted and these options are not currently offered up for selection in the infotainment unit (see Figure 1) then the following process can be performed

If the vehicle is to be fitted with 21" winter tyre option or 20" snow chain option then additional software can be loaded into the infotainment system to enable the correct tyre detail to be displayed
