Field campaign

Topic	Mulsanne side view camera control module (SC12/15)
Market area	Worldwide Bentley (1WBE)
Brand	Bentley
Transaction No.	2030874/2
Campaign number	E775
Note	
Type	
US code

Mulsanne

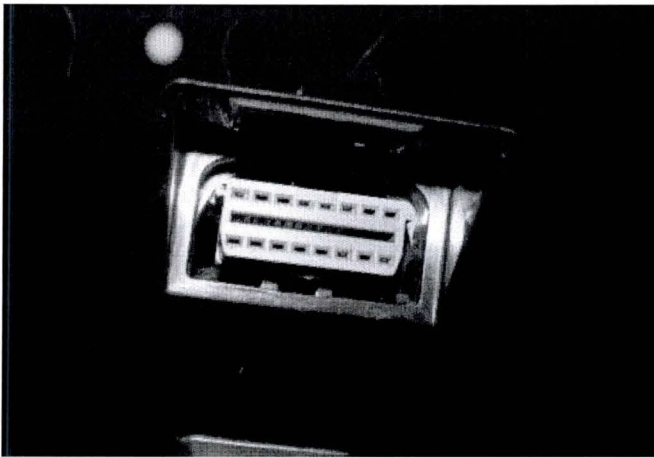
Figure 1

In January 2012 a TPI was released which instructed Dealers to remove where fitted the side view camera control module as a potential fault was identified with the original part. The latest specification side view camera control module is now available for all Bentley Mulsanne vehicles which were specified with the side view camera option. If the original module has been previously removed and replaced with the link loom as per previous instruction, a Yellow paint mark will be evident on the diagnostic plug surrounding cover as shown in Figure 1, please remove the loom and fit the replacement side view camera module as detailed within this document.

Should the vehicle still have the original side view camera module fitted or the link loom was installed at the time of production a Yellow paint mark will not be evident, if this is the case please replace the existing module or remove the link loom and replace with the latest specification part as detailed within this document.

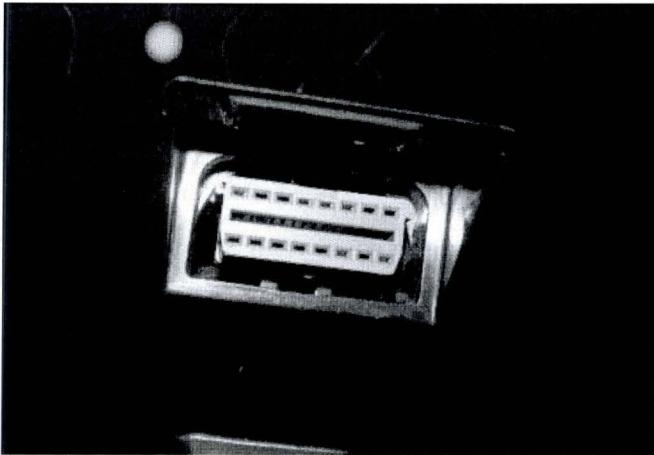
Figure 1

In January 2012 a TPI was released which instructed Dealers to remove where fitted the side view camera control module as a potential fault was identified with the original part. The latest specification side view camera control module is now available for all Bentley Mulsanne vehicles which were specified with the side view camera option. If the original module has been previously removed and replaced with the link loom as per previous instruction, a Yellow paint mark will be evident on the diagnostic plug surrounding cover as shown in Figure 1, please remove the loom and fit the replacement side view camera module as detailed within this document.

Should the vehicle still have the original side view camera module fitted or the link loom was installed at the time of production a Yellow paint mark will not be evident, if this is the case please replace the existing module or remove the link loom and replace with the latest specification part as detailed within this document.

3. Should the original side view camera control module have been previously removed and replaced with the link loom 3Y0 998 381 there should be a Yellow completion paint mark on the diagnostic plug surrounding cover (Figure 1), please carefully remove this and replace with a White paint completion mark as shown in Figure 2. If the original control module has been replaced for the latest specification part or the factory fitted loom has been replaced with the latest specification part, a White paint completion mark should also be added (Figure 2)

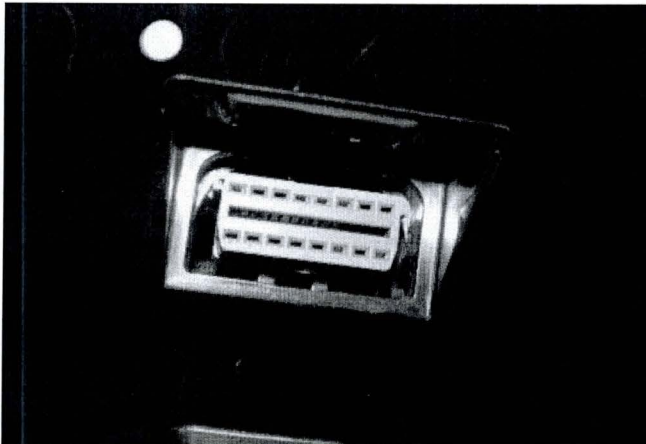
If the vehicle is not already listed as repaired in "Repair history" (in Elsa pro), check for the Campaign completion identification mark which is a White paint mark located above the diagnostic plug cover (Figure 2) the White mark confirms the latest specification part has been fitted, should neither be evident carry out the required work in accordance with instructions.

White paint mark on the diagnostic plug surrounding cover confirms the latest specification part has been fitted.
