Topic	W12 De - gas hose radiator connection - incorrect hose clip (SC12/11)
Market area	Worldwide Bentley (1WBE)
Brand	Bentley
Transaction No.	2031352/2
Campaign number	E771
Note	
Type	Service campaign
US code

Service campaign E771

W12 De - gas hose radiator connection - incorrect hose clip (SC12/11)

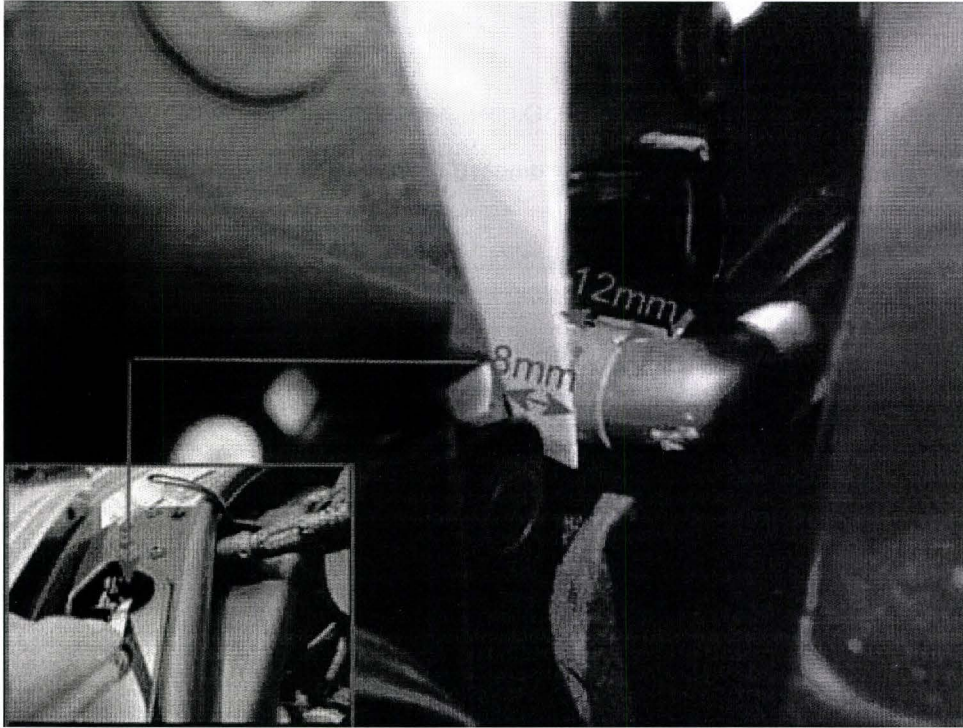
Note: The hose routing to the engine cooling radiator stub pipe differs on some installations but the stub pipe location on that radiator is the same and therefore these variations do not impact the following hose clamp replacement procedure

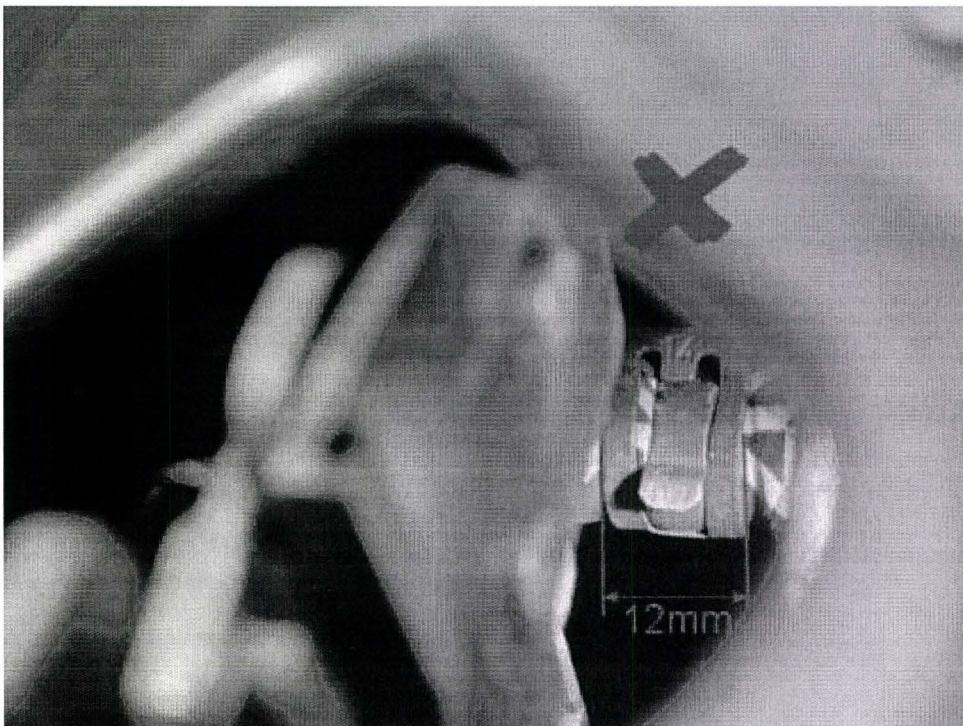
Using a measuring device, in this example a nylon spatula has been cut to 8mm, gauge the width of the spring band hose clamp at the engine coolant radiator stub pipe.

The specification calls for a hose clamp that is 8mm wide some vehicles have been fitted with a clamp that is 12mm wide. If the clamp is 8mm wide then no further action is required, apply the yellow paint campaign marker as per figure 1.

On vehicles where the incorrect 12mm hose clamp has been fitted then carry out the following replacement procedure.

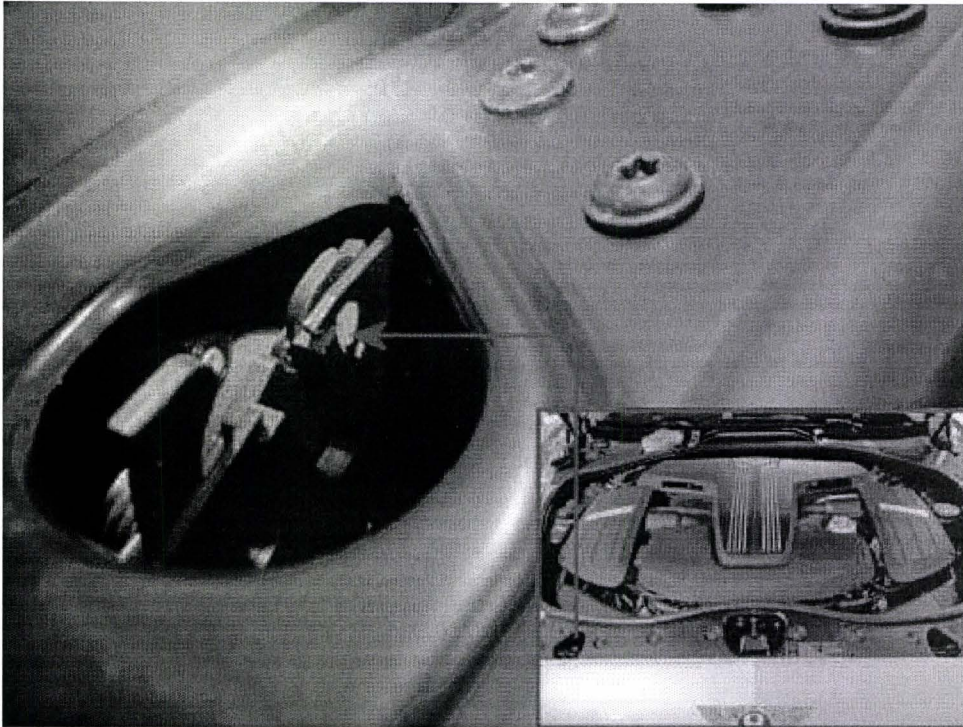
Figure 1

If the vehicle is not already listed as repaired in the "Repair history" (in Elsa pro), check for the campaign identification mark, yellow paint dot located on the bonnet right hand primary latch (Figure 1), should neither be evident carry out the required work in accordance with these instructions

On completion apply a yellow paint campaign mark to the bonnet primary latch, right hand.
