Field campaign

Topic	Convertible roof system - oversize rivet hole (SC12/13)
Market area	Worldwide Bentley (1WBE)
Brand	Bentley
Transaction No.	2031420/1
Campaign number	E773
Note	
Type	Workshop Campaign
US code

13MY New Continental GTC

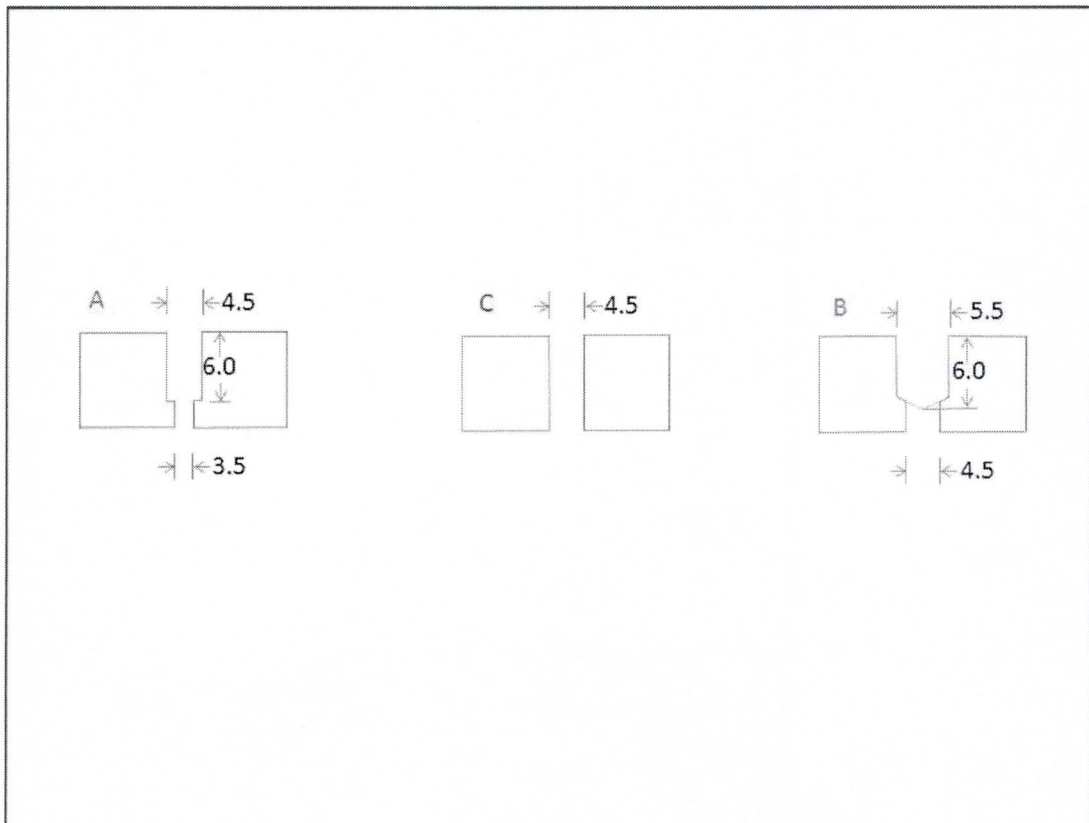
Figure 2

A counter bore operation on the left hand twin bow may have been performed incorrectly resulting in an oversize rivet hole and no counter bore. The counter bore is required to enable the rivet to expand and lock into the casting. This rivet hole requires inspection and if found to be oversize the attached rectification measure performed

If the rivet hole is found to be standard dimensions (diagram A) then fit a replacement standard rivet. On vehicles where the rivet hole is found to be oversize, that is the counter bore dimension has been drilled all the way through leaving no counter bore (diagram C), then a new larger counter bore has to be drilled, 5.5mm, to produce diagram B and the larger rivet used.

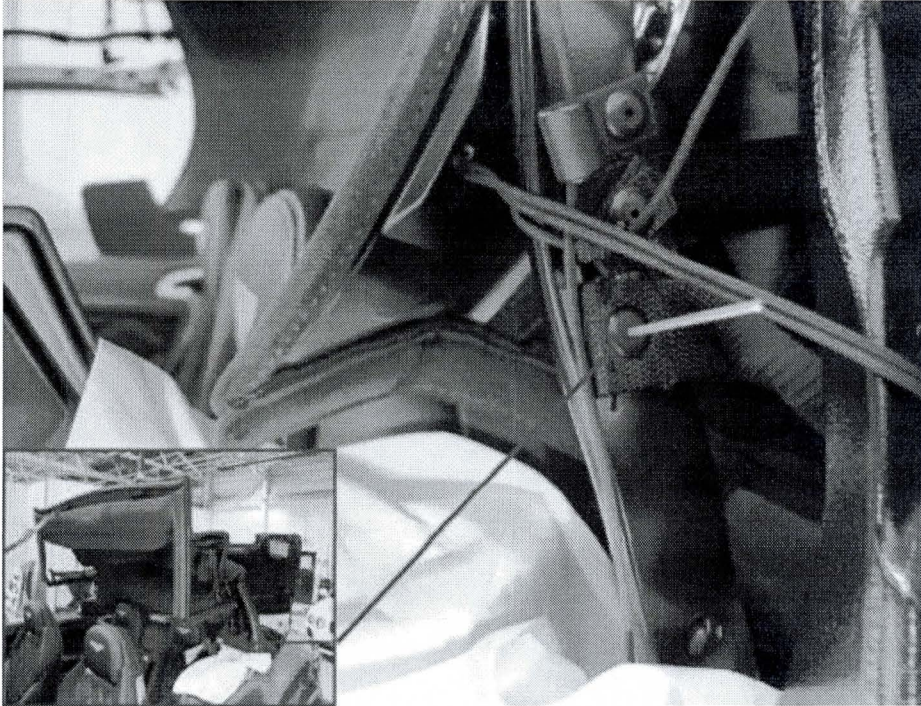
Figure 3

Note: Only check and if necessary repair the rivet on the left hand twin bow as shown in figure 3.
There are no known issues with the similar rivet on the right hand twin bow

1. With the ignition on, use the power operated roof open and close buttons to position the roof partially open. It is recommended that the roof position is maintained primarily with the ignition still on, and secured using a pair of tensioning straps (T10038) linked together.
2. **Note:** The vehicle must be adequately protected from the swarf that will be produced during the following operation. When removing rivets a 6mm drill is best suited to remove the rivet head before extracting the centre of the rivet with a 3mm parallel drift. **Eye protection must be worn**
