Technical product information

Topic	GTC - Rattle in rear of cabin - convertible roof
Market area	Worldwide Bentley (1WBE)
Brand	Bentley
Transaction No.	2031919/1
Level	EH
Status	Approval
Release date

Continental GTC

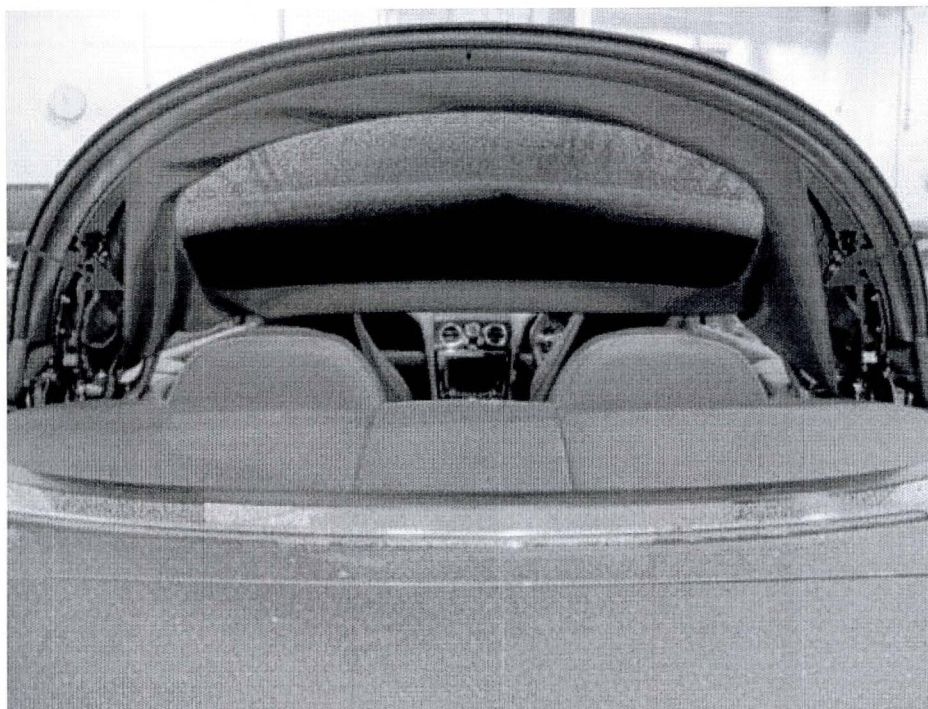
The single plastic terminal housing used on each of the two heated rear screen electrical connections can in some instance rattle

Two terminals located one each side of the heated rear screen can produce a high frequency rattle. On this occurrence the following procedure should be performed. (see Figure 1)

1. With the ignition on, use the power operated roof open and close buttons to position the roof partially open. Figure 1 shows the optimum position to enable this procedure to be performed. It is recommended that the roof position is maintained primarily with the ignition still on, and secured, for the operators safety, using a pair of tensioning straps (T10038) linked together.
