Technical product information

Topic	Mulsanne front suspension - control module parameter updates
Market area	Worldwide Bentley (1WBE)
Brand	Bentley
Transaction No.	2032620/1
Level	EH
Status	Approval
Release date

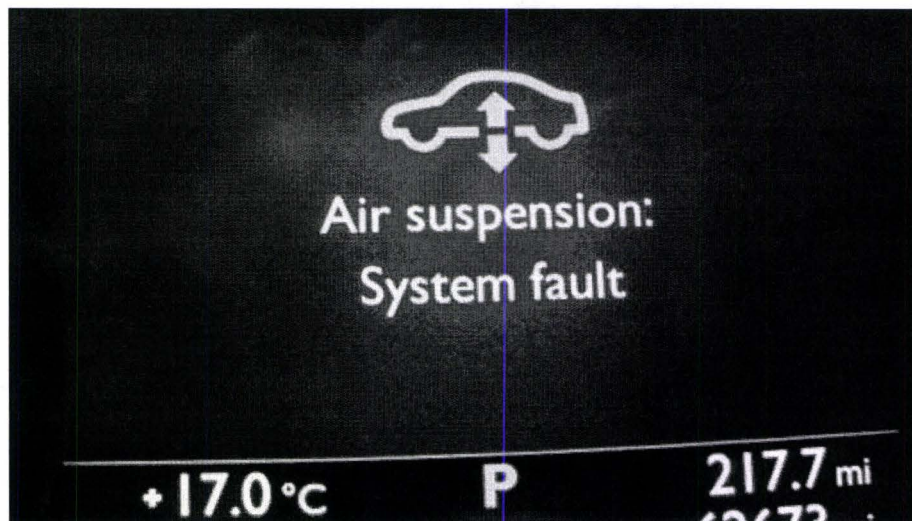
Figure 1

The air suspension warning light (Figure 1) is illuminated and/or event codes C103429 (Front left hand ride height sensor) and C103529 (Front right hand ride height sensor) are present within the air suspension control module.

The parameters of the front ride height sensors are insufficient, this TPI describes the process which must be followed should the air suspension warning light be evident and/or the suspension control module event codes are logged relating to the front ride height sensors.
