## Technical product information

| <b>Topic</b> | Mulsanne front suspension - control module parameter updates |
| <b>Transaction No.</b> | 2032620/2 |

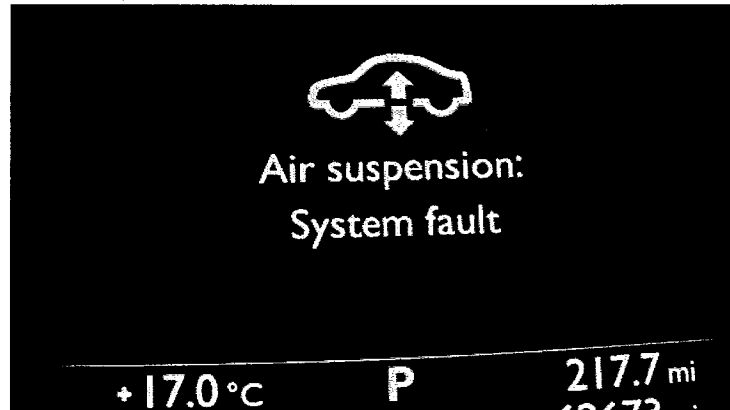
Figure 1

The air suspension warning light (Figure 1) is illuminated and/or event codes C103429 (Front left hand ride height sensor) and C103529 (Front right hand ride height sensor) are present within the air suspension control module.

The parameters of the front ride height sensors are insufficient, this TPI describes the process which must be followed should the air suspension warning light be evident and/or the suspension control module event codes are logged relating to the front ride height sensors.
