### Field campaign

Topic	Mulsanne exterior door mirror software update (SC13/03)
Market area	Worldwide Bentley (1WBE)
Brand	Bentley
Transaction No.	2033282/1
Campaign number	E779
Note	
Type	
US code

#### Mulsanne exterior door mirror software update

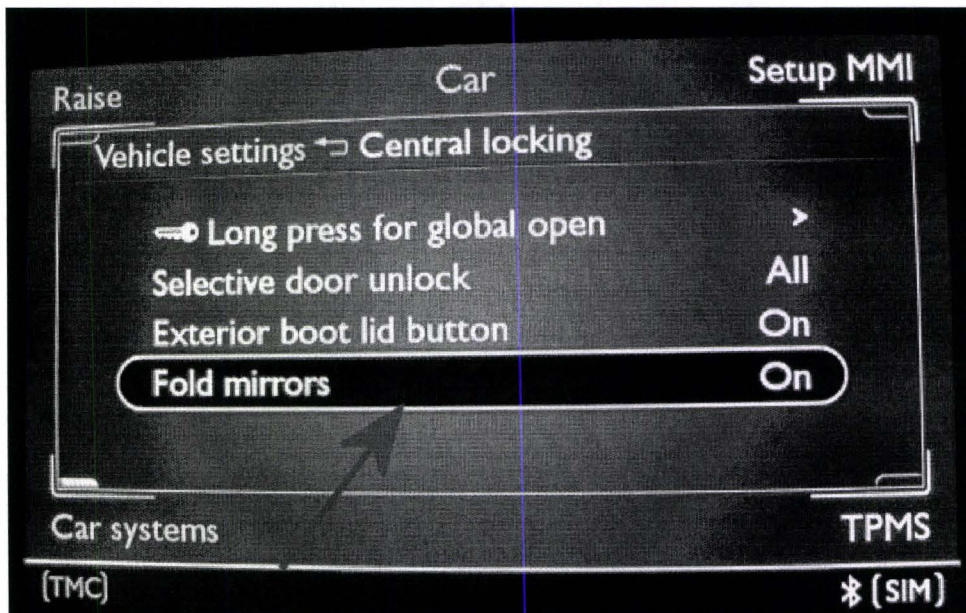
Figure 1

The SVM update also prevents the possibility of a separate mirror related issue from occurring, the issue concerned can occur when the 'Fold mirrors' function is selected to be On within the MMI as shown in Figure 1. Selecting this function allows the mirrors to be power folded when the vehicle is locked. Bentley Motors has received isolated reports of only one mirror folding. The SVM update eliminates the customer from experiencing this issue.

Bentley Motors has devised a Software Version Management (SVM) update which eliminates the possibility of a customer experiencing issues relating to the exterior door mirror power fold/unfold operation.

The containment measure within the SVM update reduces mirror motor cut off time which prevents the door mirrors sticking and jolting sporadically during the power fold/unfold operation issue.

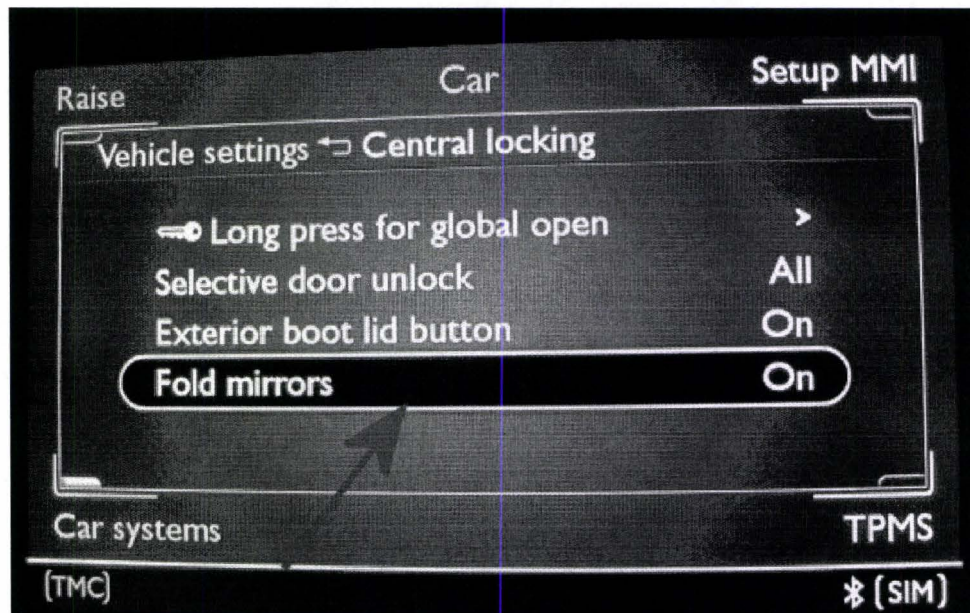
Figure 1

The SVM update also prevents the possibility of a separate mirror related issue from occurring, the issue concerned can occur when the 'Fold mirrors' function is selected to be On within the MMI as shown in Figure 1. Selecting this function allows the mirrors to be power folded when the vehicle is locked. Bentley Motors has received isolated reports of only one mirror folding. The SVM update eliminates the customer from experiencing this issue.

Bentley Motors has devised a Software Version Management (SVM) update which eliminates the possibility of a customer experiencing issues relating to the exterior door mirror power fold/unfold operation.

The containment measure within the SVM update reduces mirror motor cut off time which prevents the door mirrors sticking and jolting sporadically during the power fold/unfold operation issue.

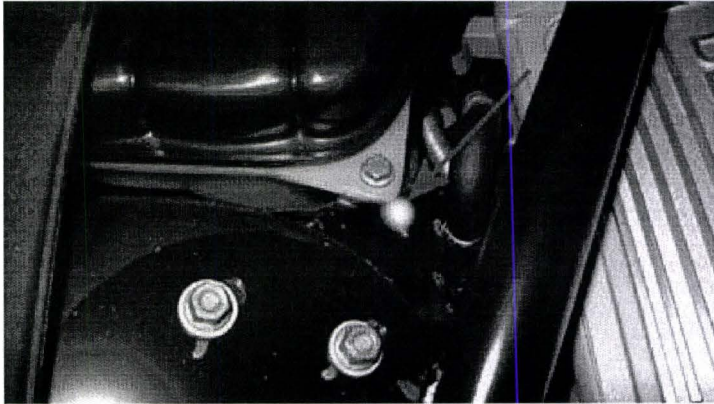
Figure 8

White paint completion mark on the expansion tank bracket (see Figure 8)

11. When prompted enter the following code: 3Y452A0003P and follow all on screen prompts
    - When requested accept all updates for the following:
      - 42 – Driver door control units J386 and 52 – Front passenger door control unit – J387 and follow all on screen prompts until **Program end**
  12. Once complete, place a White paint completion mark on the expansion tank bracket (Figure 8)
- NOTE:** Should a Blue paint mark may be evident on the expansion tank bracket this should be removed and then apply the White completion mark
