| Topic | Mulsanne exterior door mirror software update (SC13/03) |
| Campaign number | E779 |

### Mulsanne exterior door mirror software update

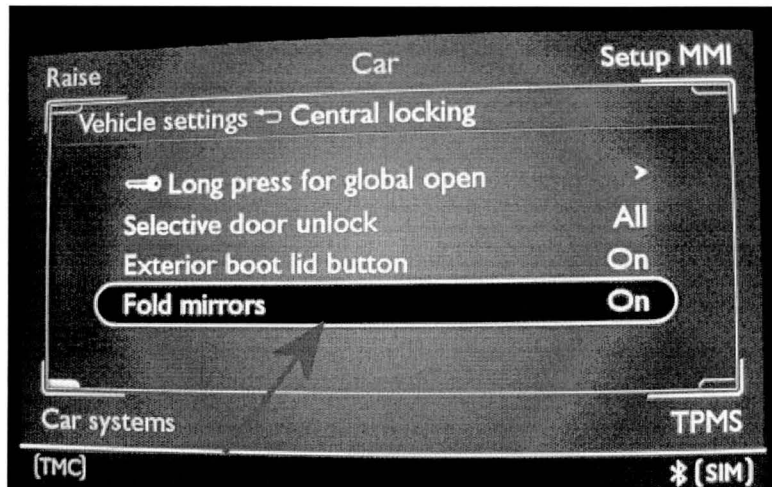
Figure 1

The SVM update also prevents the possibility of a separate mirror related issue from occurring, the issue concerned can occur when the 'Fold mirrors' function is selected to be On within the MMI as shown in Figure 1. Selecting this function allows the mirrors to be power folded when the vehicle is locked.

Bentley Motors has devised a Software Version Management (SVM) update which eliminates the possibility of a customer experiencing issues relating to the exterior door mirror power fold/unfold operation.

The containment measure within the SVM update reduces mirror motor cut off time which prevents the door mirrors sticking and jolting sporadically during the power fold/unfold operation.

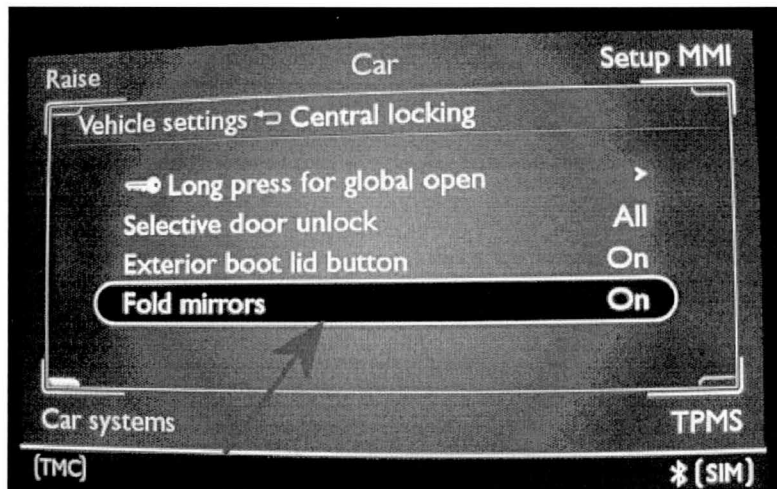
Figure 1

The SVM update also prevents the possibility of a separate mirror related issue from occurring, the issue concerned can occur when the 'Fold mirrors' function is selected to be On within the MMI as shown in Figure 1. Selecting this function allows the mirrors to be power folded when the vehicle is locked.

Bentley Motors has devised a Software Version Management (SVM) update which eliminates the possibility of a customer experiencing issues relating to the exterior door mirror power fold/unfold operation.

The containment measure within the SVM update reduces mirror motor cut off time which prevents the door mirrors sticking and jolting sporadically during the power fold/unfold operation.
