Field campaign

Topic	Convertible Roof - Revised Clip Arrangement - C Flap Bowden Cable (SC13/12)
Market area	Worldwide Bentley (1WBE)
Brand	Bentley
Transaction No.	2033508/3
Campaign number	E788
Note	E788
Type	E788
US code

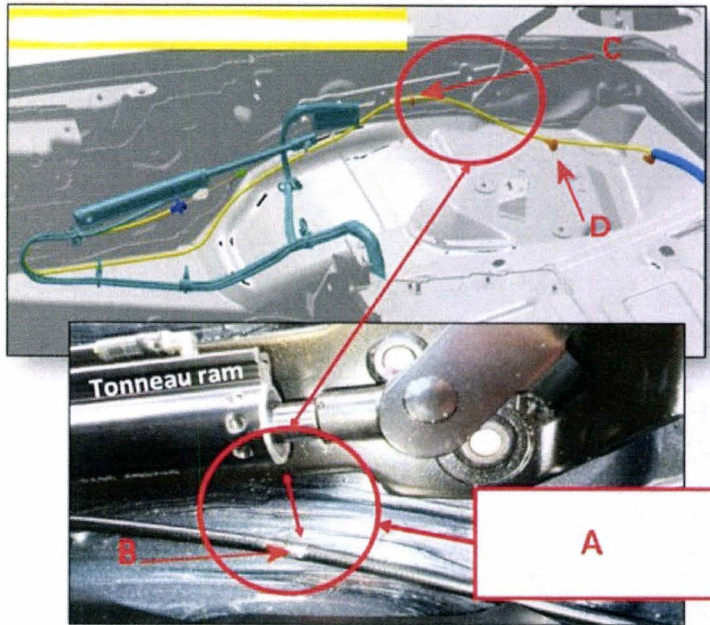
A potential compression point has been identified between the tonneau cover hydraulic ram and the C flap Bowden cable as it routes under the tonneau cover drive system (see Figure 1). A revised clip arrangement has been specified to avoid this compression damage. In severe cases the damage to the Bowden cable is such as to impair correct operation of the C flap, therefore a test of the C flap function is required to ensure the Bowden cables are serviceable before implementing the revised clip arrangement

- Figure 1 details the original routing and single cable tie (C) securing the Bowden cable (shown in yellow). The detail at point A shows the potential contact point between the tonneau cover hydraulic ram and the Bowden cable. The actual contact takes place when the tonneau is almost closed and therefore the close proximity of the hydraulic ram and the Bowden cable cannot be seen when viewed with the tonneau cover in a transient position. Detail B shows, in this case, a section of the outer sheath of the Bowden cable that has been removed by repeated contact with the ram. Note: as long as the system has passed the C flap function test then the absence of some of the outer sheath is not sufficient grounds to change the cables

All affected vehicles require a C flap function check to ensure correct operation before either applying the revised clip arrangement or in the case of failed function test refer to TPI 2033467 C flap Bowden cable replacement

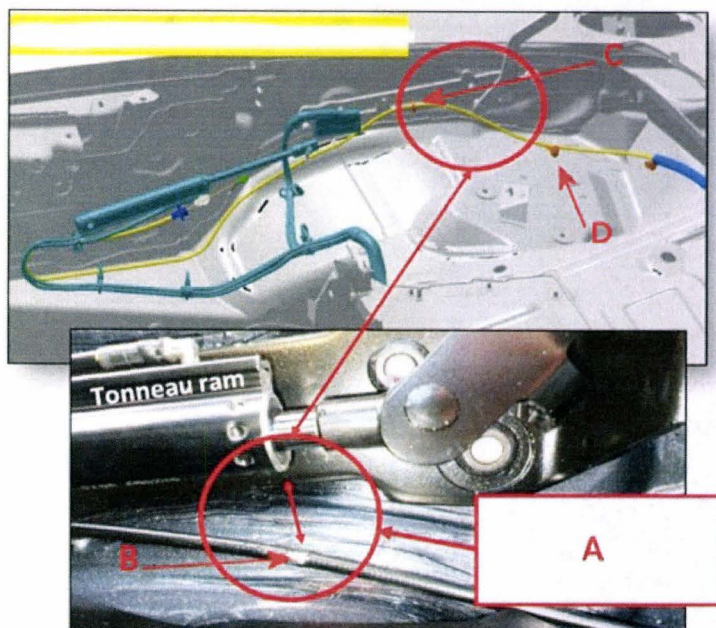
A potential compression point has been identified between the tonneau cover hydraulic ram and the C flap Bowden cable as it routes under the tonneau cover drive system (see Figure 1). A revised clip arrangement has been specified to avoid this compression damage. In severe cases the damage to the Bowden cable is such as to impair correct operation of the C flap, therefore a test of the C flap function is required to ensure the Bowden cables are serviceable before implementing the revised clip arrangement

- Figure 1 details the original routing and single cable tie (C) securing the Bowden cable (shown in yellow). The detail at point A shows the potential contact point between the tonneau cover hydraulic ram and the Bowden cable. The actual contact takes place when the tonneau is almost closed and therefore the close proximity of the hydraulic ram and the Bowden cable cannot be seen when viewed with the tonneau cover in a transient position. Detail B shows, in this case, a section of the outer sheath of the Bowden cable that has been removed by repeated contact with the ram. Note: as long as the system has passed the C flap function test then the absence of some of the outer sheath is not sufficient grounds to change the cables

6. With the tonneau cover still held in the vertical position, support the tension bow with a suitable prop taking care not to damage any trim (see figure 6)
7. Remove the original cable tie securing the Bowden cable (C) to the tonneau cover drive system and discard the clip securing the Bowden cable at point D, securing point D is not used with this revised clip arrangement (see Figure 1)

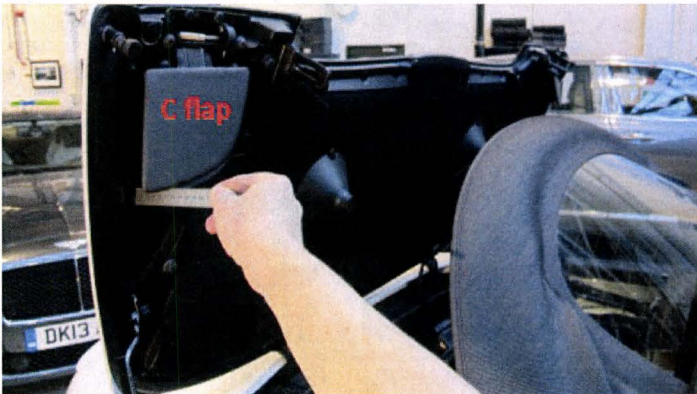
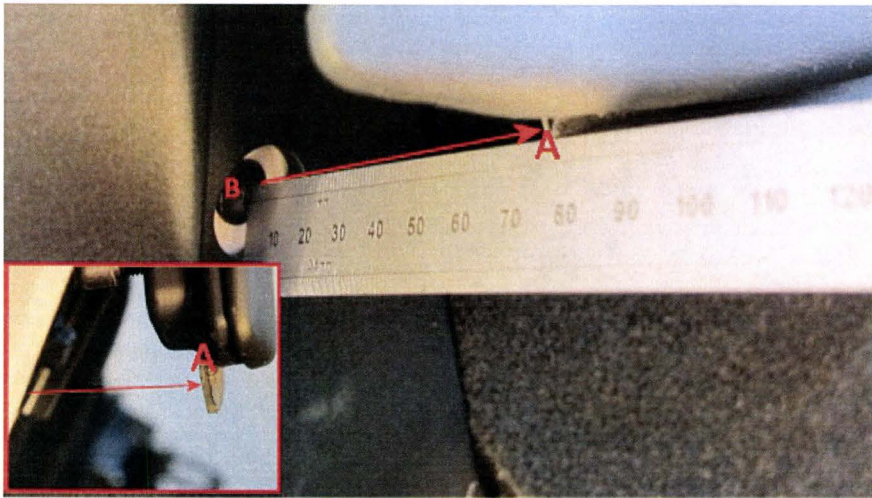
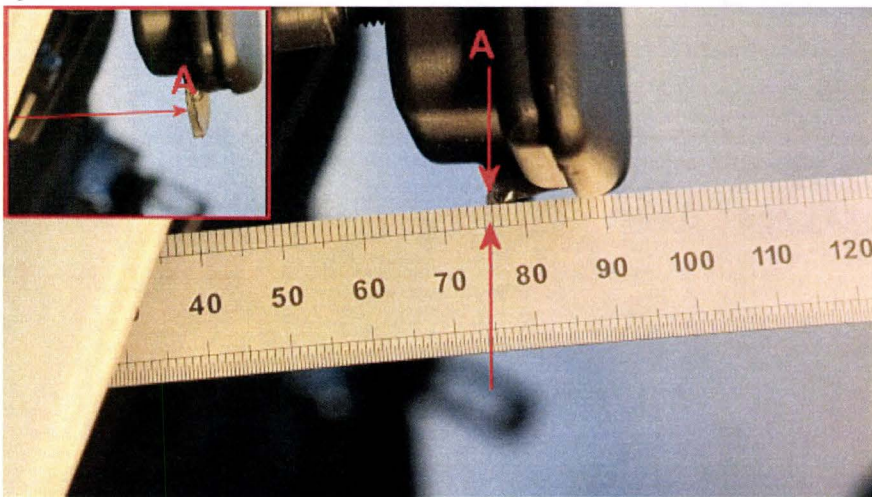
5. Referencing figures 3, 4 and 5 take a measurement between point (A), C flap obscuration lip, and (B), tonneau brightware securing bolt head. The correct specification for this measurement is 74mm to 90mm. If this measurement is not to specification or the C flaps are out of synchronisation or judder during operation then refer to TPI 2033467 to carry out C flap Bowden cable replacement. If the C flap is to specification then perform the revised clip arrangement
