Technical product information

Topic	Bentley Continental Series - Power boot close switch - Correct diagnosis
Market area	Worldwide Bentley (1WBE)
Brand	Bentley
Transaction No.	2033745/2
Level	EH
Status	Approval
Release date

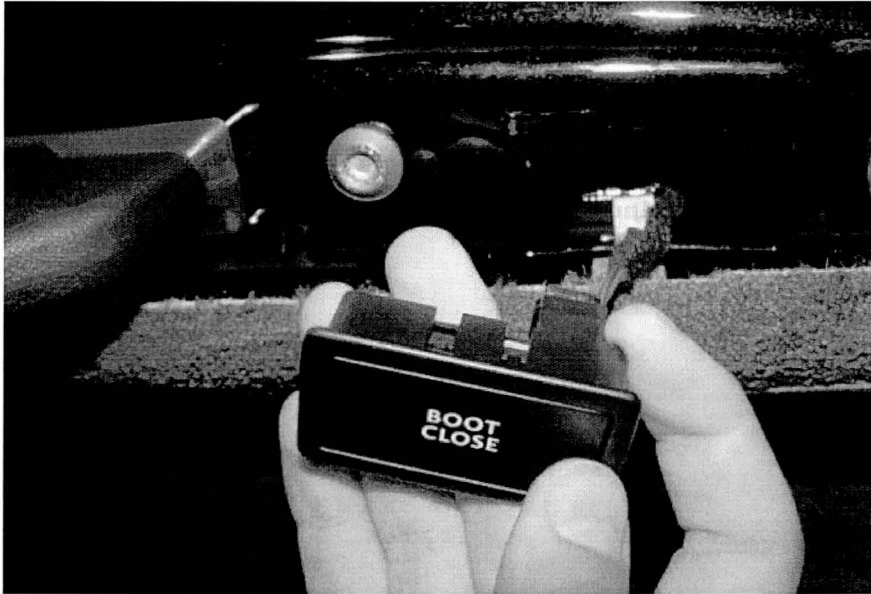
Figure 2

-With the boot close switch hanging in free air press the switch to check if the boot lid starts to close, should this be the case and the boot lid starts to close the switch is serviceable, you should now proceed with procedure 6 **NOTE:** should the boot not start to close proceed to procedure 5

4. Reconnect the switch to the electrical connection (Figure 2) allowing the switch to hang in free air

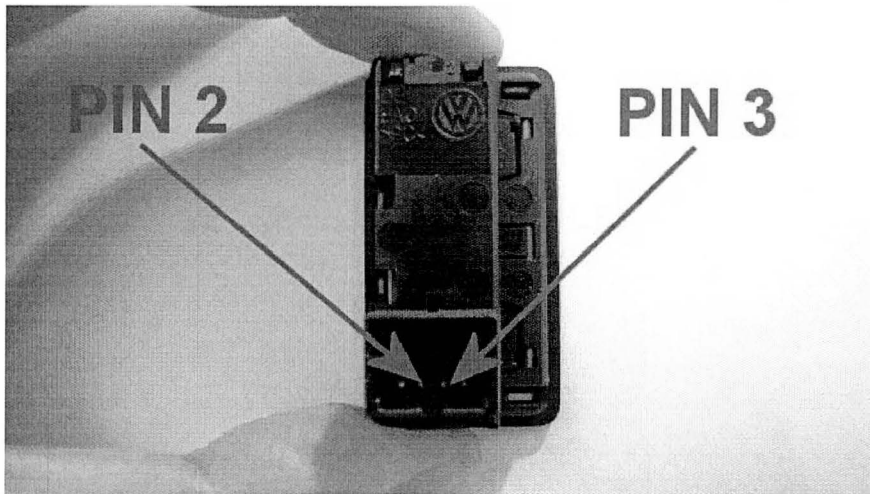
Figure 3

The resistance for a fully serviceable switch when operated (pressed) is 0.2 Ohms

- Measure the resistance between pins 2 and 3 (Figure 3) The button on the boot close switch must be pressed and held in otherwise a correct reading will not be obtained
